Santa Cruz Wharf Engineering Report

October 8, 2014

Engineering Evaluation Summary

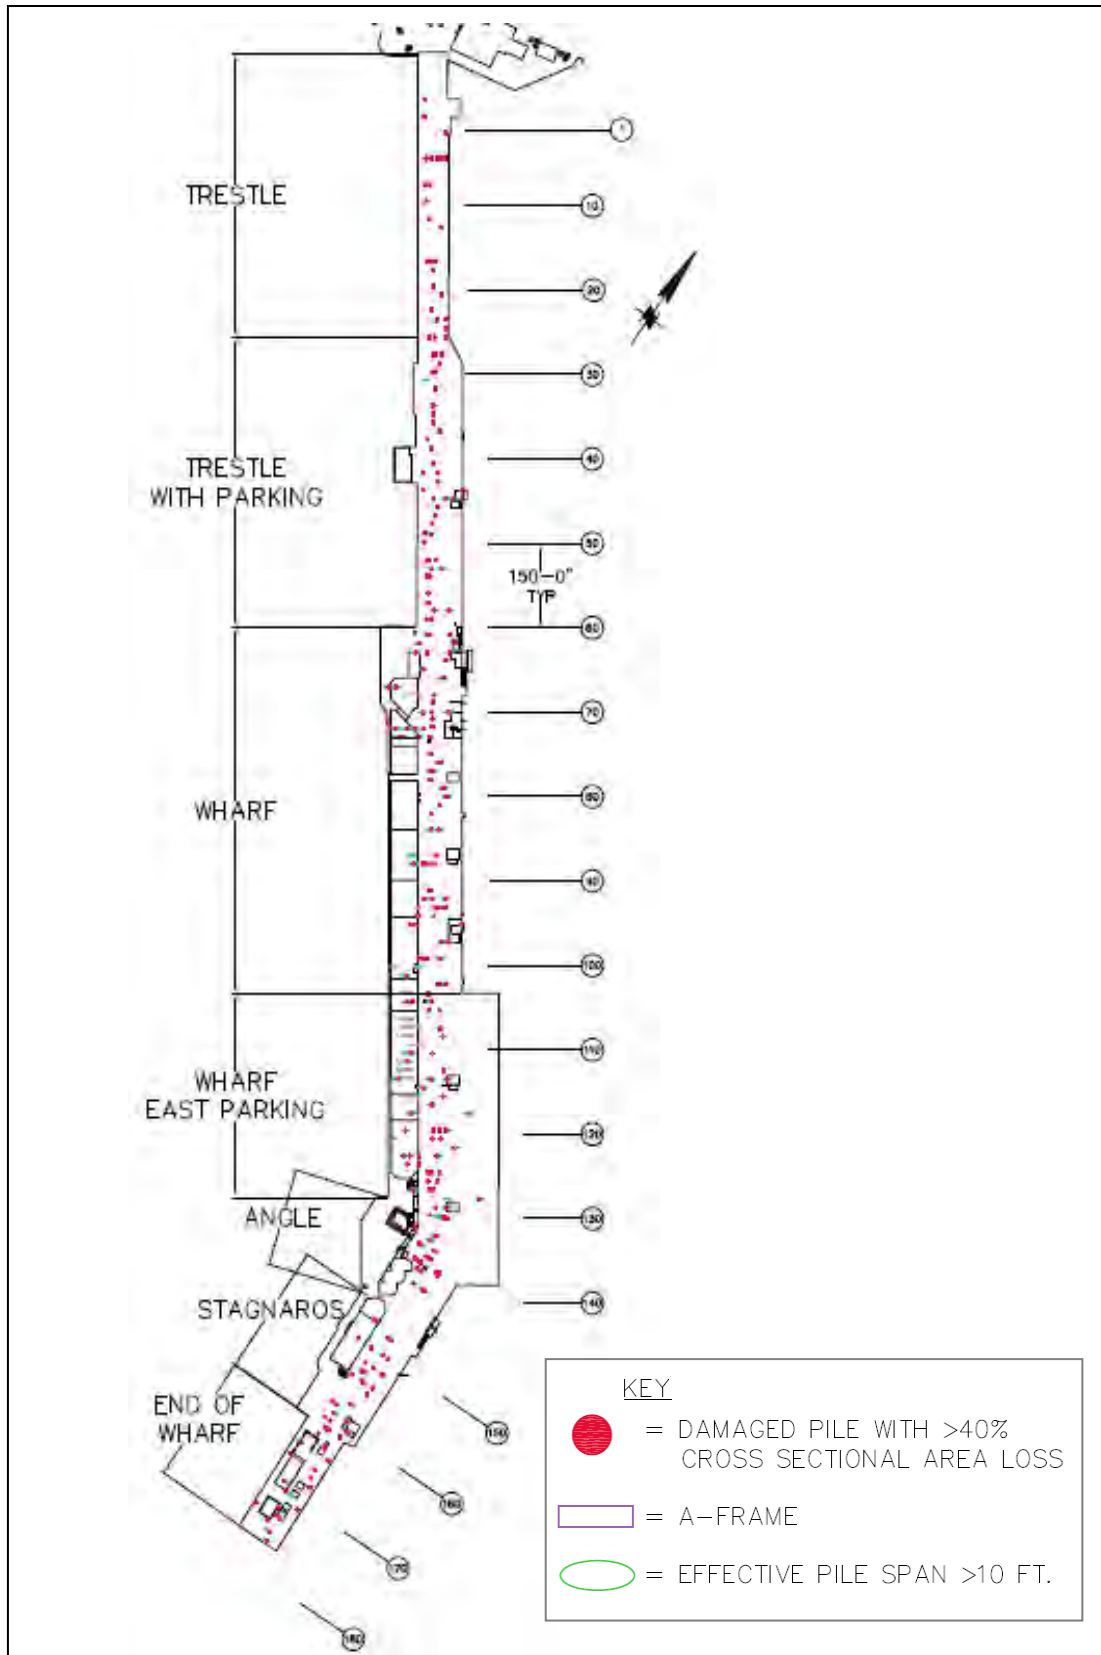
Figure 1-1: Piling Survey Summary Plan

The piles are in good condition, overall. Less than 5% of the 4,450 piles need replacement. Notable exceptions are underneath buildings where replacement is difficult with the building structure in place. A major factor contributing to the longevity of the piles has been the practice of using Douglas fir piles treated with preservative (different treatment methods have been used on the existing piles depending on the time period they were installed. Observed damage to the piles is caused by storm waves, floating logs and marine borers. There is some presence of marine borers (Teredo) in the piles as observed in damaged piles during the inspection. The continued replacement of damaged piles by the Wharf staff will allow the continued functioning of the Wharf well into the future.

- Continuing full time Maintenance crew to replace piles as damaged,
- Use of treated piles for replacement
- Addition of piles for lateral stability and where required for additions to the Wharf

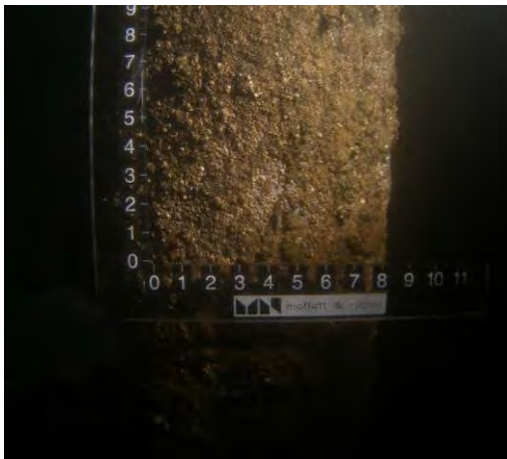
Photo 1-2: Typical non-damaged pile in “excellent” condition

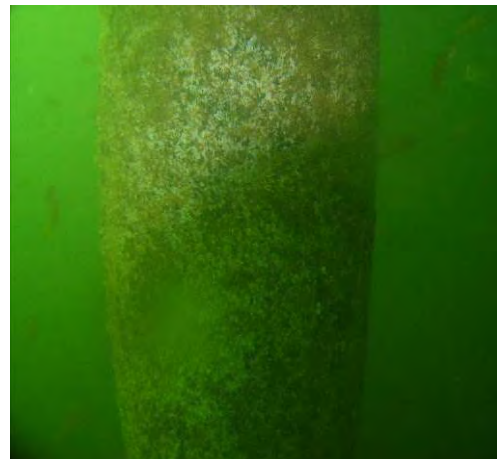
Photo 1-3: Typical non-damaged pile in “excellent” condition

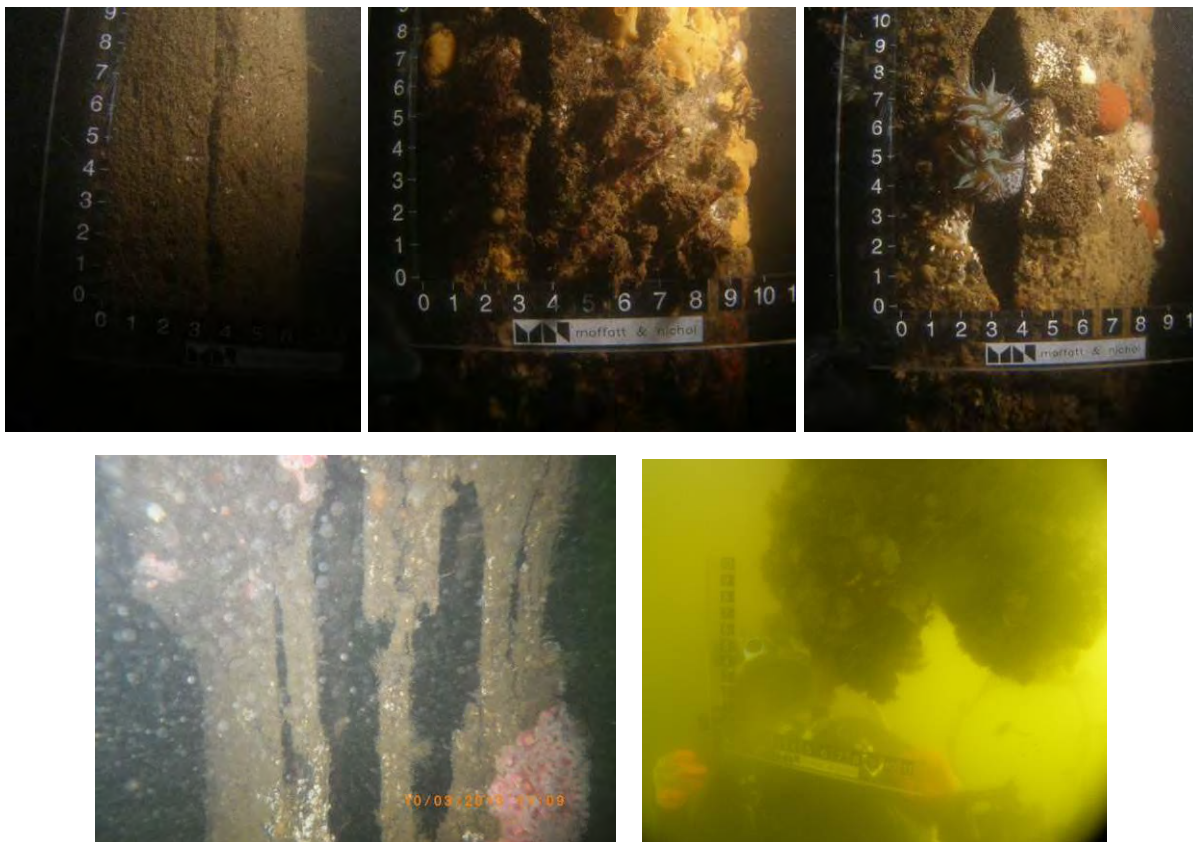
Pile damage at Santa Cruz Wharf was observed to follow a pattern (see Photo 1-4):

- A split develops in the grain of pile surface.
- The split deepens and provides access to the untreated interior of the pile for marine borers. The pressure-treated preservative treatment only penetrates the outer circumference (approximately 2 in.) of the pile. The marine borers consume the untreated wood inside the preservative-treated ring.
- It is not uncommon for the exterior preservative-treated pile shell to remain, with the interior hollowed-out by the Teredo.

Photo 1-4: Stages of Pile Deterioration

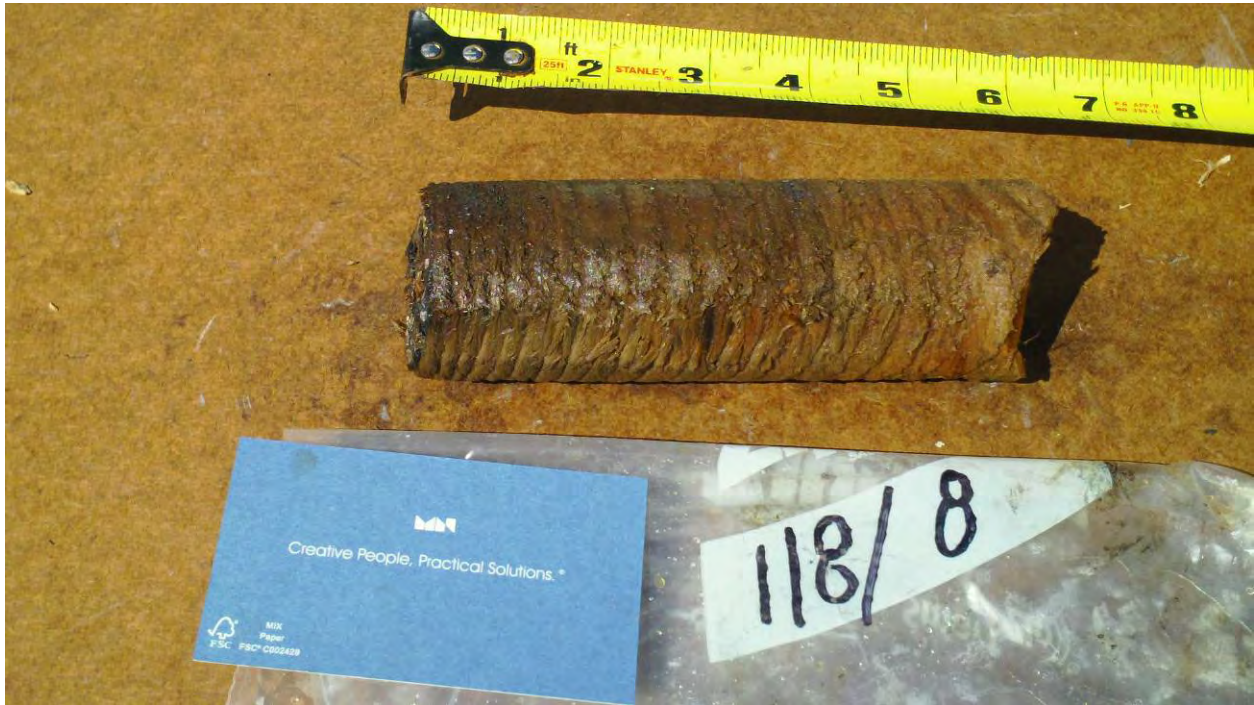
Photo 1-5: Typical Core (From Pile 8 on Bent 118)

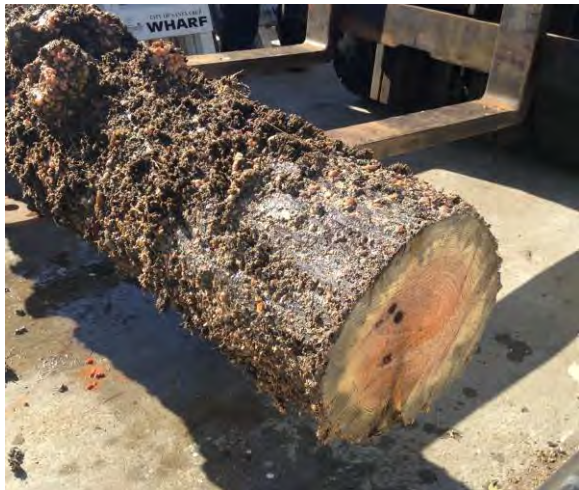
Photo 1-6: Pile with Teredo damage

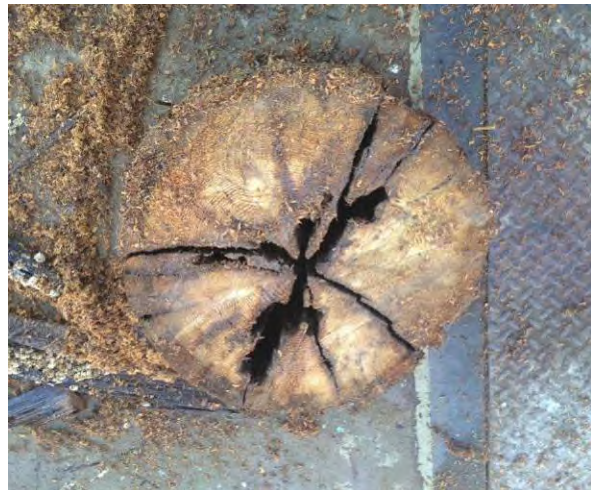
Photo 1-7: Pile with Teredo damage

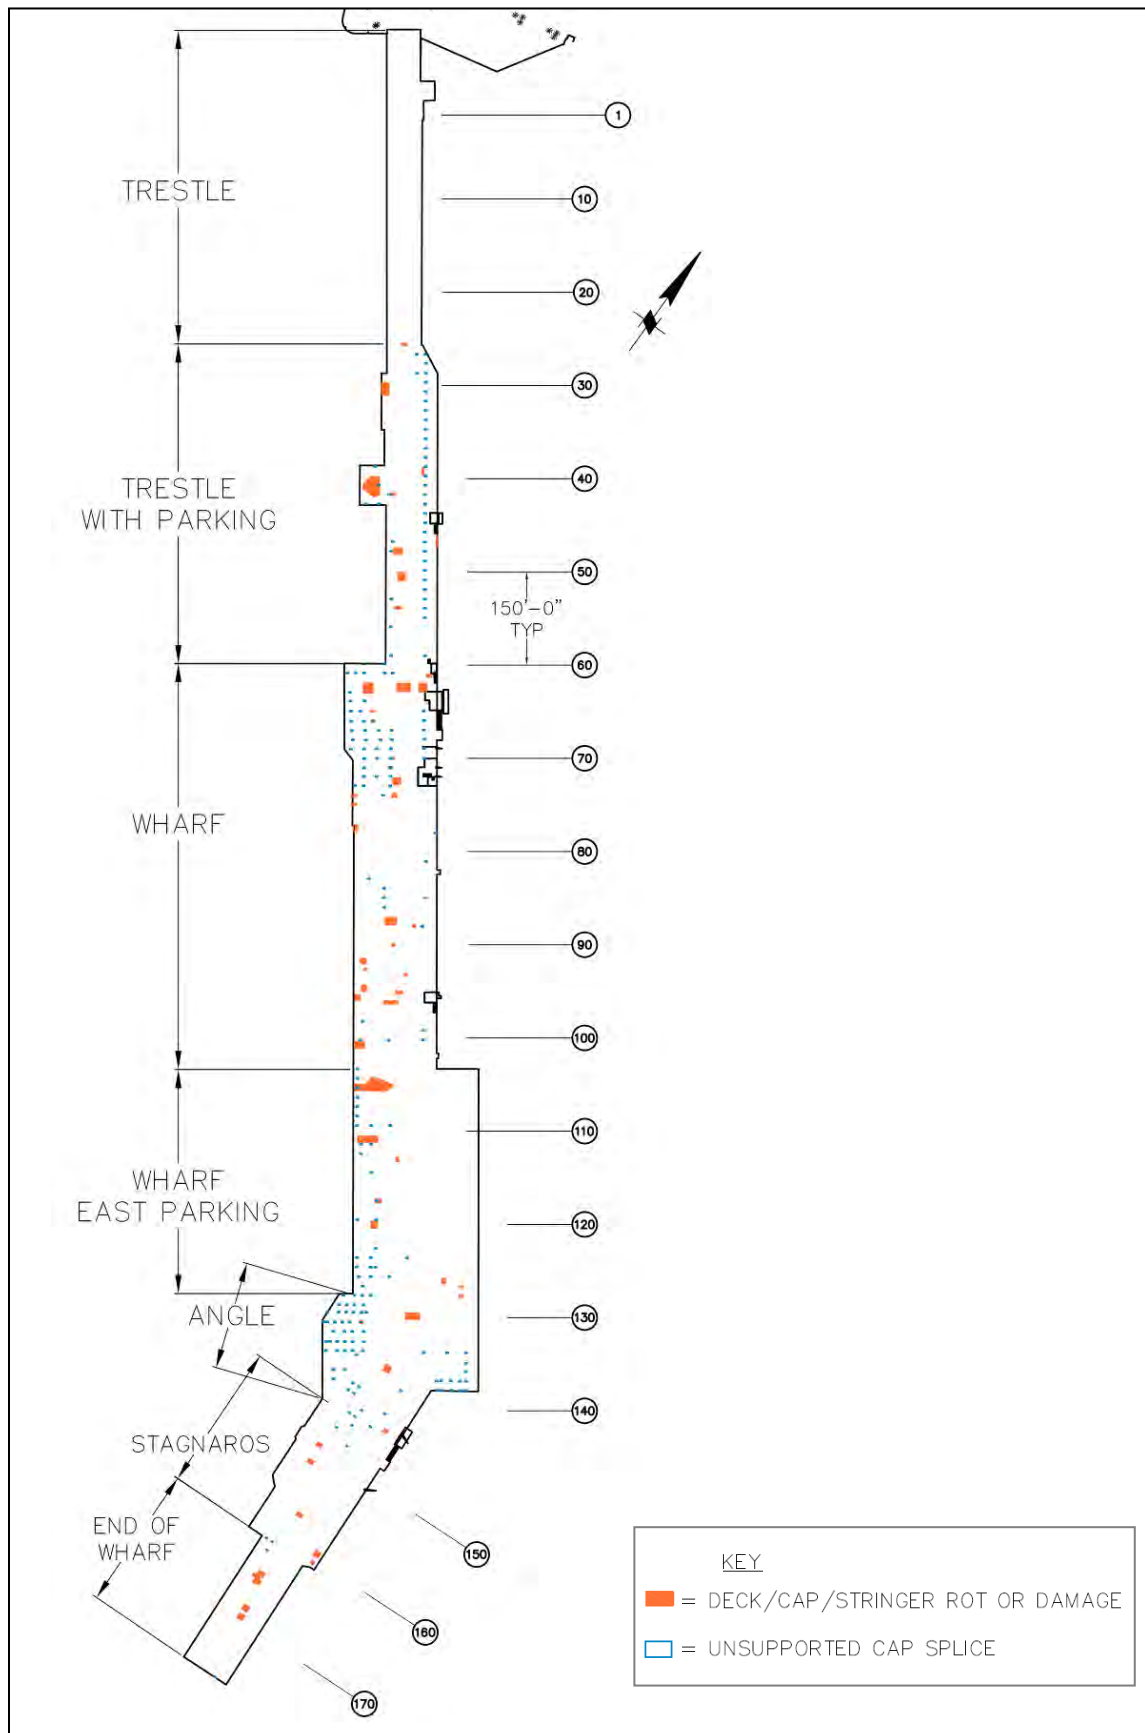
Figure 2-2: Structural Evaluation – Substructure Damage Plan

- Replace deteriorated stringers, decking, and caps
- Installation and improvement of connections to stringers and caps
- Reduce large vehicle access onto the Wharf and mark restricted areas
- Retrofit turnaround areas to increase the load capacity and test existing wharf timbers to if higher load capacity is sought
- Design the new East Promenade for a 36,000 lbs. axle load

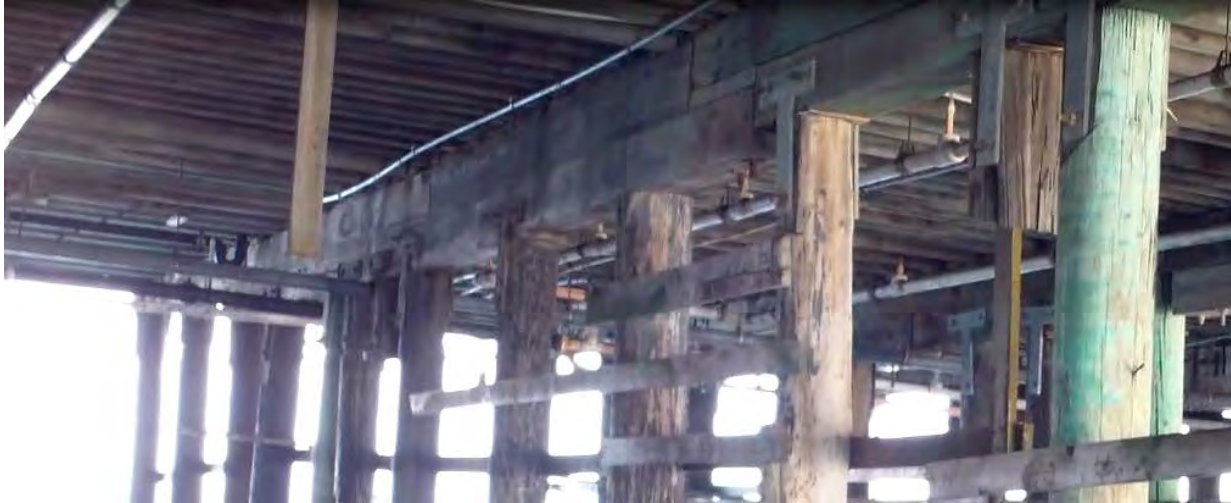
In general, cap splices on the Wharf have been created by adding an additional cap below the splice, creating two layers of cap. Ideally, these are located over a pile. A photo showing such a splice is Photo 1-34 (Attachment 1A). The interior portion of most of the Wharf has many segments of double cap, probably due to the Wharf elevation change and/or the addition of new piles on the west side of the Wharf. See Photo 2-13 for a typical example. Near Stagnaro's, there are some locations where there is a triple cap.

Photo 2-13: Long segment of double cap with multiple splices (Bent 165, looking east)

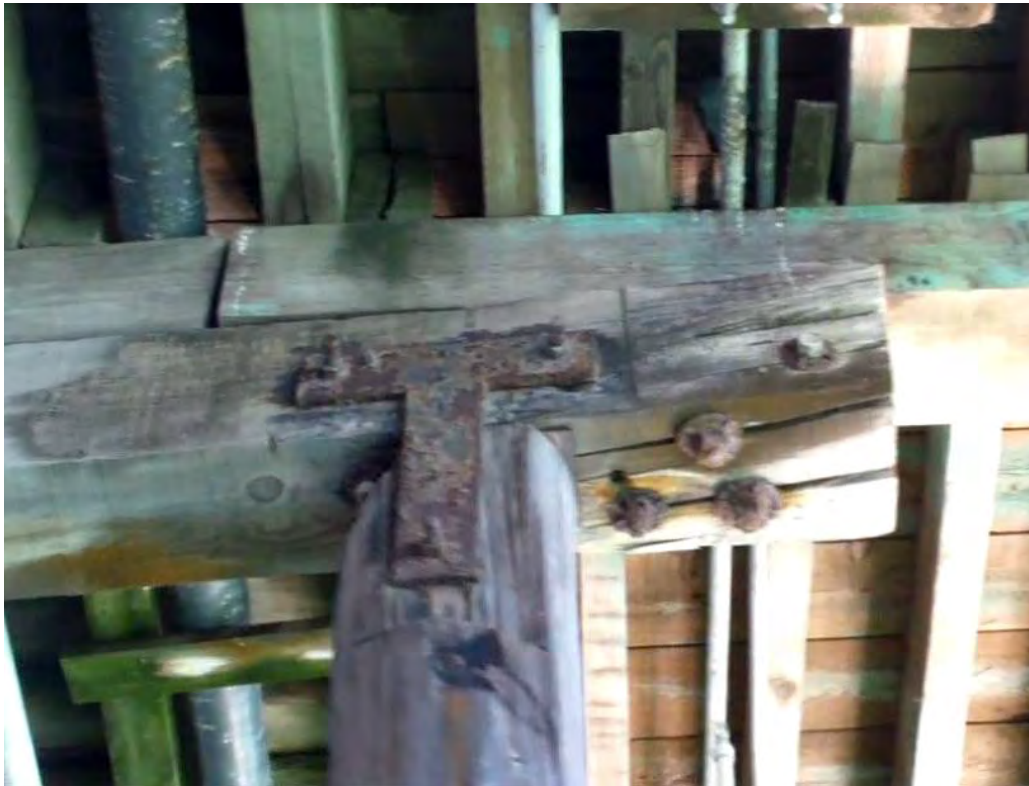
The caps and stringers that support the decking are in serviceable condition. The structural strength of some members has deteriorated where wetting has occurred due to water leakage, particularly below the buildings and kiosks. Such deterioration was observed on the underside of the Wharf along the east edges of the buildings and beneath the west walkway at the older Wharf joint. Some stringers, decking, and tops of caps appear soft and require replacement. Some caps and cap splices have large splits in them from the edge to the first bolt (Photo 2-14). In general, the wood around the splits is still in adequate condition. These areas are shown on the drawings in Attachment 2B and a summary of the major areas of rot is presented in Table 2-1.

Photo 2-14: Cap Splitting at End – Bent 62, Pile 3

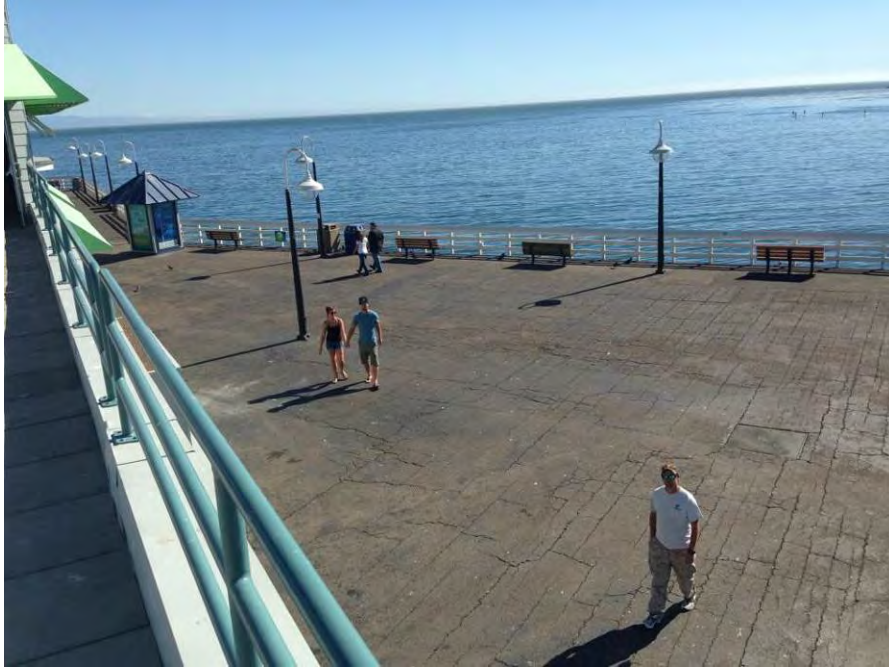
The walkway on the west side of the trestle is asphalt and on the east side is recently constructed stamped concrete. The surfacing in front of the buildings is mixed asphalt and concrete. There are a number of ramps and other structures that protrude into this walkway. The walkway surfacing is in good condition along most of the Wharf. Cracks in the surfacing are minor and there are no significant areas of unravelling of the pavement. A notable exception is the south Commons area that has reflective cracks in the asphalt surfacing (see Photo 4-5). These cracks are visually apparent but do not present a significant trip hazard or reduce the function of the walkway.

Photo 4-5: Pavement on South Commons

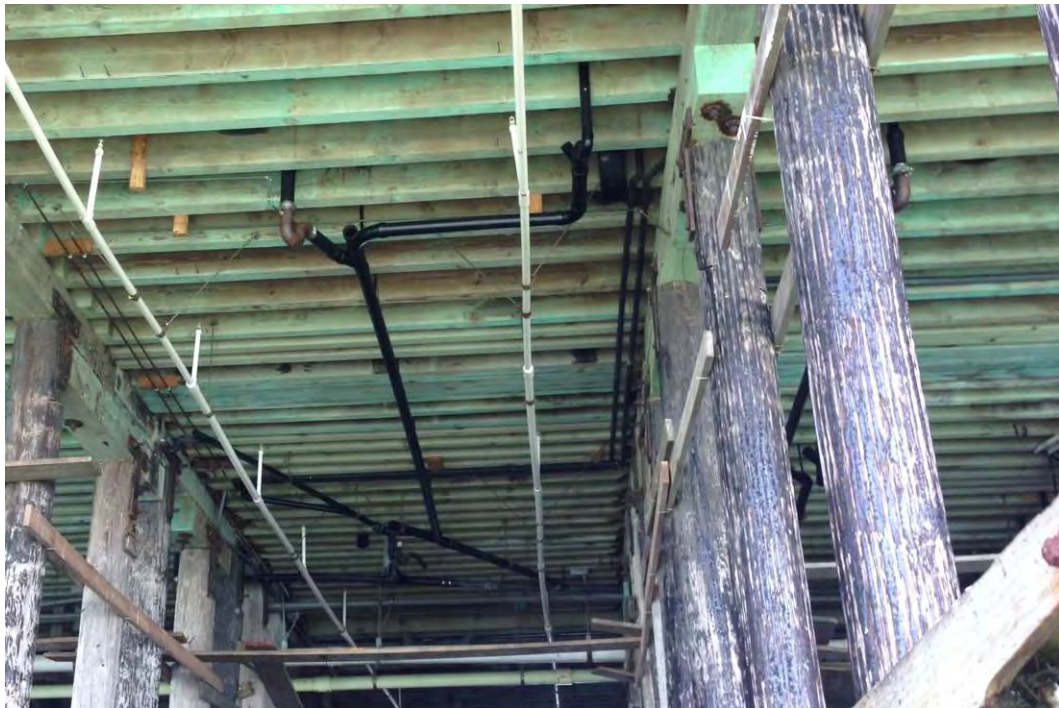
Photo 5-2: Lateral line at Bent 128, New Construction

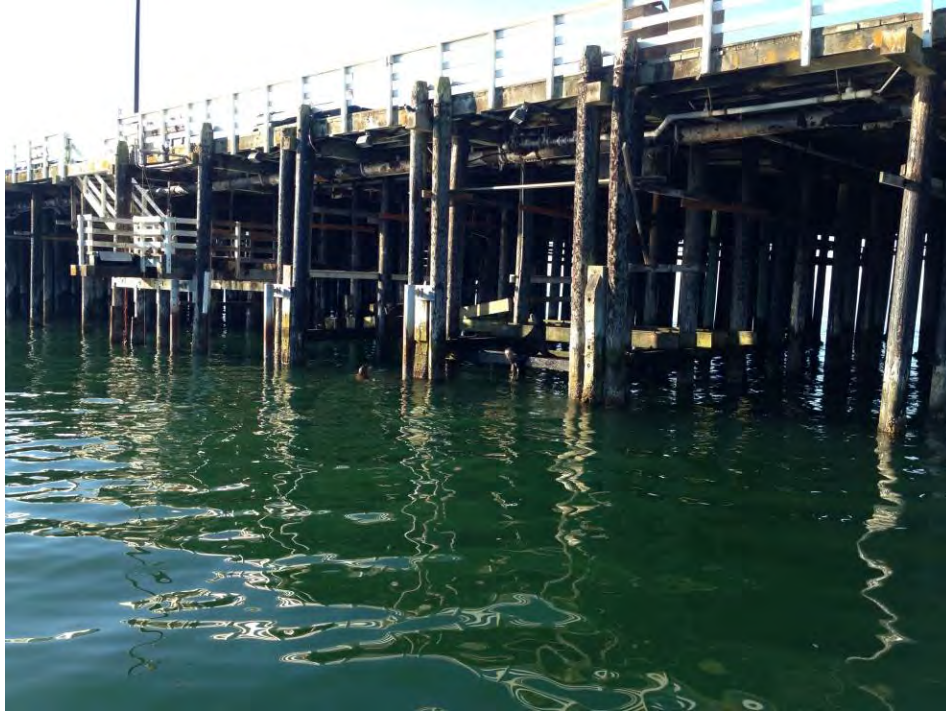
Photo 8-5: Stagnaros Landing (abandoned)

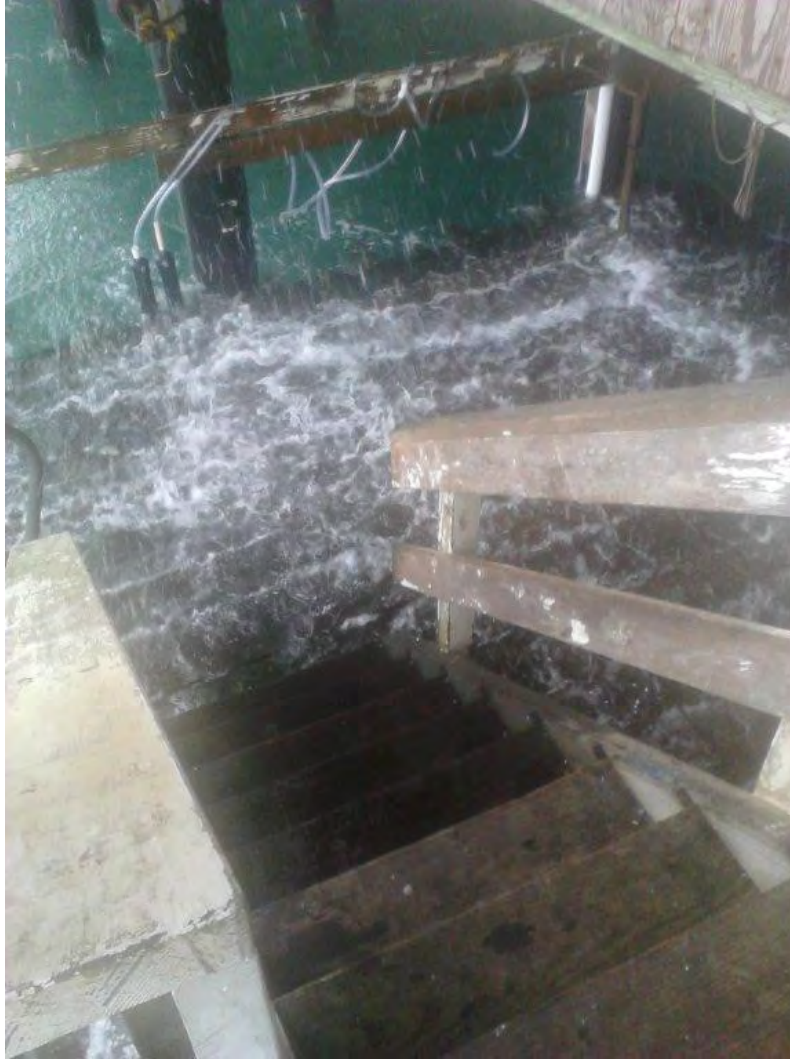
Photo 8-7: Wave Uplift at Existing Wharf Staff Landing
