Santa Cruz Memorial Park Crematorium Project

Tree Resource Analysis/ Construction Impact Assessment

Santa Cruz Memorial Park Crematorium Relocation Project

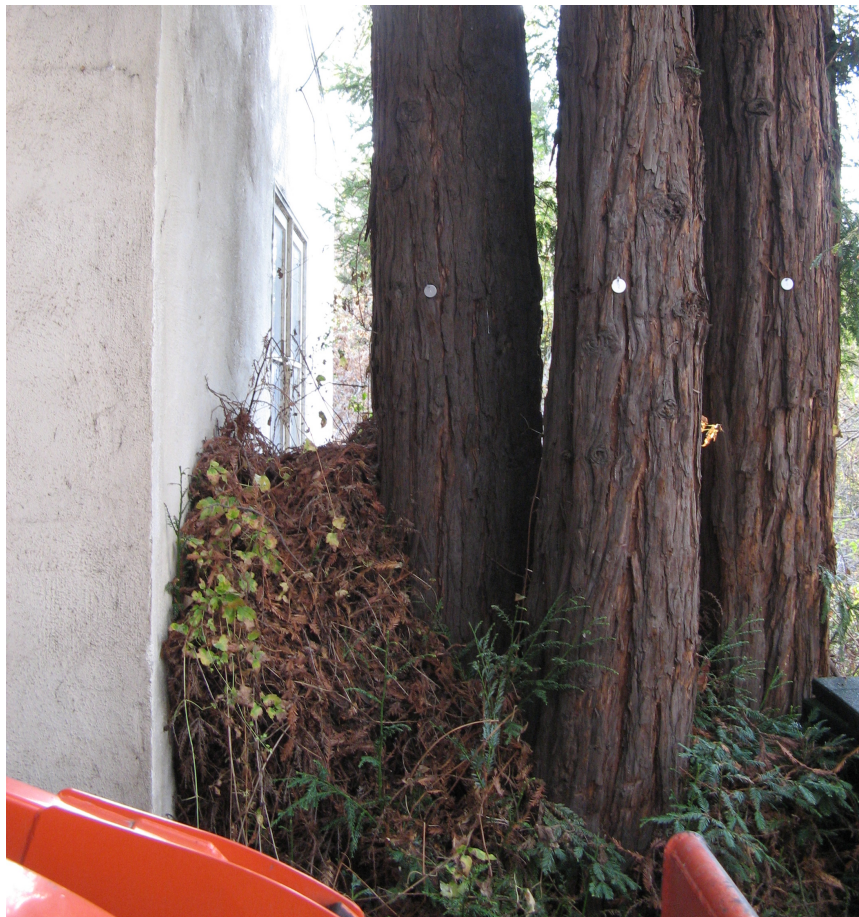
Trees #2 through 7, coast redwoods *Sequoia sempervirens*

This tree/tree group is composed of six trunks growing within 18 inches of the existing building. Tree trunks are **codominant** with **imbedded bark** and **poor trunk/stem attachments**. The canopy of this tree/tree group is thin with lighter green colored foliage indicating a fair state of health.

Each of the tree/tree groups grows in proximity to the existing building. Although currently there is no visible damage, there may be unseen damage and/or damage may occur in the future from root development.

The foundation to be constructed near Trees #2 through 7 could be designed at greater depth and width to help prevent damage from future root growth.
