**ARBORIST REPORT  
AND  
TREE PRESERVATION PLAN  
190 WEST CLIFF DRIVE  
SANTA CRUZ, CALIFORNIA**

**PREPARED FOR  
ENSEMBLE INVESTMENTS**

**SITE OBSERVATIONS:  
MAY 8, 2018**

**Arborist Report  
190 West Cliff Drive  
Santa Cruz, California**

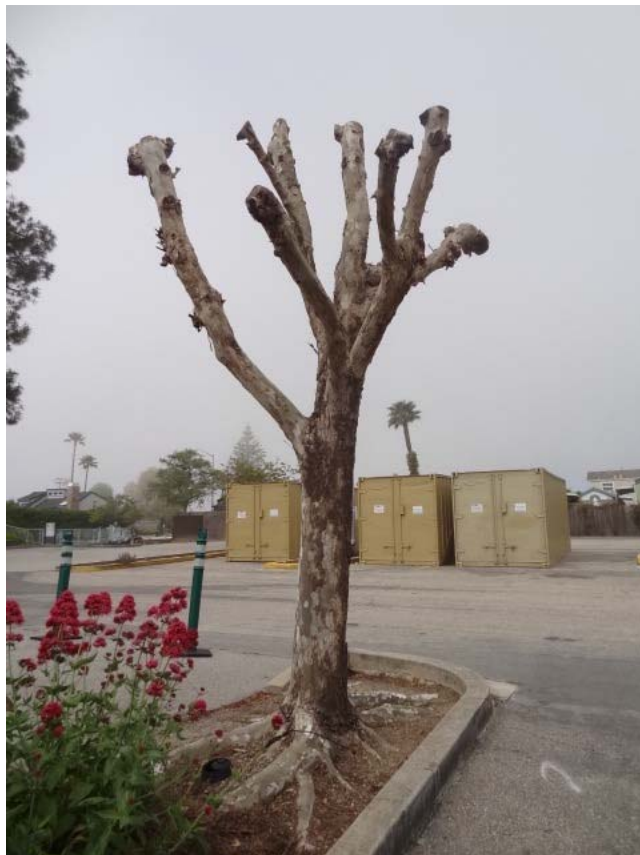
The Yarwood sycamore (*Platanus acerifolia* ‘Yarwood’) trees are examples of good health, but poor structural integrity. All of these trees have been “Topped” since the Coate report, August 26, 2017. Coate had also reported that these trees had been topped.

This photo is Tree # 22. It is representative of all of the Yarwood sycamore trees at this site. They currently have no leaves or side branches. There is no canopy at this point. Each one has been “topped” at 8-10 feet. I expect that, by mid-summer, their canopies will be approximately 15 feet wide, possibly wider. However, most of these are not irrigated. How much they will grow after a 5-year drought, no current irrigation, and having been topped, is uncertain.

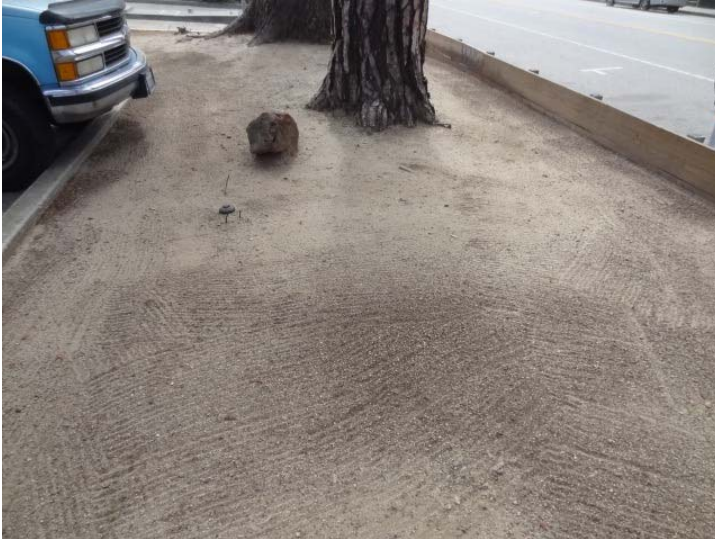
The surface soil is raked clean by the landscape maintenance crew and there is no organic material on the surface; if mulch were present, it would hold moisture for a longer period. This is seen in the following photo. It appears that this sandy soil dries quickly.

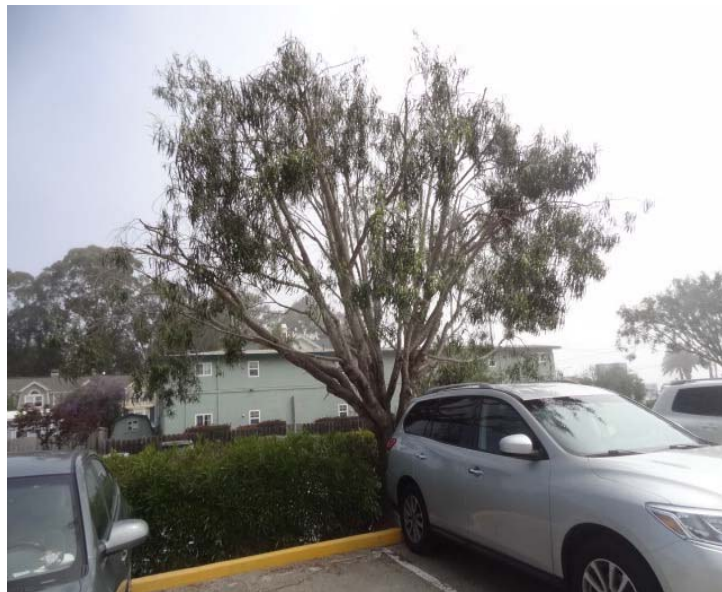
The following photo of Australian Willow Tree # 34 shows a moderately sparse canopy. This is fairly typical of all of the Australian willow trees on site at this time. The reduced canopies are primarily a result of drought stress.

Since Mr. Coate's report, the tops of these trees have been reduced by 10 -15 feet.

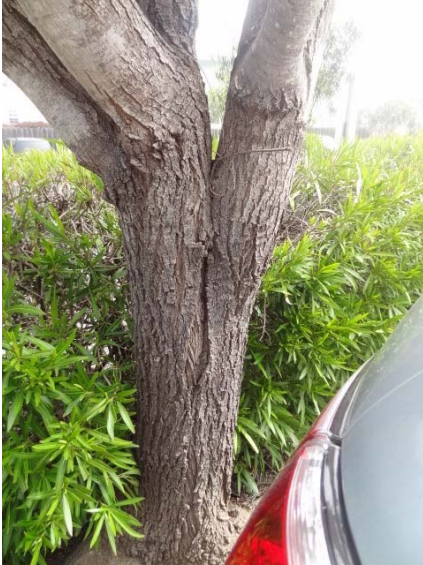
This photo shows the trunk of Australian Willow Tree # 34. This tree has a long vertical seam between the two primary leaders, referred to as Co-Dominant Leaders with Imbedded Bark. This often results in the tree splitting apart. In this case, the actual attachment is about 18-24 inches above grade.

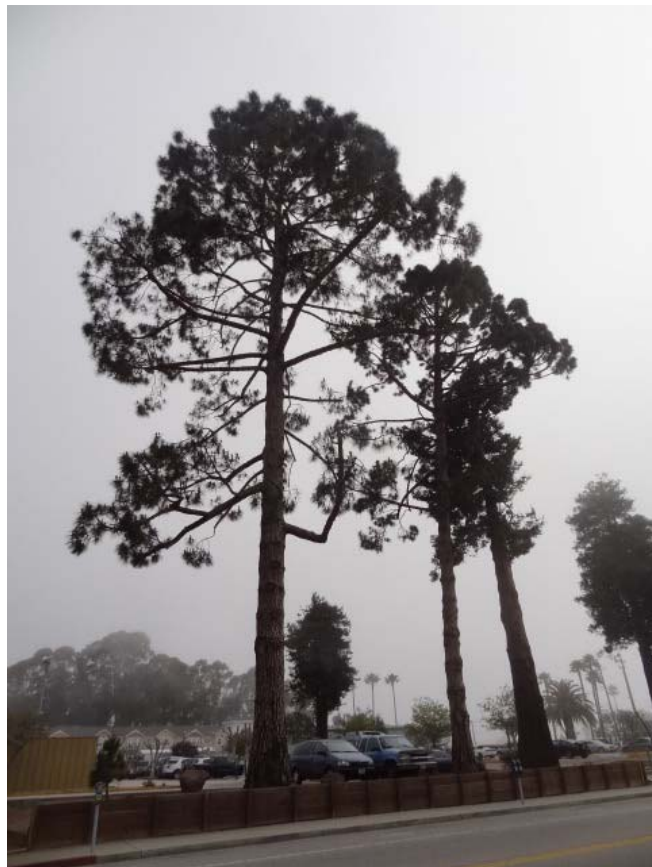
The photo at right shows Trees # 5, 6, 7 (right to left) in the foreground with Tree # 32 (center) at a distance. A portion of Tree # 4 is seen in the lower right corner.

Tree # 5 is reasonably dense.

Tree # 6 is healthy, but only has canopy in the top 20% of its structure. This structure is more prone to wind throw failure, especially if Tree # 7 were to die or be removed. Tree # 7 appears to buffer the wind force somewhat.

The canopy of Tree # 7 is sparse except for the top of the canopy.

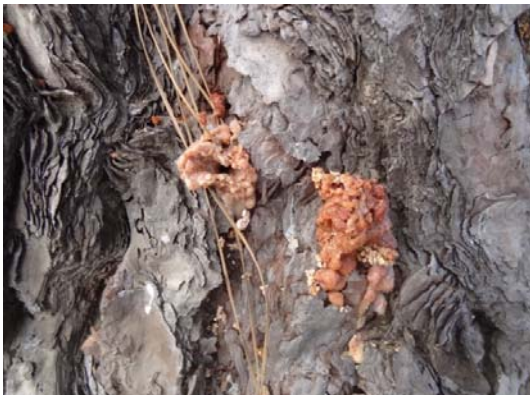
However, Tree # 7 is under attack by the red turpentine beetle (*Dendroctonus valens*). The photo on the left shows 2 exit holes. I counted 16 of these exit holes on the northeast side of the trunk. This insect attacks conifers that are suffering from drought stress. The larvae bore a gallery of tunnels in the vascular tissue, where eggs are hatched.

The gallery created by each individual red turpentine beetle cuts off a portion of the vascular system of the tree. The damage can typically be stopped by irrigating the tree. Because of the number of exit holes observed, I predict this tree will be dead in a year if no irrigation is provided or if the irrigation is insufficient.

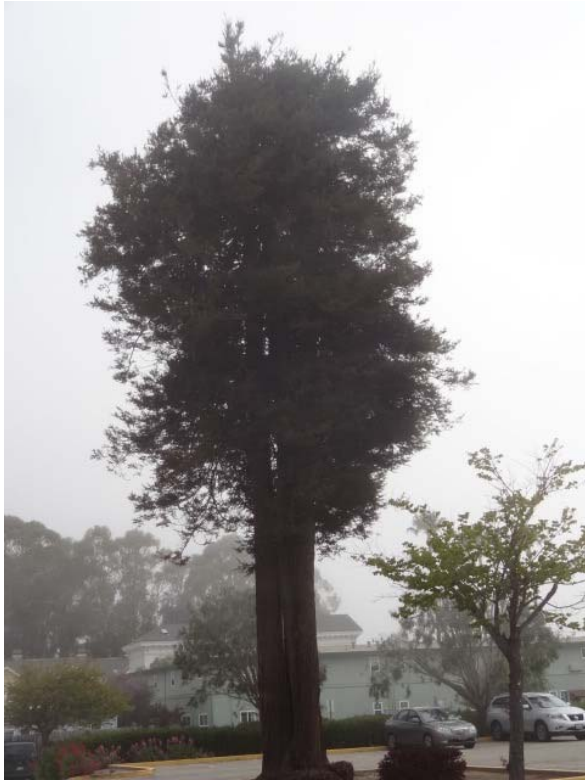
The photo on the right shows Coast Redwood Tree # 4 (*Sequoia sempervirens*). The top 20-30 feet of the canopy is sparse. This is commonly caused by a lack of irrigation.

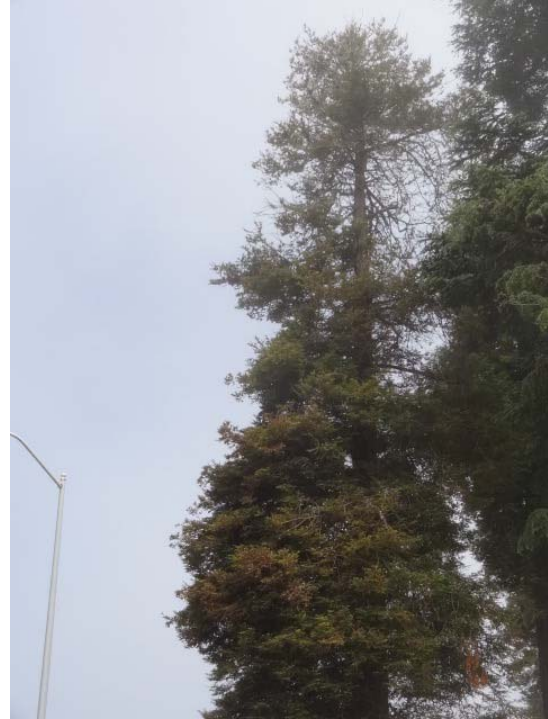
Tree # 32 (*Sequoia sempervirens*) is shown in the photo on the left. This specimen has a dense canopy to the top and appears to be faring better than many of the other trees on site.

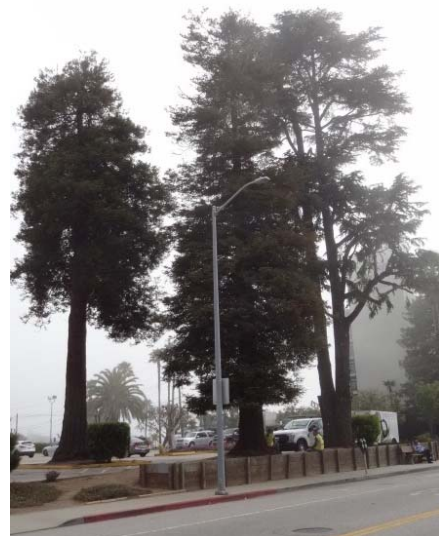
Tree # 51 (*Sequoia sempervirens*) is seen on the left side of this photo on the right. Tree # 51 has a dense canopy that is only slightly less dense at the top, which would recover with irrigation. Overall this tree is in good condition.

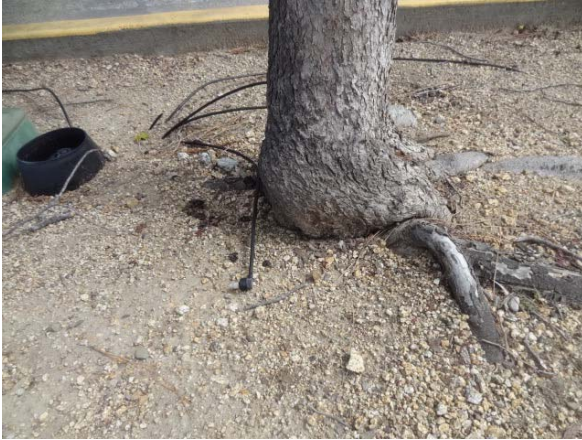
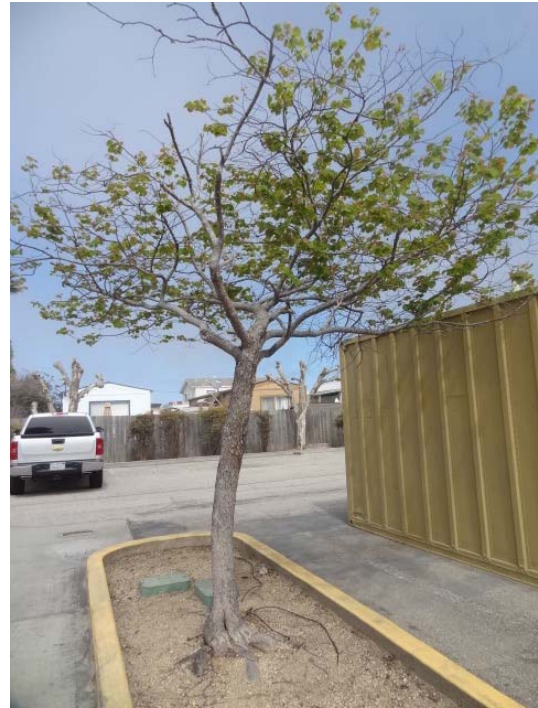
Tree # 57, a Canadian Redbud (*Cercis Canadensis*). The sparse canopy and die-back may be partially explained by the fact this tree has girdling roots, as seen in the photo below of its root collar.

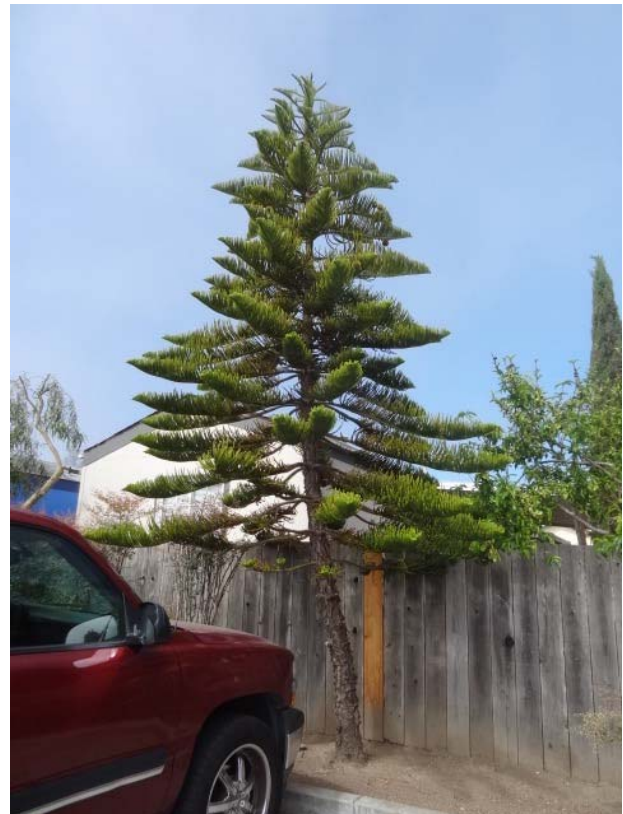
Tree # 58, Norfolk Island Pine (*Araucaria heterophylla*). This tree is in excellent condition. It is a species that can become very large.
