Gary B. Griggs
Registered Geologist No. 3277
Certified Engineering Geologist No. 1282
321 Alta Avenue - Santa Cruz, CA 95060
(831) 332-9318 - griggs@ucsc.edu

October 2, 2018

RE: EVALUATION OF POTENTIAL IMPACT OF EXCAVATION ON THE 190 WEST CLIFF DRIVE PROJECT SITE ON COASTAL BLUFF STABILITY

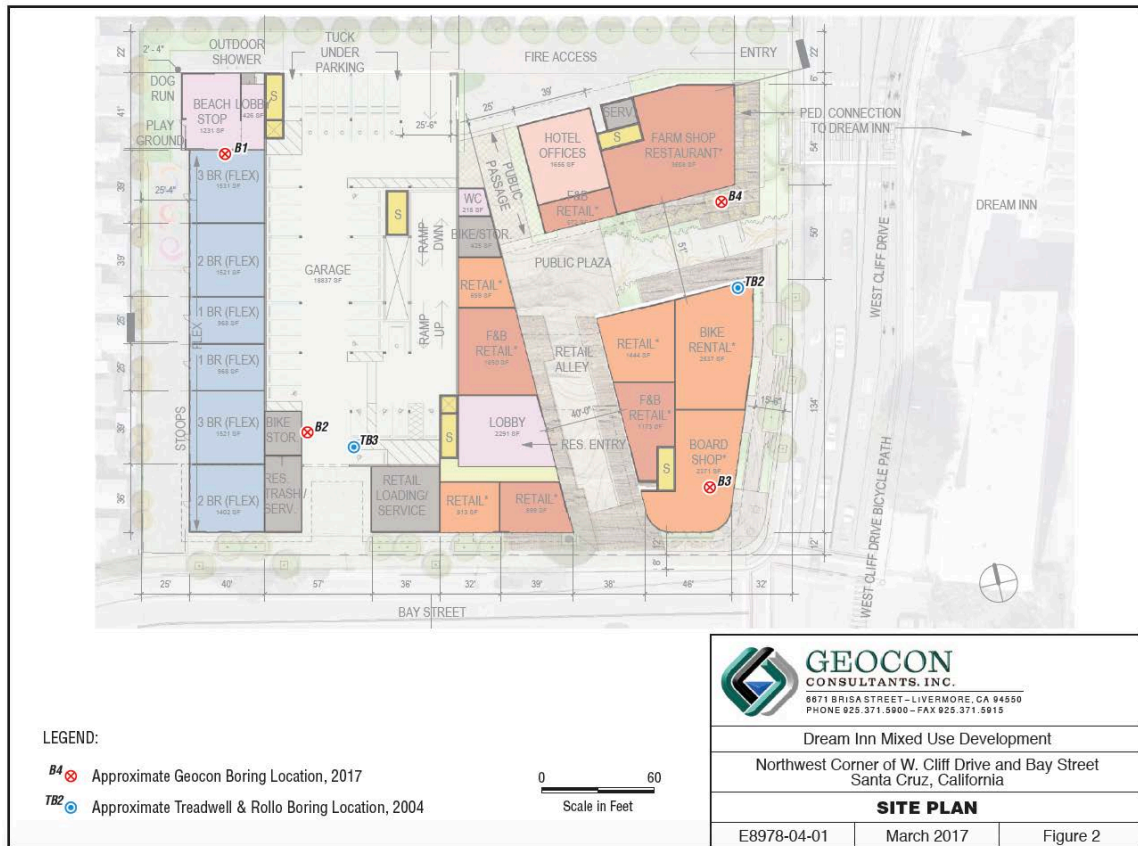
Five borings across the site from geotechnical investigations in 2004 and in 2017 extended to depths of 19.5 to 29.5 below grade and penetrated six to sixteen feet of the Purisima bedrock (Figure 1). As a standard measure in soil engineering of the hardness and density of subsurface materials a 140 pound sampling device is dropped repeatedly from a height of 30 inches in order to determine how many of these "blows" are required to drive the soil sampler 12 inches. Twelve of these measurements were obtained during boring within the overlying terrace deposits, with values ranging from 10-29. This material is thus categorized as *loose to medium dense*. A total of thirteen of these tests were performed within the Purisima Formation. One value was in the *dense* category (Dense = 30-50 blows to drive the sampler 12 inches) and all of the rest were in the *very dense* category (Very Dense > 50 blows to penetrate 12 inches). In contrast to the overlying sandy terrace deposits, the Purisima is dense bedrock. This can easily be observed along the lower bedrock portions of the bluff along West Cliff Drive, immediately up coast from the Dream Inn and beneath the pool area of the Dream Inn.

Figure 1. Site plan and locations of soil borings from both Treadwell and Rollo (2004) and GEOCON (2017).

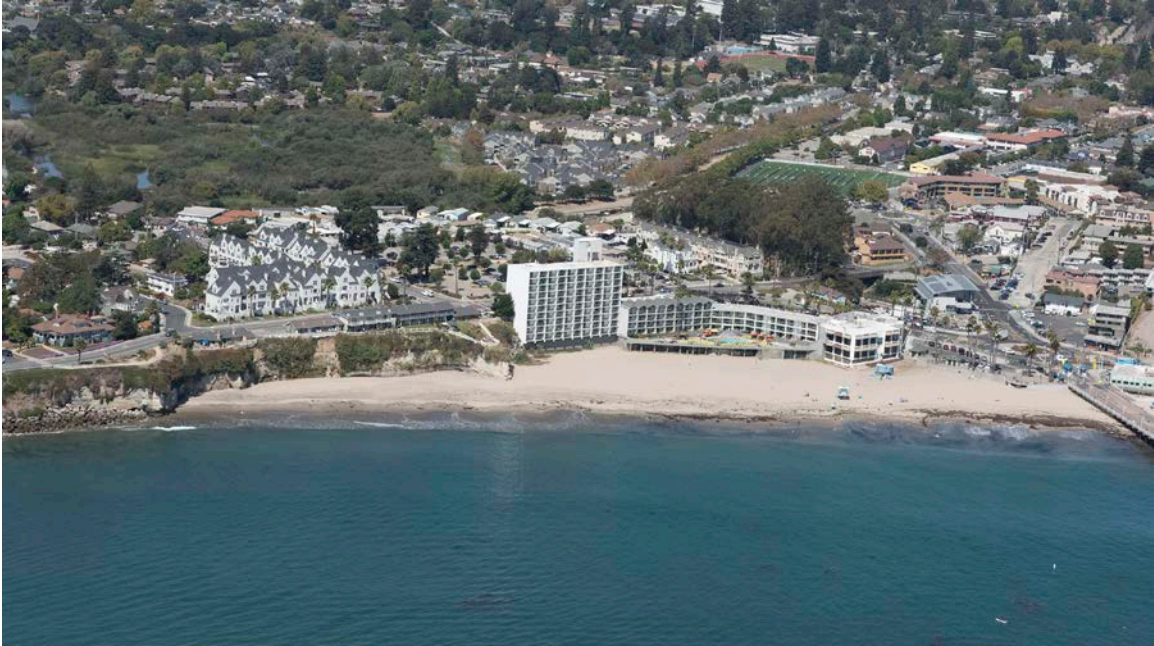
was occurring. However, because of the shoreline orientation along Cowell's Beach from just upcoast of the Dream Inn and extending to the Santa Cruz Small Craft Harbor and beyond to Soquel Point, sand has accumulated to form a wide protective beach such that waves rarely reach the base of the bluff (Figure 2). Waves have washed completely across the beach during severe El Niño years, when elevated water levels coincide with high tides and storm waves (e.g. the 1983 and 1997-98 winters, for example).

Figure 2. Wide sandy beach fronting Dream Inn. Note rip-rap and lack of beach immediately to the left (upcoast). (2015 photo from California Coastal Records Project)

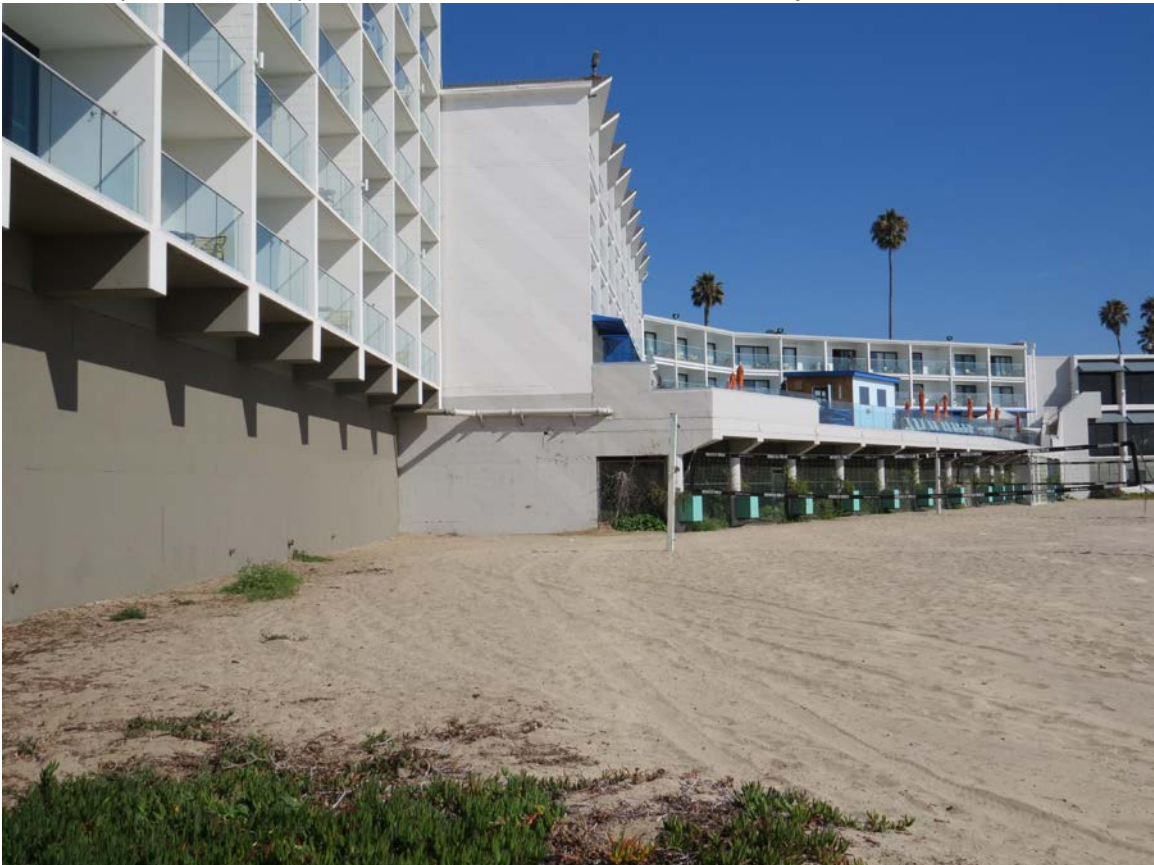
"The existing hotel has foundation elements that armor the bluff and prevent it from eroding... These include: concrete piers and grade beams seaward of the pool and at the restaurant, as well as a continuous concrete wall across the front of the ten-story section."(Figures 3 and 4). These foundations and coastal protection structure elements have historically retarded coastal erosion seaward of and underneath the hotel." The upcoast area (actually the bluff at the south corner of the Dream Inn) has also been armored with rip-rap, further strengthening the bluff.

Figure 3. Protection of the bluff fronting the Dream Inn. The concrete wall on the left beneath the 10-story hotel portion spans 140 feet of hotel frontage. The restaurant on the far right is

protected by 150 feet of concrete wall. In the middle beneath the pool, 235 feet of the bluff is partially protected by a series of concrete caissons and also by a chain link fence, which helps to dissipate any wave energy that might reach this far inland during extreme storms and also prevents logs and debris from impacting the Purisima bedrock.

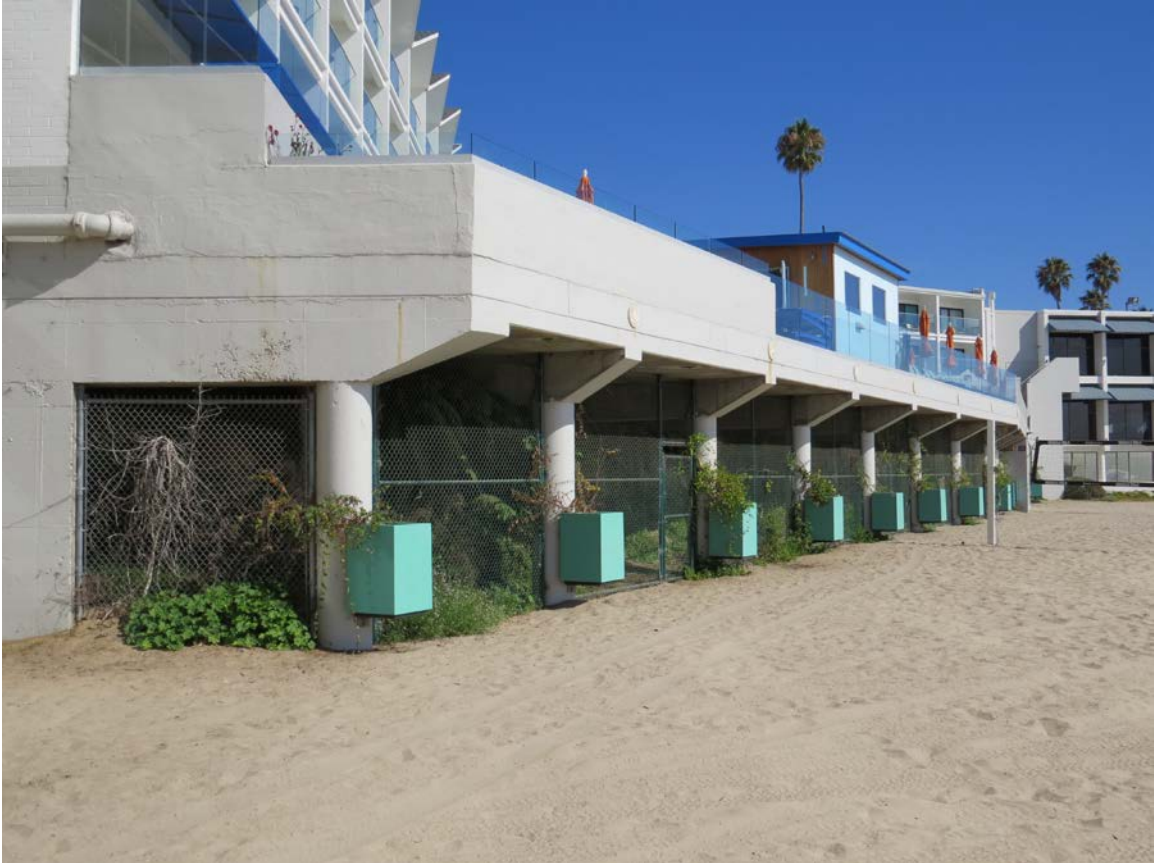
Figure 4. Area beneath the Dream Inn pool where Purisima Formation bedrock is exposed behind the row of concrete caissons and fencing.
