ARBORIST REPORT-
Tree Survey & Preliminary Impact Assessment
130 Center Street
APN: 007-023-26
Santa Cruz, CA
December 13, 2020

Swenson
740 Front Street, Suite 315
Santa Cruz, CA 95060

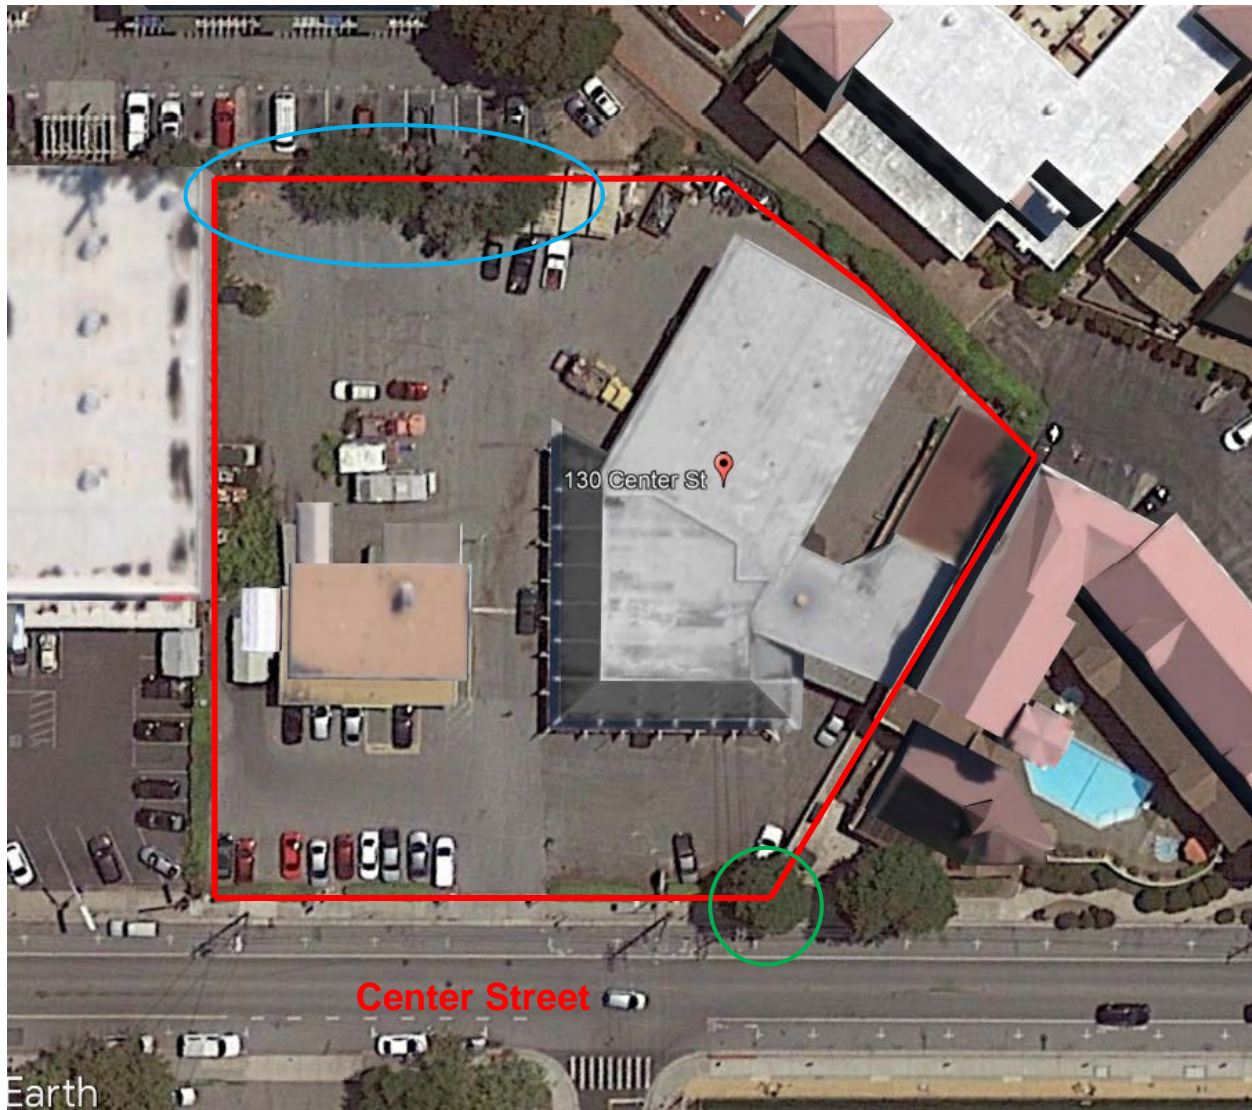
Image #1- 130 Center Street. Project boundary outlined in red. The projects tree resources are towards the rear left of the property (5 trees circled blue) and one tree (circled green), at front right.

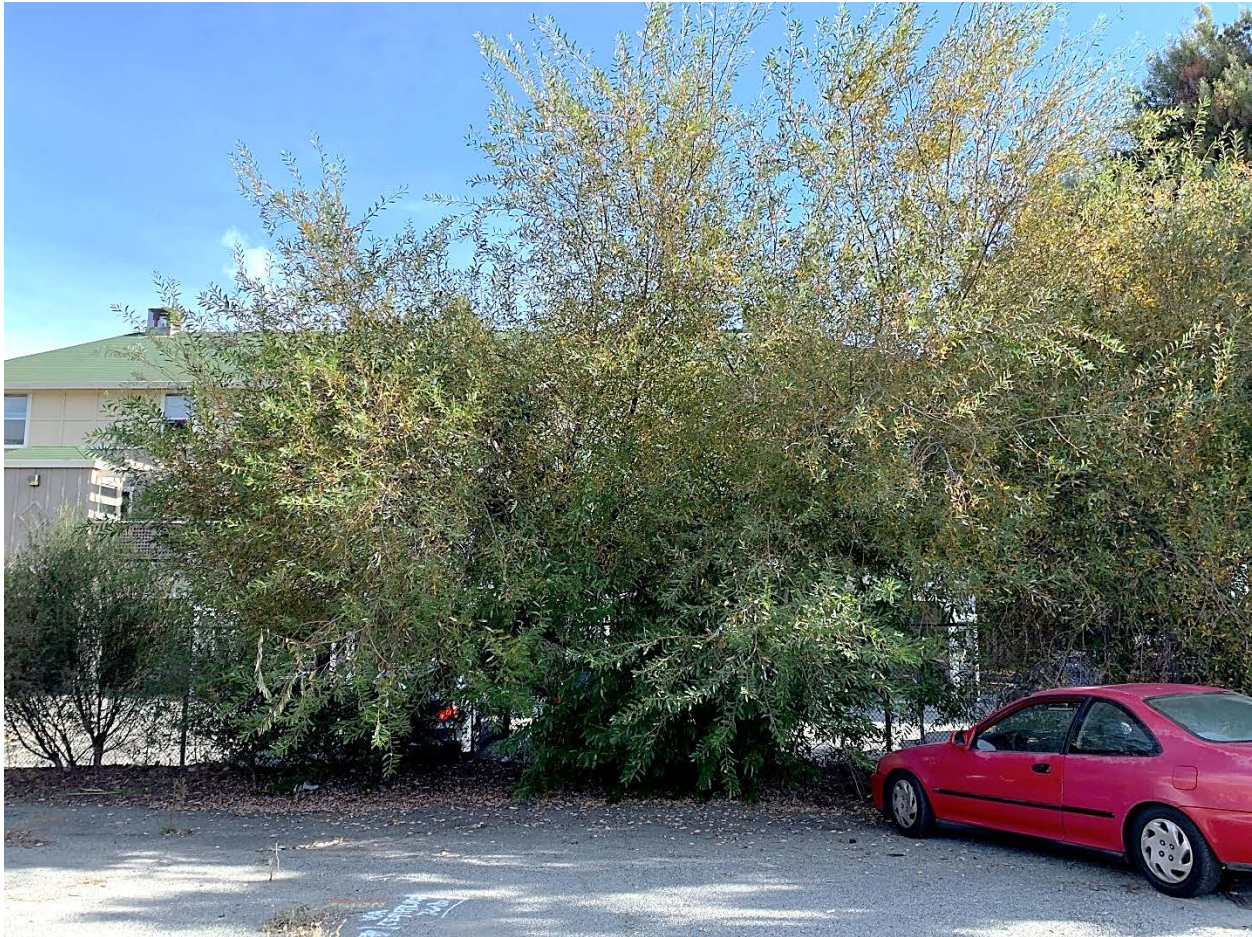
Image #2 – Trees T2, willow.

The tree is in poor condition. The tree was topped at 8 feet above grade. A cavity and significant amounts of deadwood and decay have developed at the location the tree was topped. Two mostly horizontal trunks with upright growing watersprout limbs have developed where the tree was topped, and branch attachment points are weak.

Tree T2, willow has very poor structure, with significant amounts of deadwood and decay and is recommended for removal due to its poor condition. Further, since it is located less than four feet from excavation and clearance pruning limits, the tree will suffer extensive loss of both roots and foliar canopy and is recommended for removal.

| Tree # | Species | Trunk Diameter @ 54 inches a.g. | Protected Tree | Crown Height & Diameter Spread | Health Rating | Structural Rating | Suitability for Preservation (Based Upon Condition) | Tree Protection Zone (in feet from trunk) | Construction Impacts (Rating & Description) | Retention or Removal Code | Comments |
|---|---|---|---|---|---|---|---|---|--|---|--|
| T2 | willow (<i>Salix spp.</i>) | 16", 14" | Yes | 25'x30' | Poor | Poor | Poor | N/A | High (Within 4' of grading limits) | R.C.,R.I. | Boundary tree. Trunk straddles property line. Co-dominant trunks at 1' above grade. 10 degree trunk lean to east. Topped at 8' above grade. Cavity with significant amount of deadwood and decay at area of cut. Trunks grow horizontally with several poorly attached water sprout limbs. No canopy development on east half of tree. |

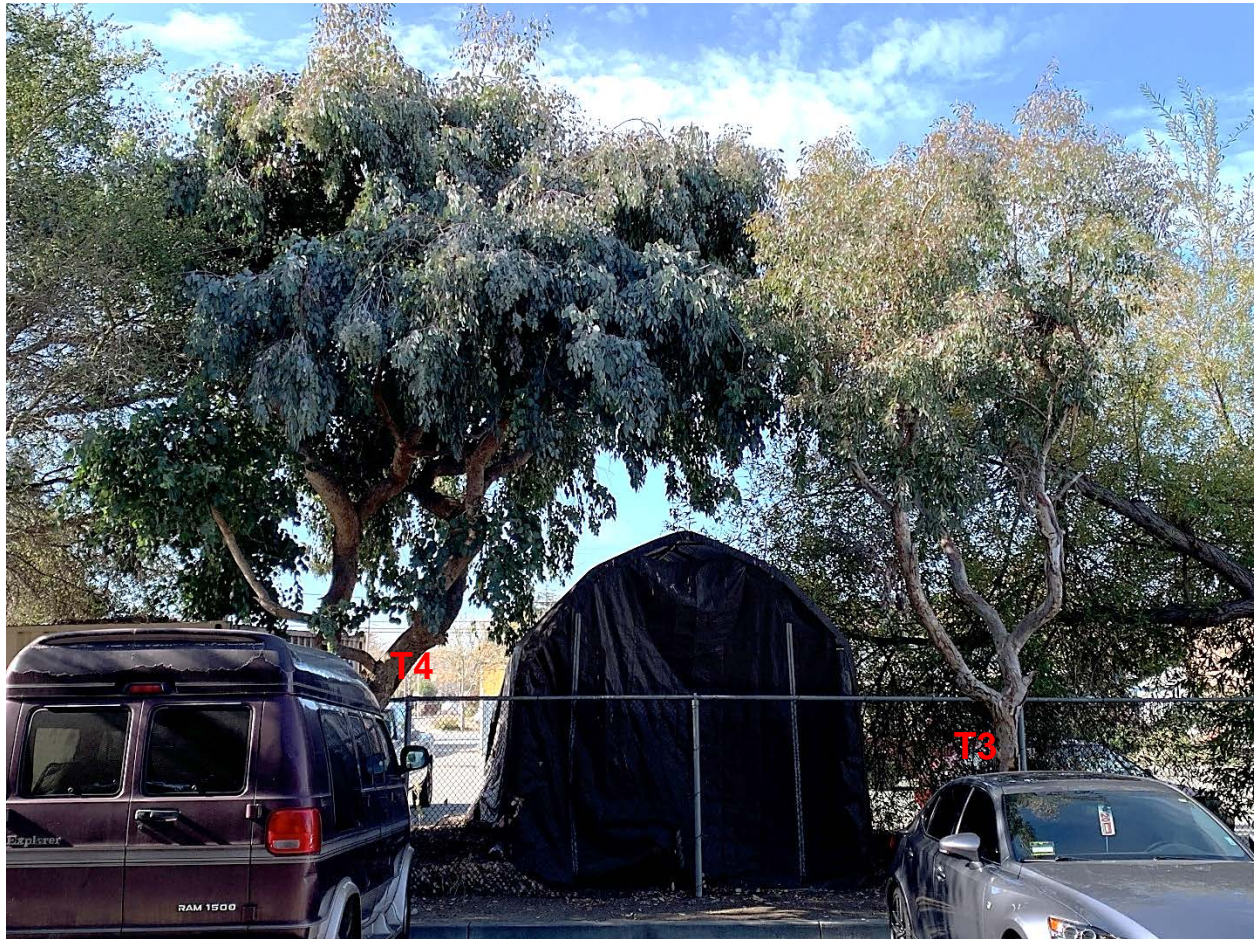
Image #3 – Trees T3 & T4, silver dollar gum, as seen from the apartment complex adjacent to the subject property.

Silver dollar gum trees T3 and T4 are in fair condition. The branching structure of tree T4 overhangs the subject property by 15 feet. Tree T3 is half the size of the other two silver dollar gums and is not a “protected” size tree.

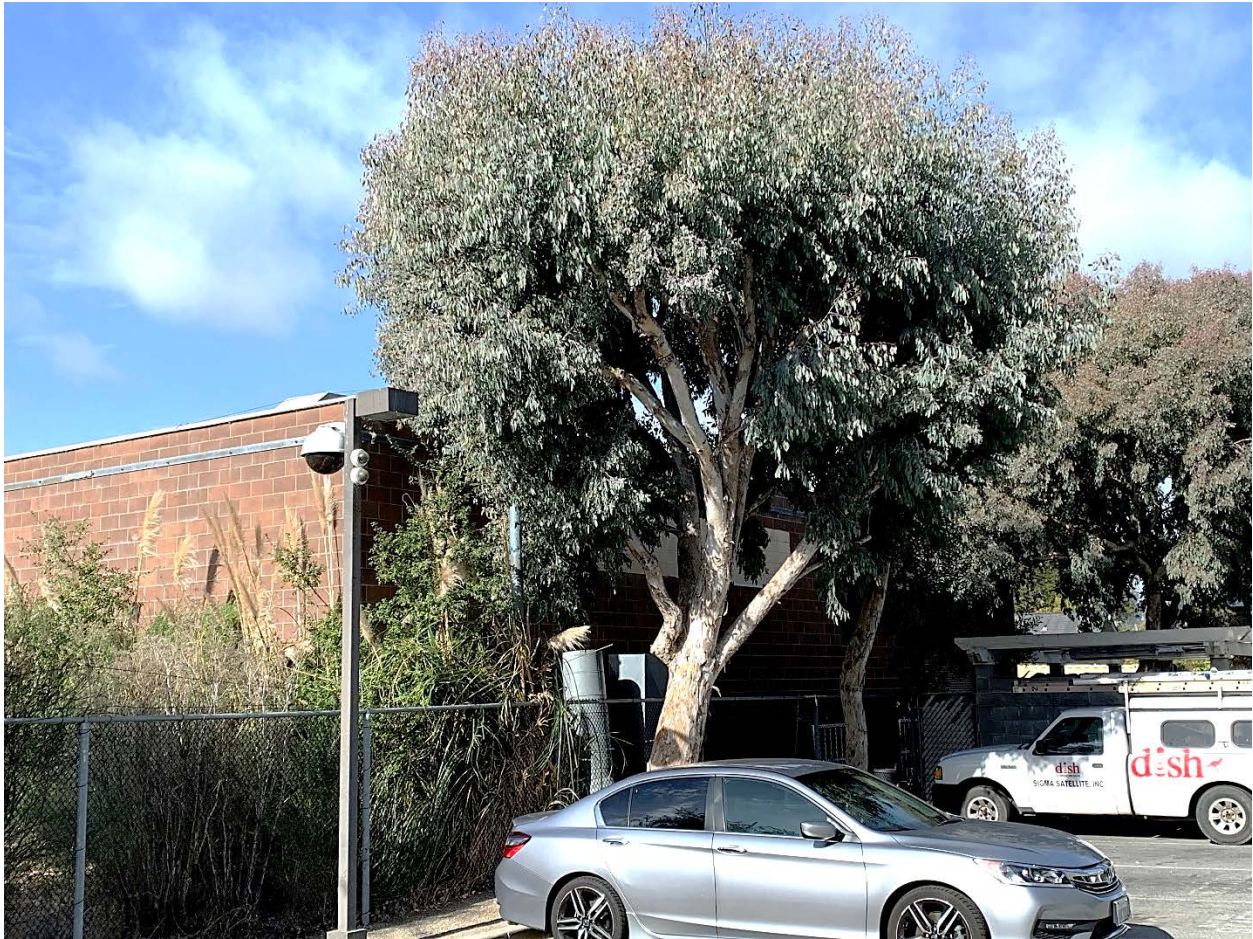
Image #4 – Tree T1, silver dollar gum, as seen from apartment complex.

Tree T1 is in fair condition. The foliar canopy of this tree overhangs the subject property by five feet.

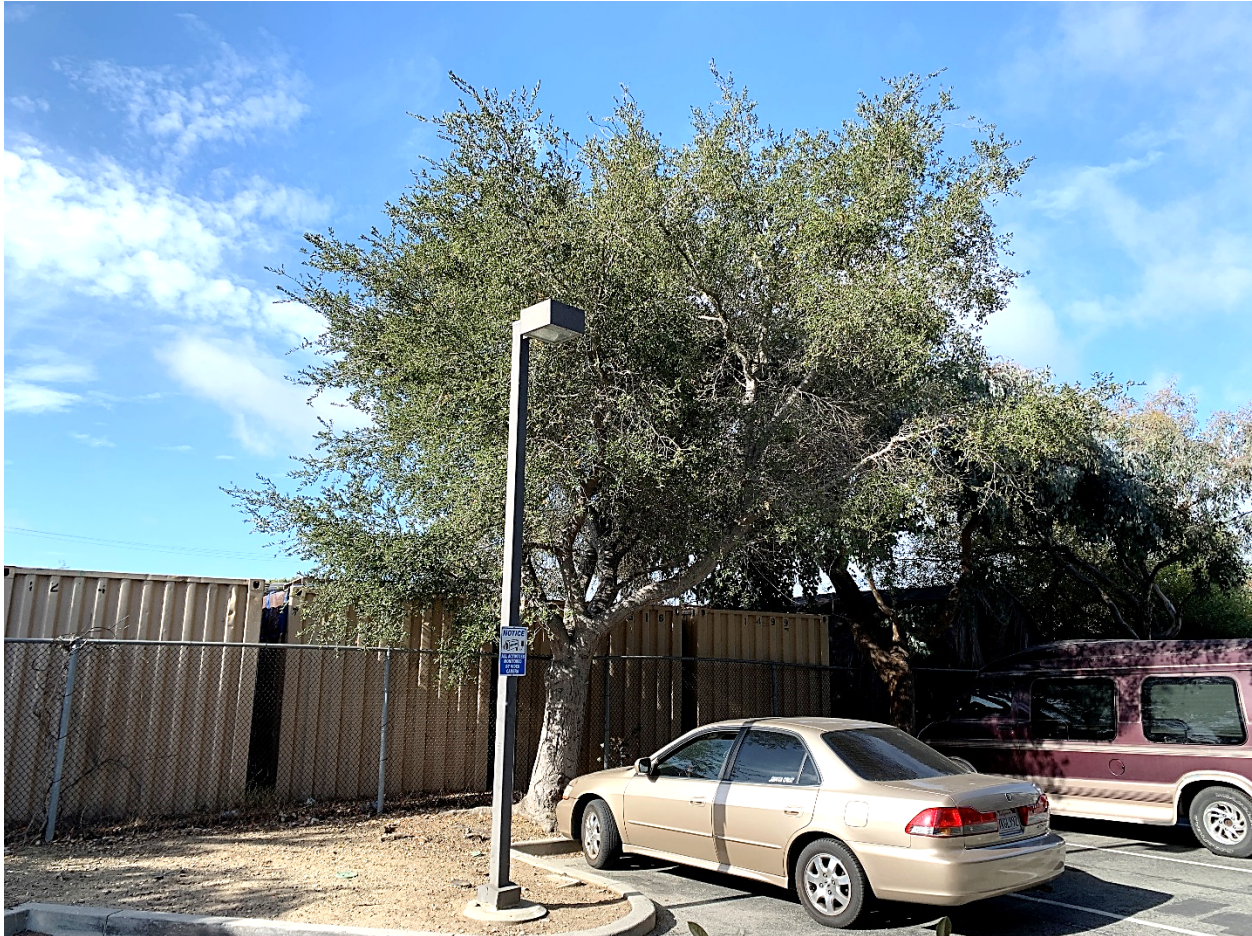
Image #5– TreeT5, coast live oak. The oak is growing in a planting strip in the adjacent apartment complex.

The oak is in fair condition. The branching structure of the tree overhangs the subject property by 15 feet.

| Tree # | Species | Trunk Diameter @ 54 inches a.g. | Protected Tree | Crown Height & Diameter Spread | Health Rating | Structural Rating | Suitability for Preservation (Based Upon Condition) | Tree Protection Zone (in feet from trunk) | Construction Impacts (Rating & Description) | Retention or Removal Code | Comments |
|---|---|---|---|---|---|---|---|---|--|---|--|
| T5 | coast live oak (<i>Quercus agrifolia</i>) | 16" | Yes | 30'X20' | Fair | Fair | Fair | 10' | Moderate (Root loss, excavation, canopy loss, clearance pruning) | R.T. | On adjacent property. In 3' wide planter strip. Co-dominant trunks at 6' above grade. Unbalanced canopy with weight bias to west. Two 8-10" diameter limbs extend 15' into subject property at 10-20' above grade. |

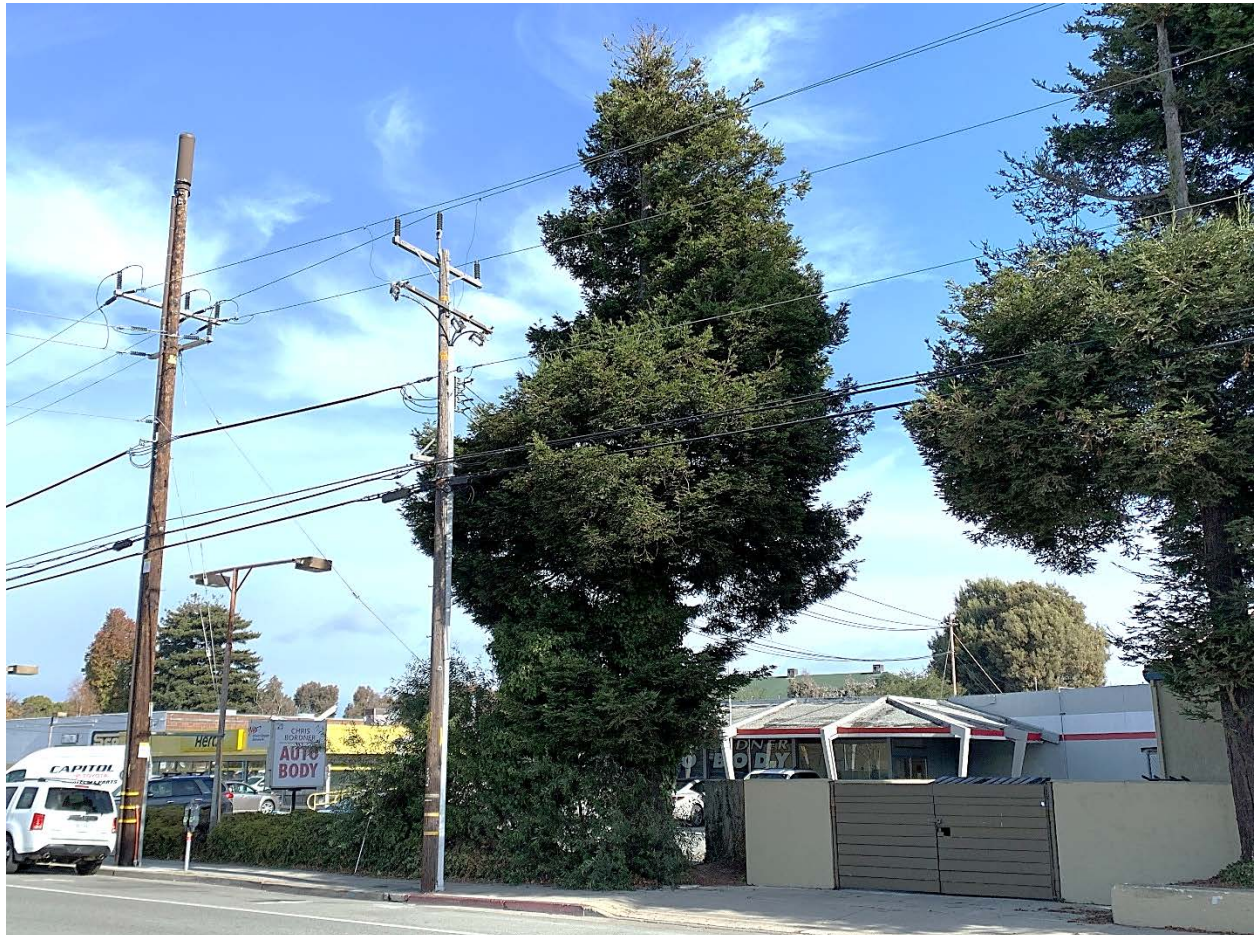
Image #6 – Tree T6, coast redwood. The redwood is growing in a planting strip between the sidewalk on Center Street, and the subject property. Note lack of canopy on left side due to clearance pruning from adjacent high voltage lines.

The coast redwood is in fair condition. The tree is growing in a planting strip with limited soil volume compared to the mature size of the tree. Shallow surface roots are cracking and lifting the adjacent sidewalk. English ivy grows over its lower canopy. The upper canopy has been clearance pruned from the adjacent high voltage lines.

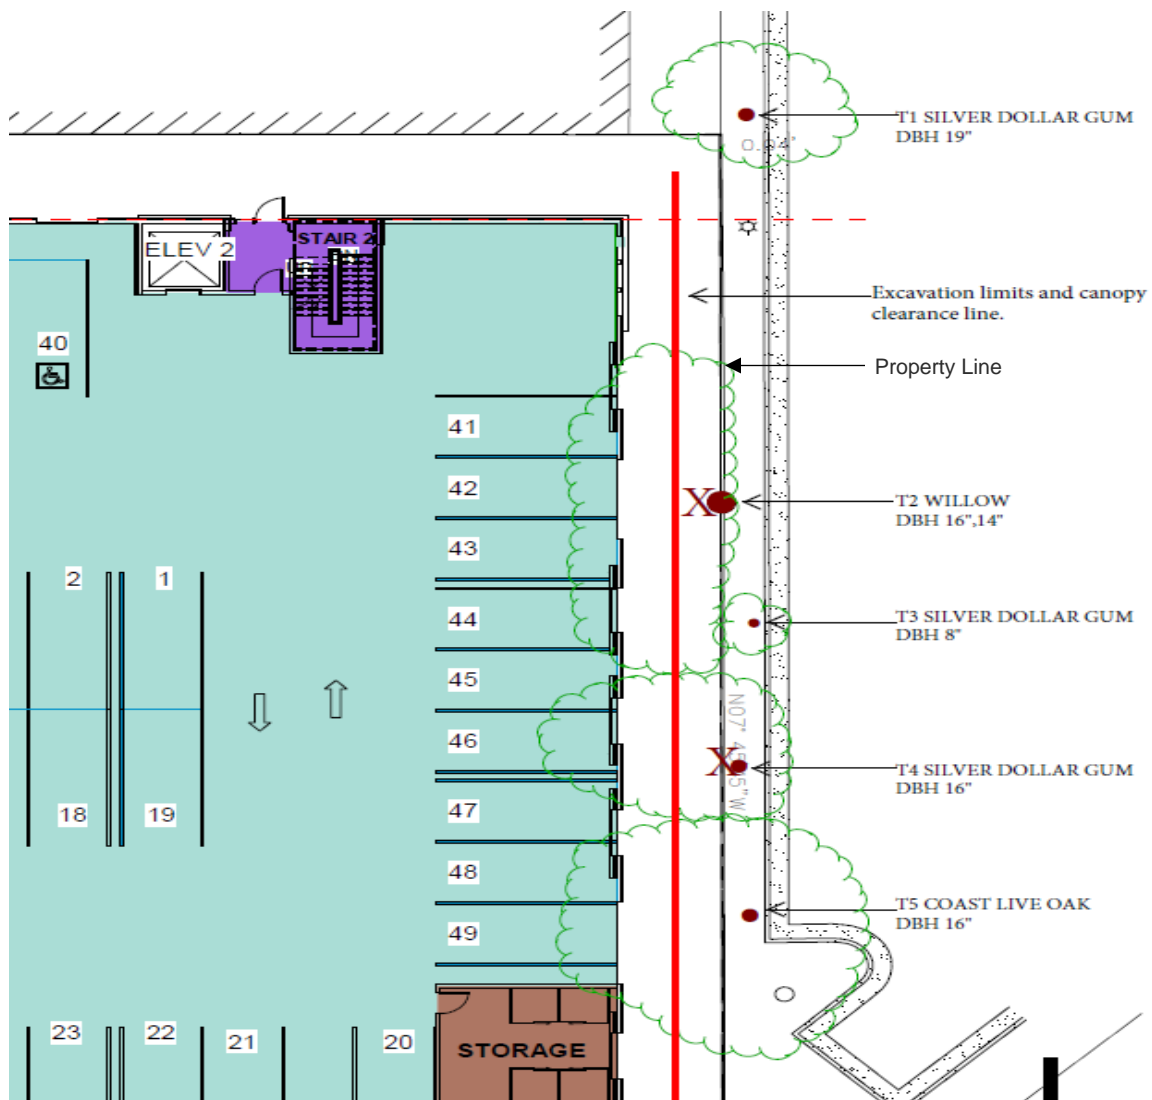
Impacts to four trees will be moderate, and they can be retained. Impacts to two tree trees will be high and their removal will be required. Root loss impacts and/or canopy loss impacts will affect all the trees (Image #7).

Image #7 – Trees T1-T5. The red line between the building and trees is 5' from the building and represents the limit of both root loss from excavation, and canopy loss from clearance pruning.

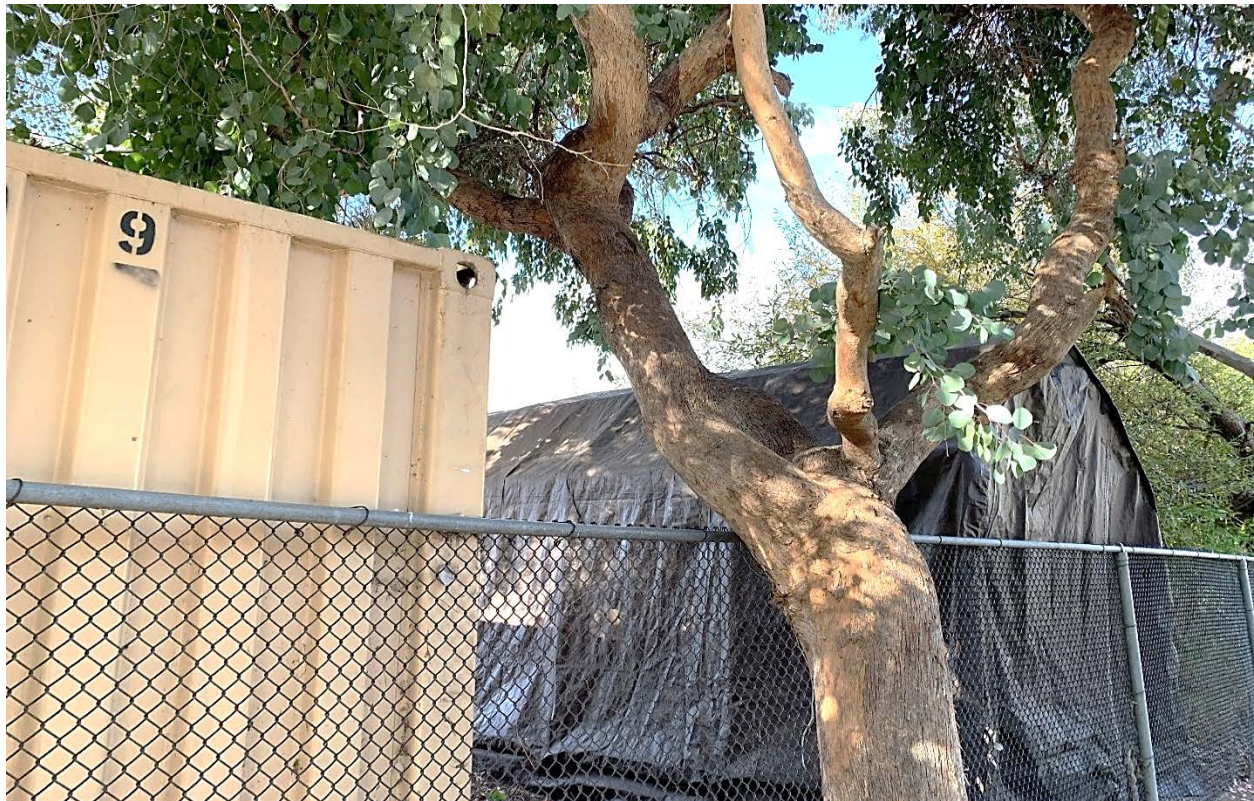
Tree T4, silver dollar gum, has an unbalanced canopy with a weight bias to the west. Nearly all of its structural development including two 8-10-inch diameter scaffolds grow to the west overhanging the subject property, (Image #8).

Image #8 – Tree T4, silver dollar gum. Note bend in trunk towards fence. Nearly all the trees branching structure is over the subject property.

There is no lower branching structure close to the trunk where this tree could be pruned back to, for building clearance. More than 75 percent of its foliar canopy is over the subject property and would require removal. The health and structure of this tree will be negatively impacted by the clearance pruning required, to a significant degree, and removal is recommended.

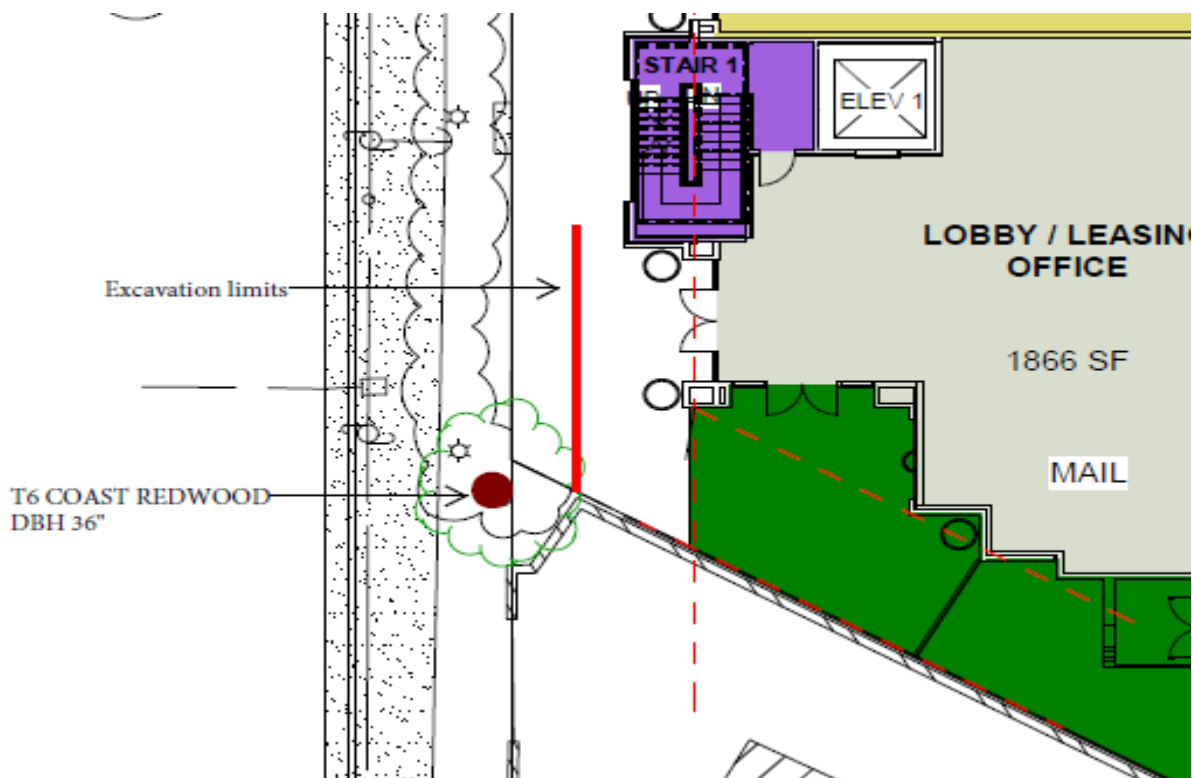
Tree T6, coast redwood will suffer moderate root loss due to excavation which will occur about 6 feet from the tree. The redwood can tolerate this root loss and can be retained (Image #9).

Image #9 – Tree T6, coast redwood. Red line indicates approximate limits of excavation.

| Tree # | Species | Trunk Diameter @ 54 inches a.g. | Protected Tree | Crown Height & Diameter Spread | Health Rating | Structural Rating | Suitability for Preservation (Based Upon Condition) | Tree Protection Zone (in feet from trunk) | Construction Impacts (Rating & Description) | Retention or Removal Code | Comments |
|---|---|---|---|---|---|---|---|---|--|---|--|
| T6 | coast redwood (<i>Sequoia sempervirens</i>) | 36" | Yes | 50'x15' | Fair | Fair | Fair | 10' | Moderate (Root loss, excavation) | R.T. | Growing in 4' wide planter. Shallow surface roots lifting and cracking concrete sidewalk. Clearance pruned from overhead high voltage wires, creating gap in canopy. English ivy growing over lower canopy. |

Since utility tie-in locations have not been determined, possible impacts to tree T6 from utility lateral connections have not been assessed in this report.
