Proposal No. PR 22-168

Subject: Geological hazards and risks related to infiltration in karst
Proposed apartment housing
900 High Street
Santa Cruz, CA 95060
County of Santa Cruz APN 001-022-40

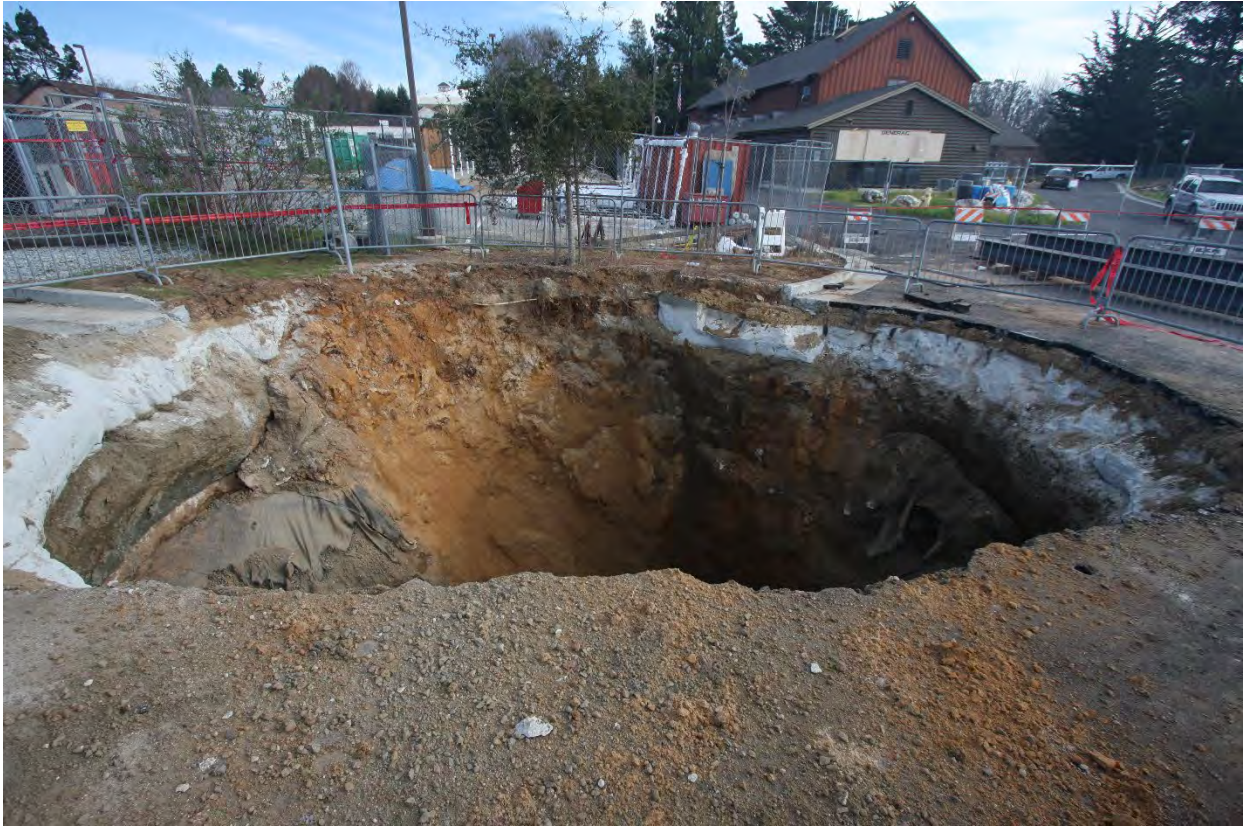
We have learned valuable lessons at the adjacent UCSC campus in the past with the reactivation of sinkholes in the vicinity of existing storm water treatment systems and bio swales/infiltration areas on campus (see Figure 1 below). Storm water infrastructure sited on karst and over dolines can create an elevated risk of triggering the reactivation of a doline because of the increase in the infiltration rate and volume of storm water. The resulting sinkholes that form can threaten important and expensive facilities. The subsequent repairs and rerouting of the storm water infrastructure also can cost significantly more than the original design and construction costs for the storm water system.

Figure 1 - 2015 photo of sinkhole developed within a reactivated doline under a stormwater treatment system on the UCSC campus

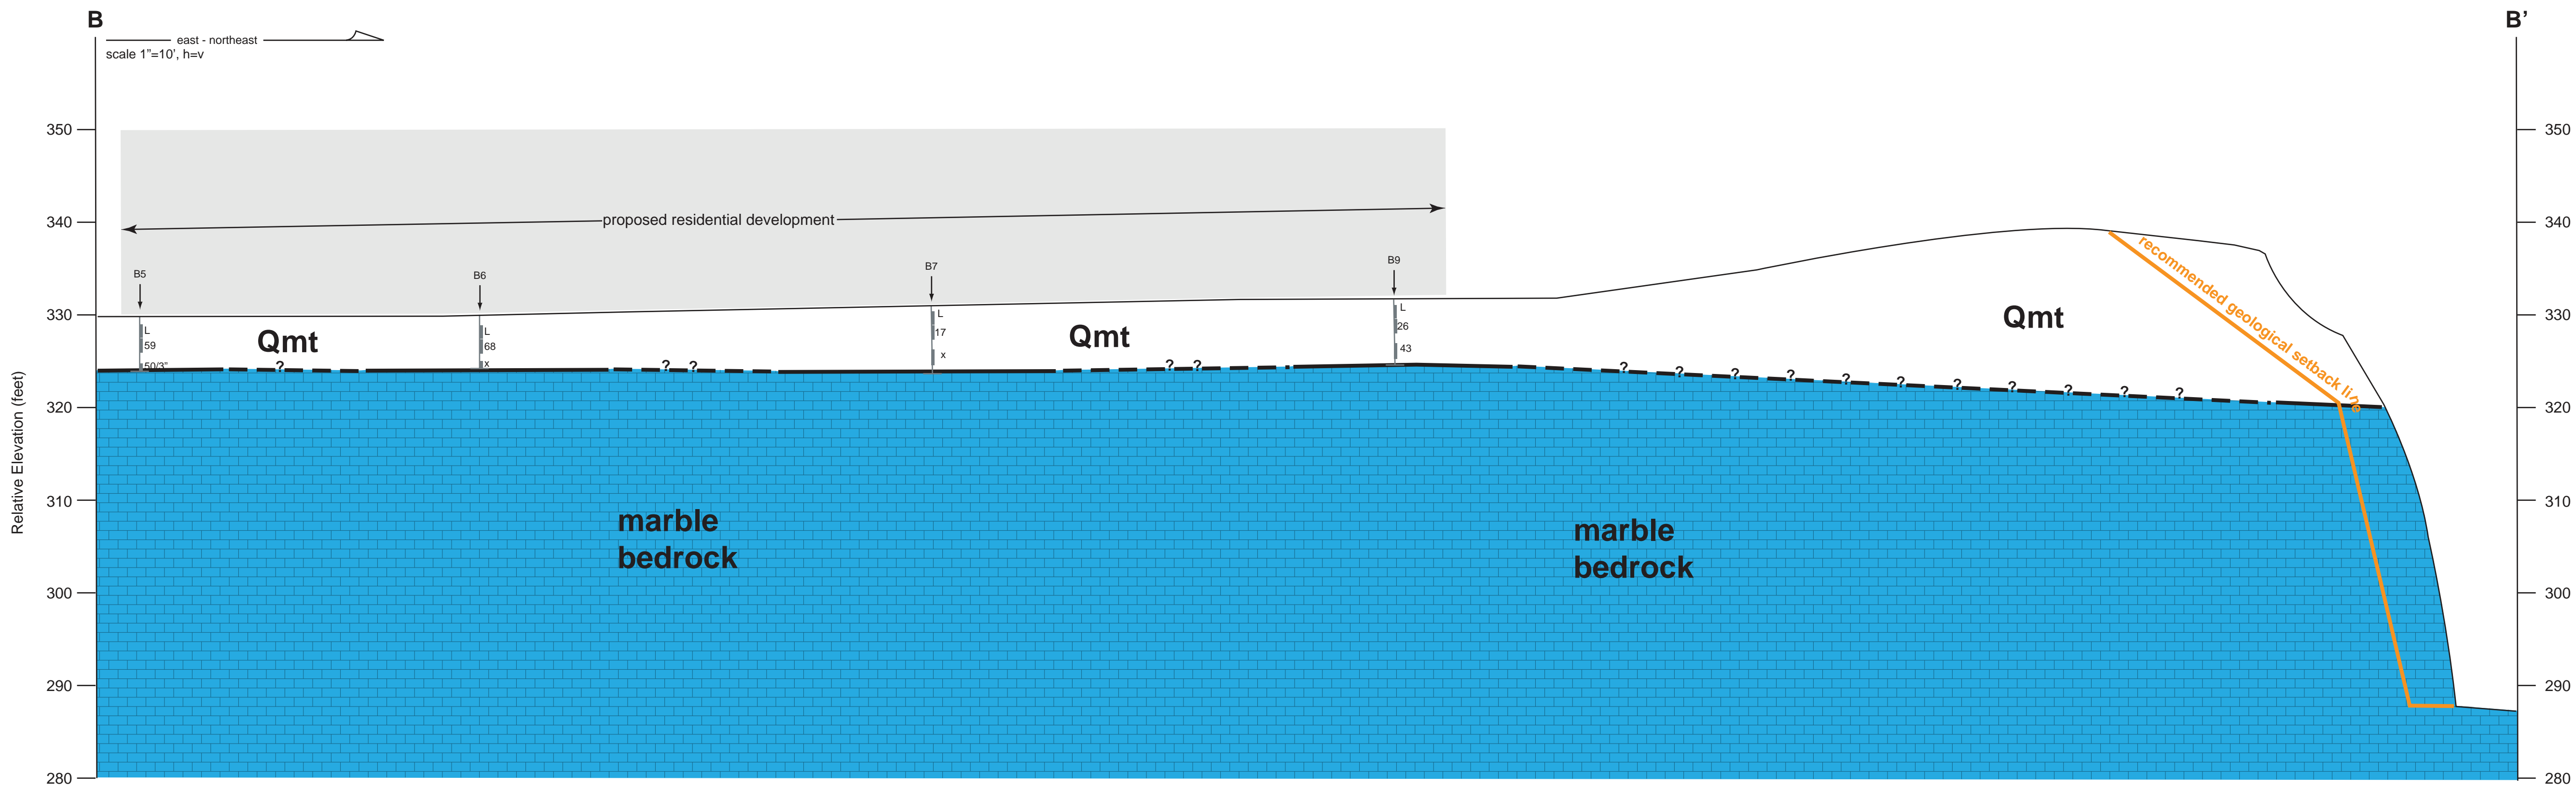
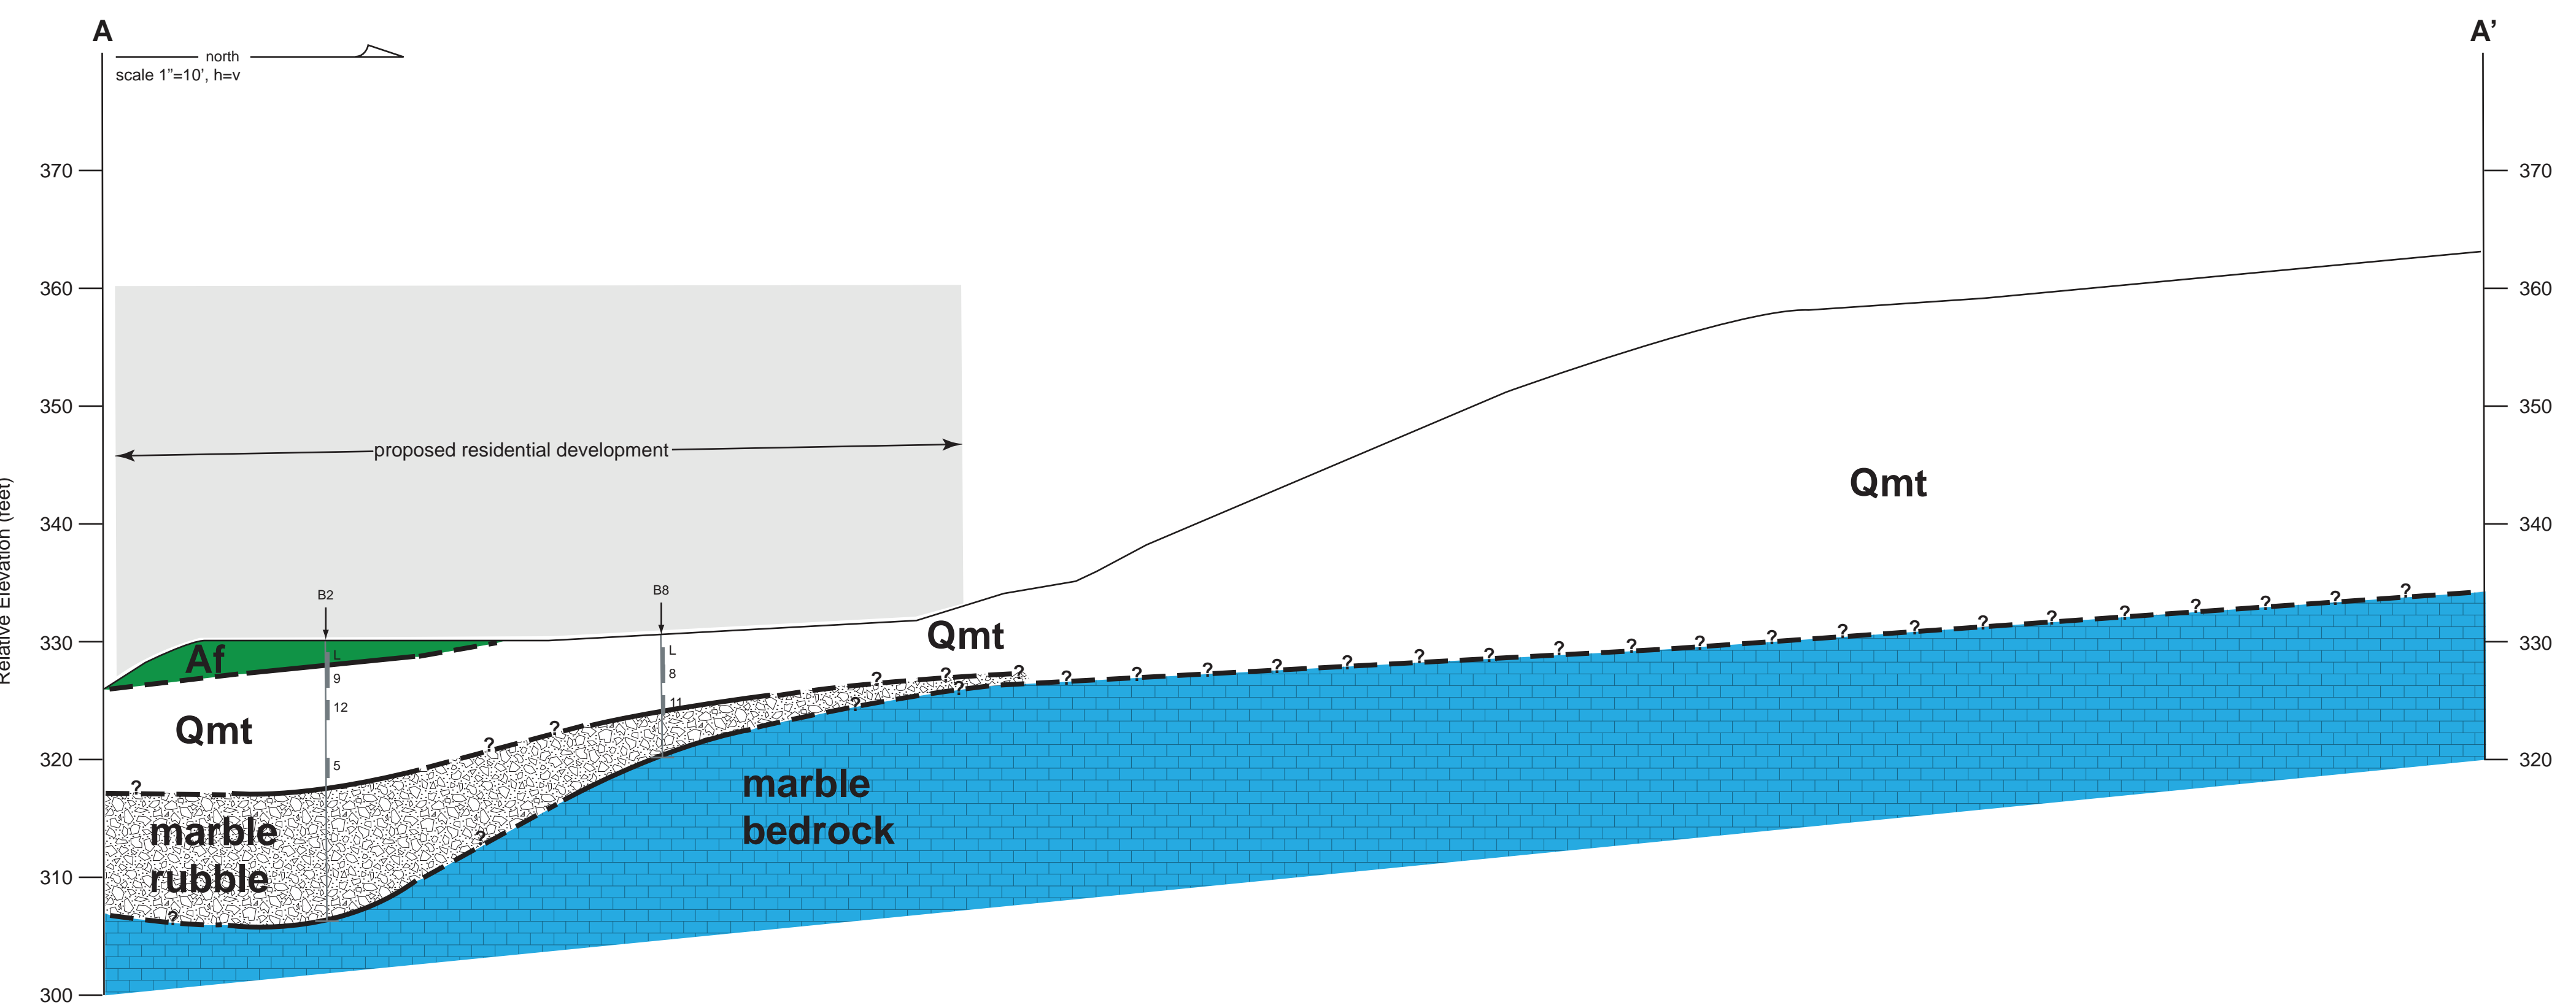
The gently sloping portion of the marble surface that underlies the subject property appears to have been formed and sculpted as part of the creation of the ~213ka second emergent marine terrace. At least one infilled doline cuts the beveled marble surface, based on the morphology of the marble surface and distribution of marble rubble encountered by Zinn Geology (see Plates 1 and 2). It is likely far more complex than that and is probably one of a complex of dolines on the property. In the author's experience of having worked on karst projects on the UCSC campus for over 30 years, dolines and sinkholes typically develop along structural geological features overprinted onto the marble bedrock in the form of ancient fault and fracture zones. The marble bedrock is crushed in those zones and falls prey to the dissolution process that creates caves, voids, dolines and sinkholes within marble bedrock over geologic time.

GEOLOGIC CROSS SECTIONS
Peace United Church - Envision Housing
900 High Street
Santa Cruz, California
