PHASE I KARST AND SLOPE STABILITY HAZARDS INVESTIGATION

Peace United Church - Envision Housing
Proposed Housing Development
900 High Street
Santa Cruz, California

Job #2018011-G-SC
2 July 2018

Re: Phase I karst and slope stability hazards investigation
Proposed apartment housing
900 High Street
Santa Cruz, CA 95060
County of Santa Cruz APN 001-022-40

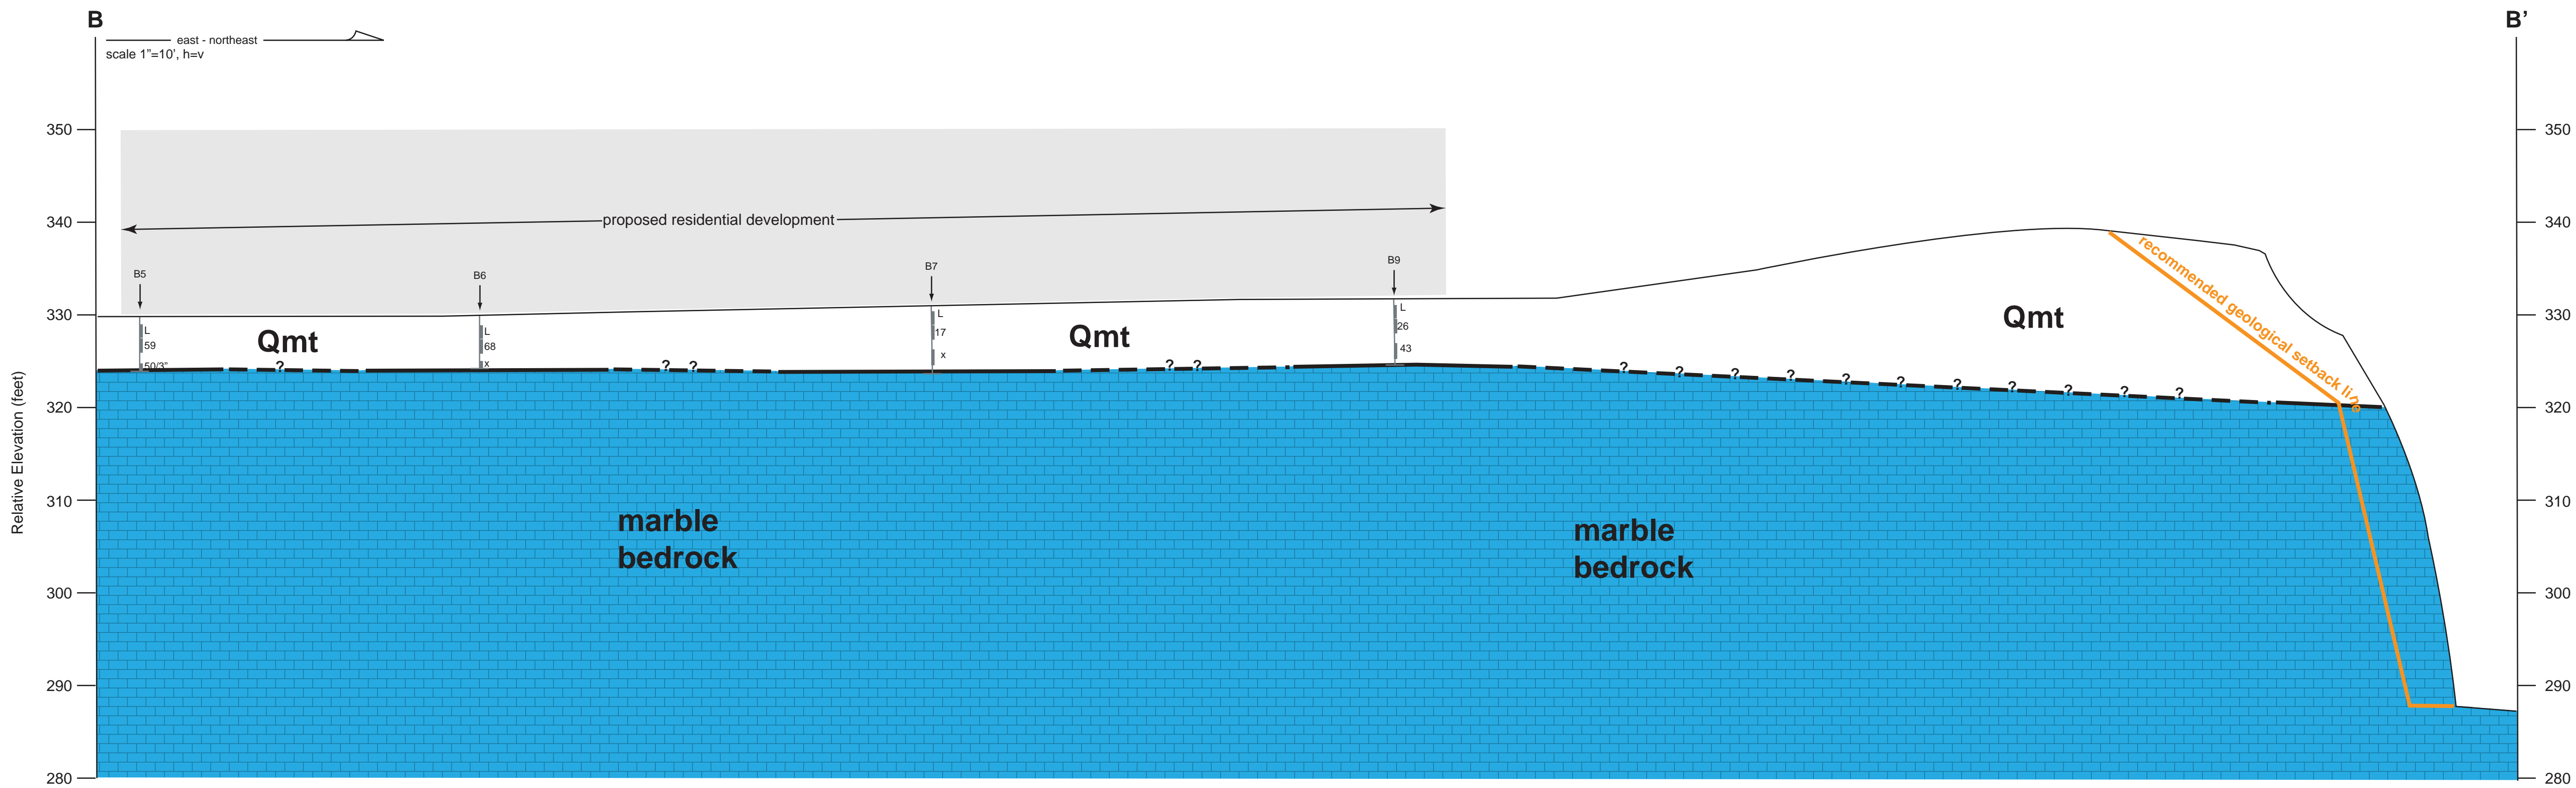
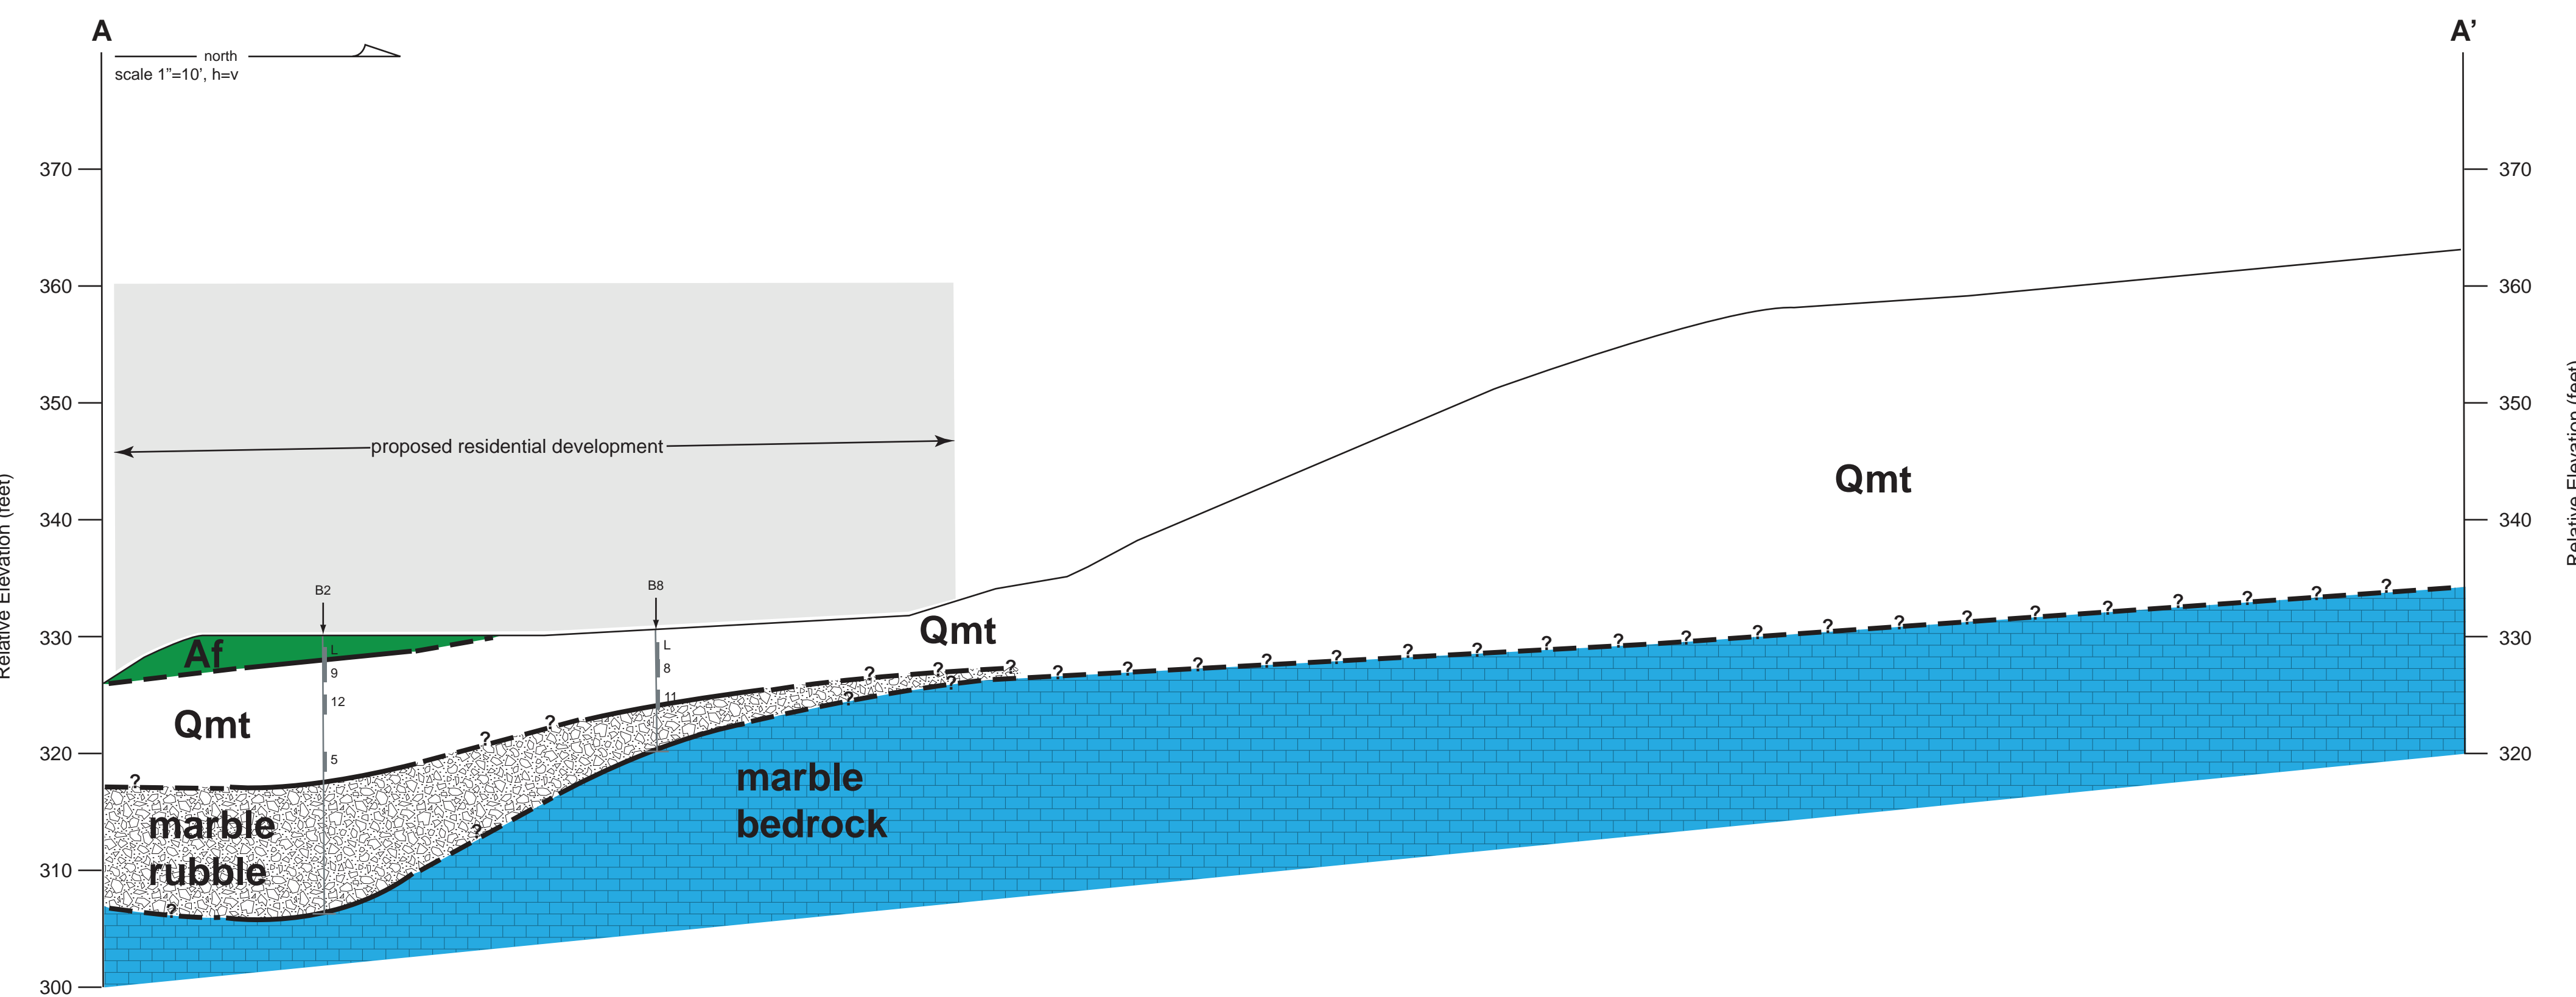
GEOLOGIC CROSS SECTIONS
Peace United Church - Envision Housing
900 High Street
Santa Cruz, California

As noted earlier, the site appears to be underlain by a marble plateau cut by a doline in the marble bedrock. The current development plan calls for residential structures to be placed over this doline, creating an elevated risk for those structures with respect to the hazards of differential settlement and doline collapse. The existing doline is relatively shallow and filled with marble rubble and relatively soft soil. We did not observe any obvious evidence of voids within the soil that has filled the doline.
