December 19, 2022

Re.: Consulting Arborist services for development – addendum report
Site: City Lot #4, Cedar St. between Cathcart St. & Lincoln St., Santa Cruz

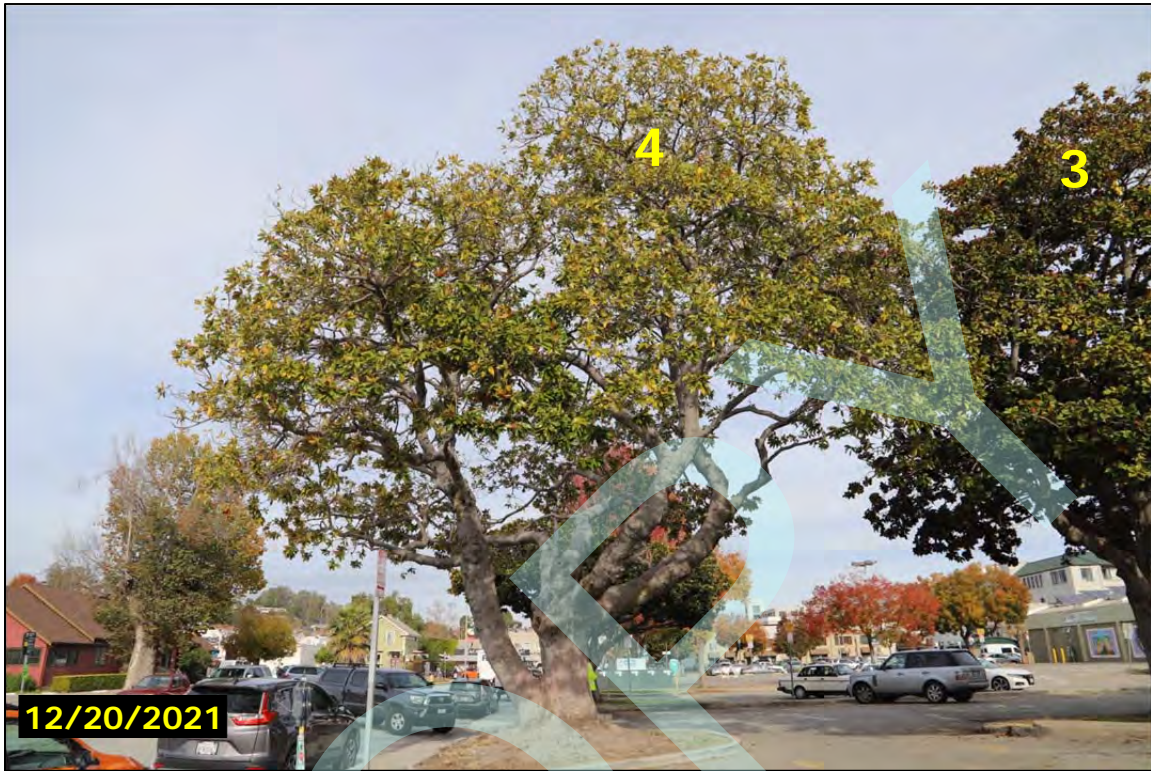
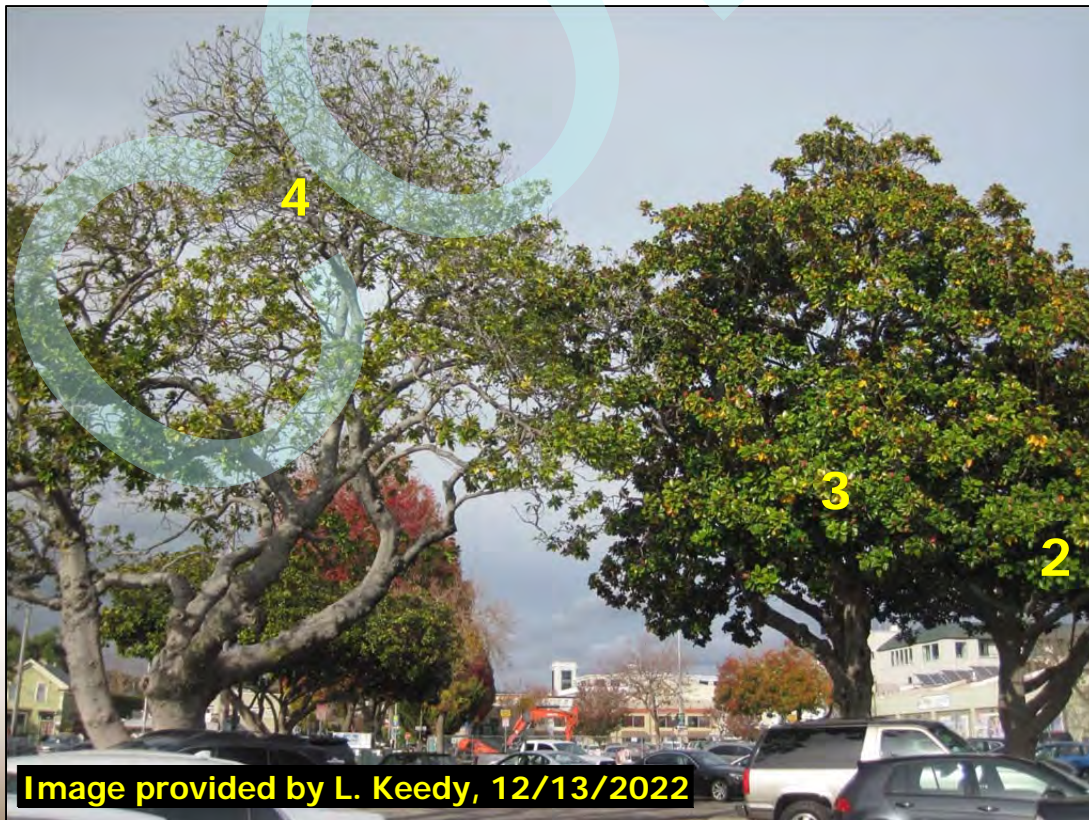
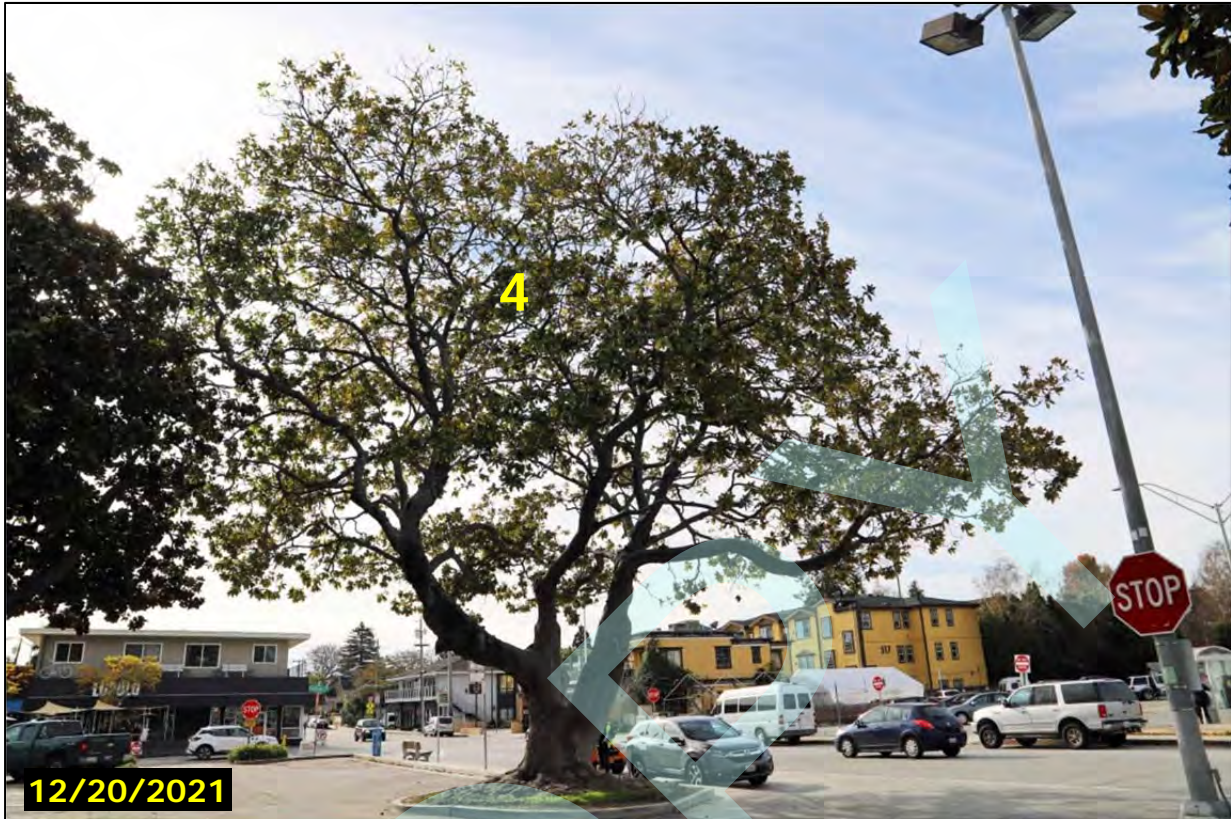
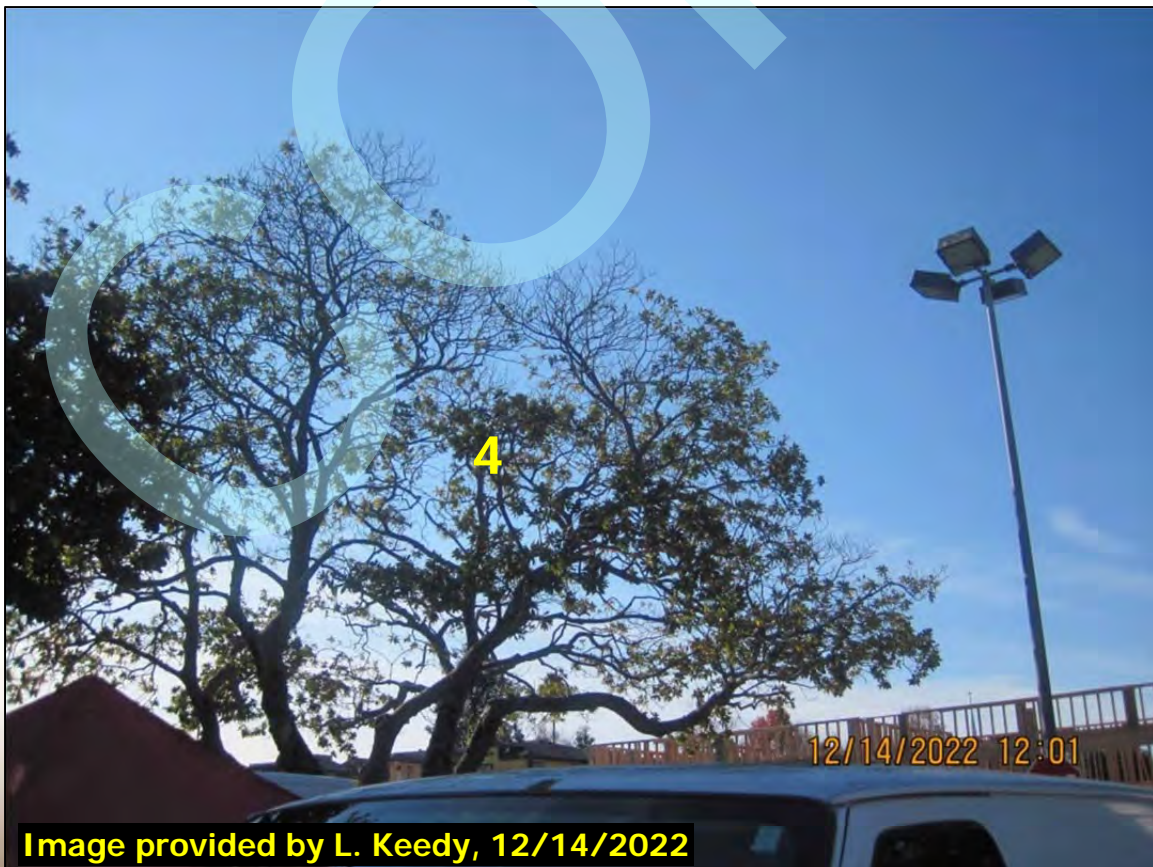
It is apparent from recent images provided by Leslie Keedy that the tree has declined significantly from its already poor condition one year ago. It is reasonable to assume such decline will continue. Even if significant site changes were possible, such as major redesign of the proposed structures, major expansion of the rooting area, hand removal of hardscapes, soil cultivation, etc., the tree would still present risk to the adjacent sidewalk and street and additional space could not be added to that side (southwest). Further, it is also likely decline would continue, based upon current condition and age of the tree.

Note: Trees nos. 2 & 3 are also southern magnolia trees, but exhibiting much denser canopies than tree no. 4.

This tree is a poor candidate for retention on site, and its existing condition renders it a poor candidate for relocation, a process that would severely exacerbate the conditions that lead to its current state of decline.

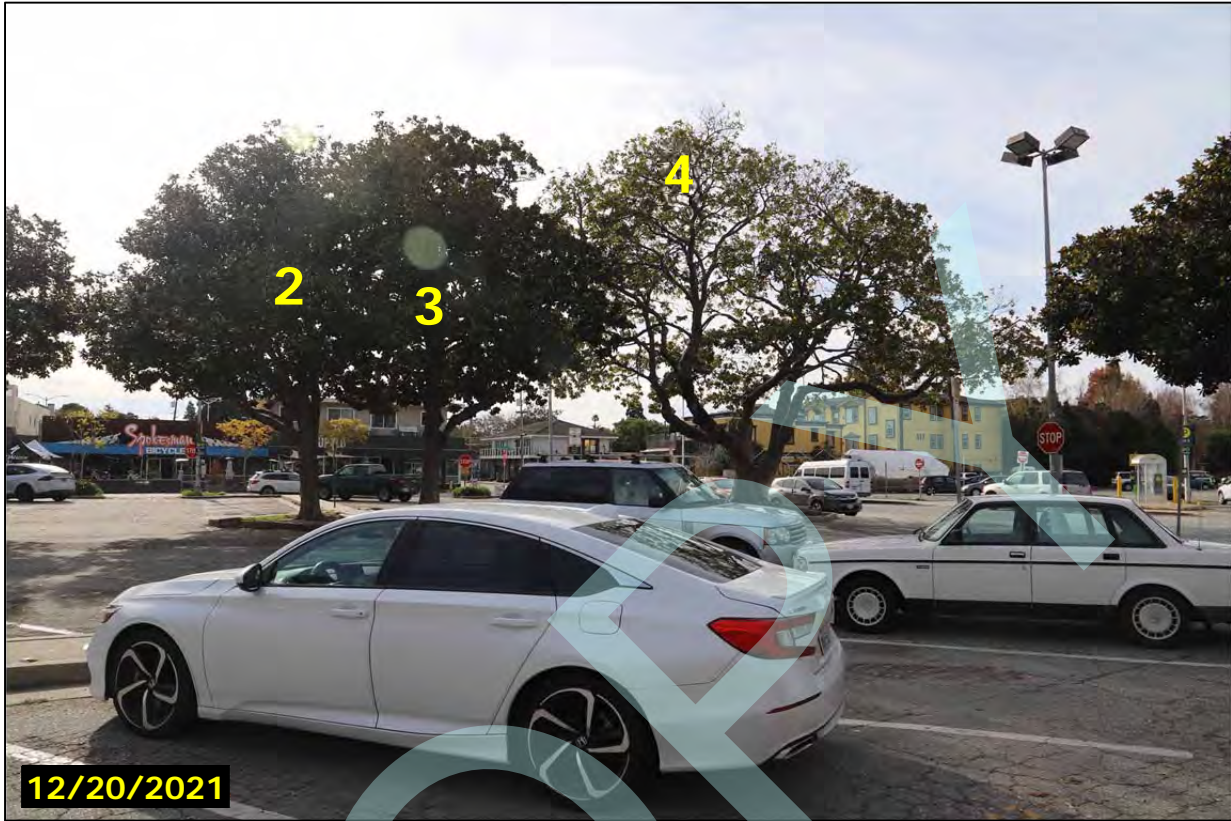
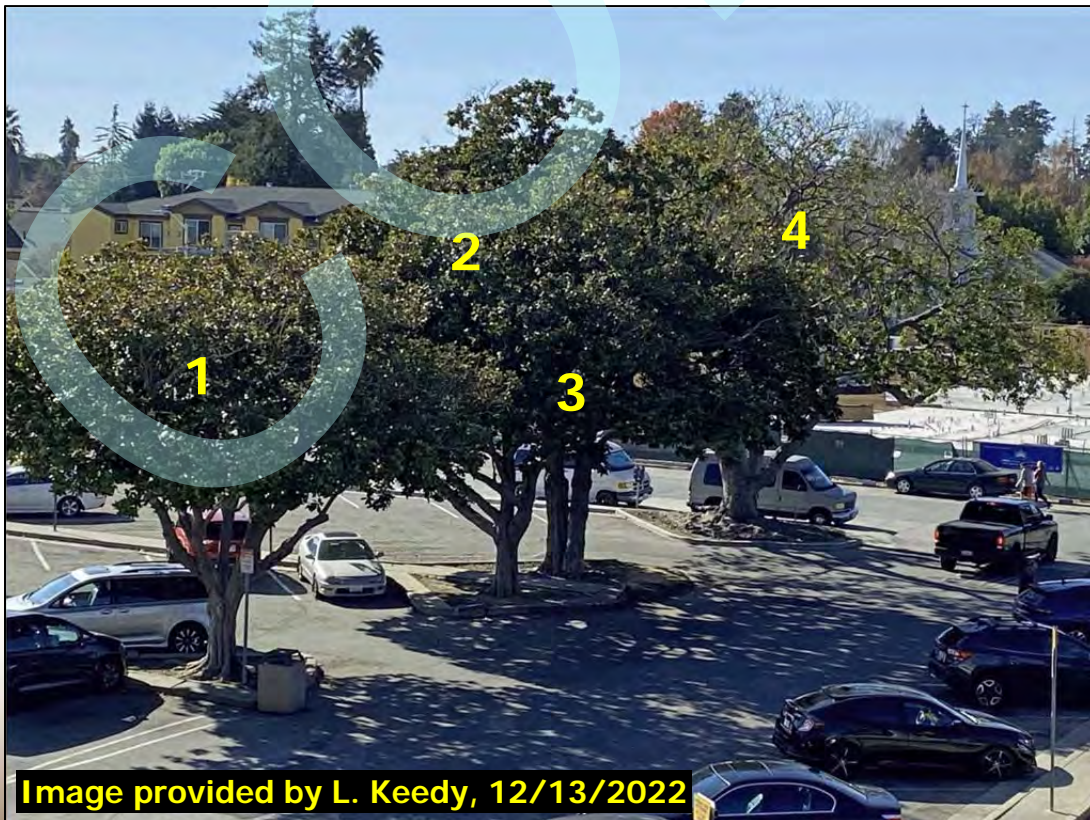
Note: Trees nos. 1, 2 & 3 are also southern magnolia trees, but exhibiting much denser canopies than tree no. 4.
