ARBORIST REPORT-
Tree Inventory & Preliminary Impact Assessment
515 Soquel Avenue
APN: 010-01-229, 010-01-230, 010-01-221
Santa Cruz, CA
November 22, 2020

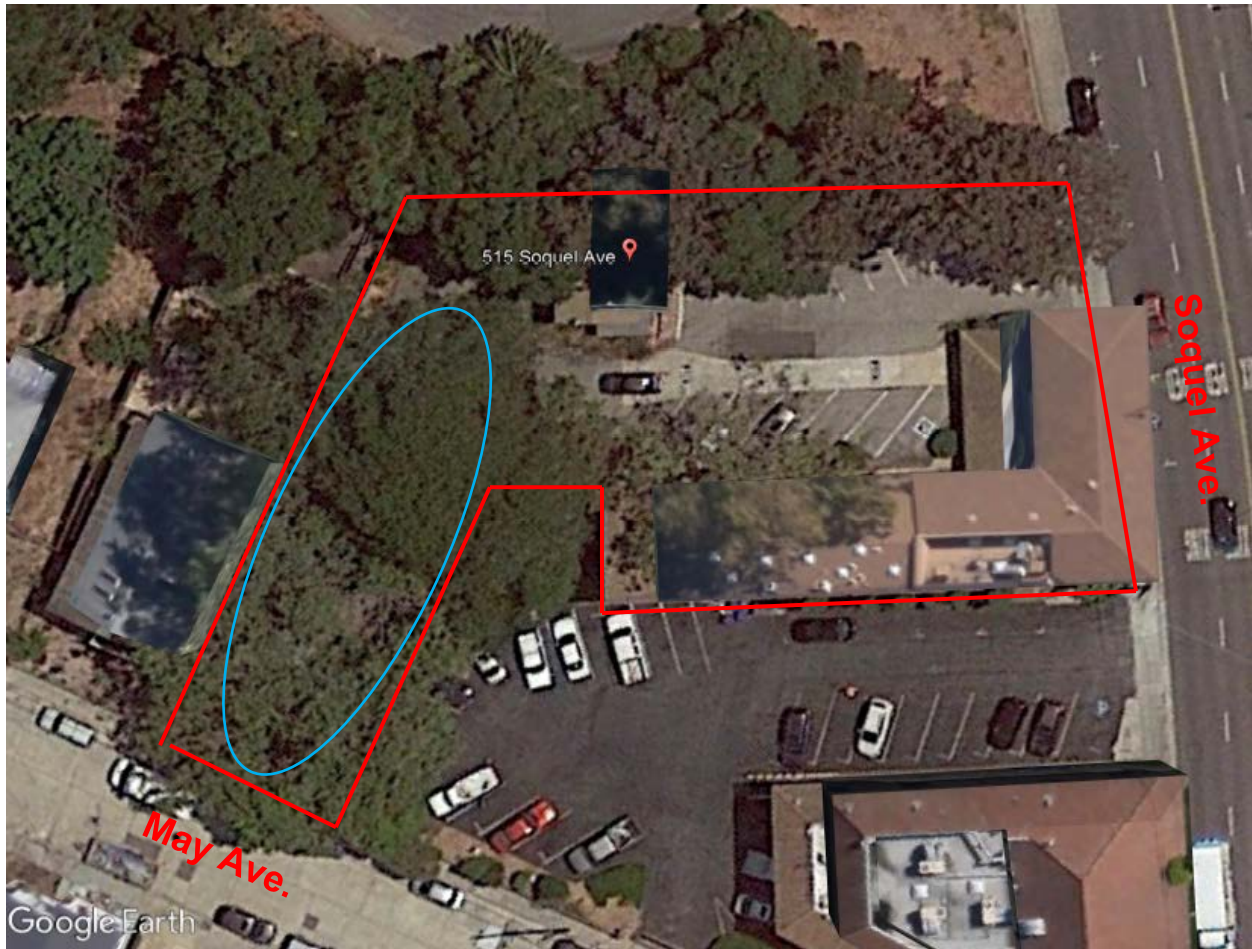
Image #1- 515 Soquel Avenue. Project boundary outlined in red. The property slopes down from Soquel Avenue to May Avenue. Lower third of property is covered with London plane and coast live oak (circled).

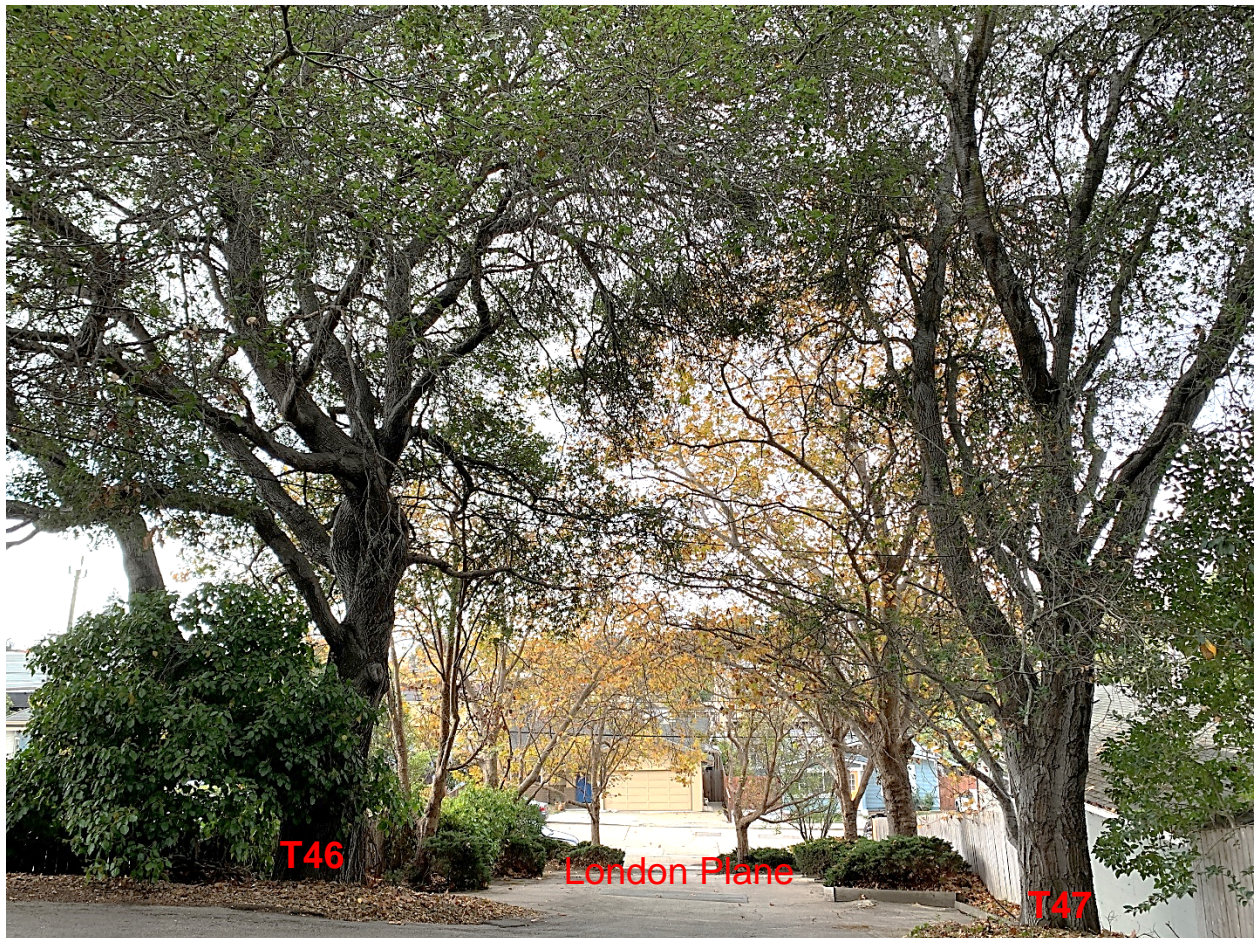
Image #2 – Trees T46 & T47 coast live oak and T48-T52, T54-T55, London plane. The oaks were in fair condition and the London plane were in fair or poor condition.

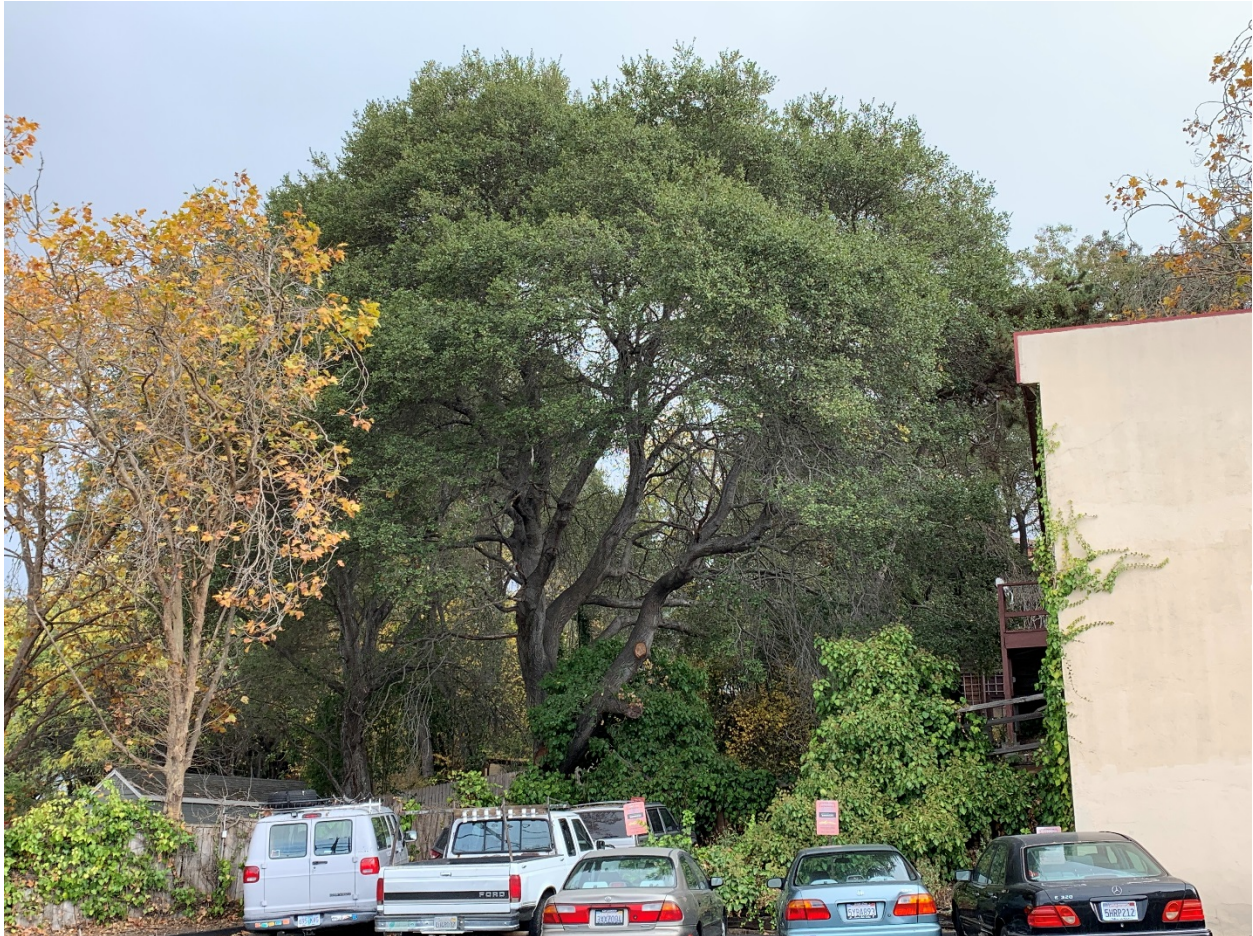
Image #3 – Tree T46 coast live oak. This oak grows in a 35' X15' planter.

The oak is growing at the top edge of a slope, in a 35 by 15-foot planting area and is in fair condition. The trees branching structure includes several large and well attached scaffold limbs.

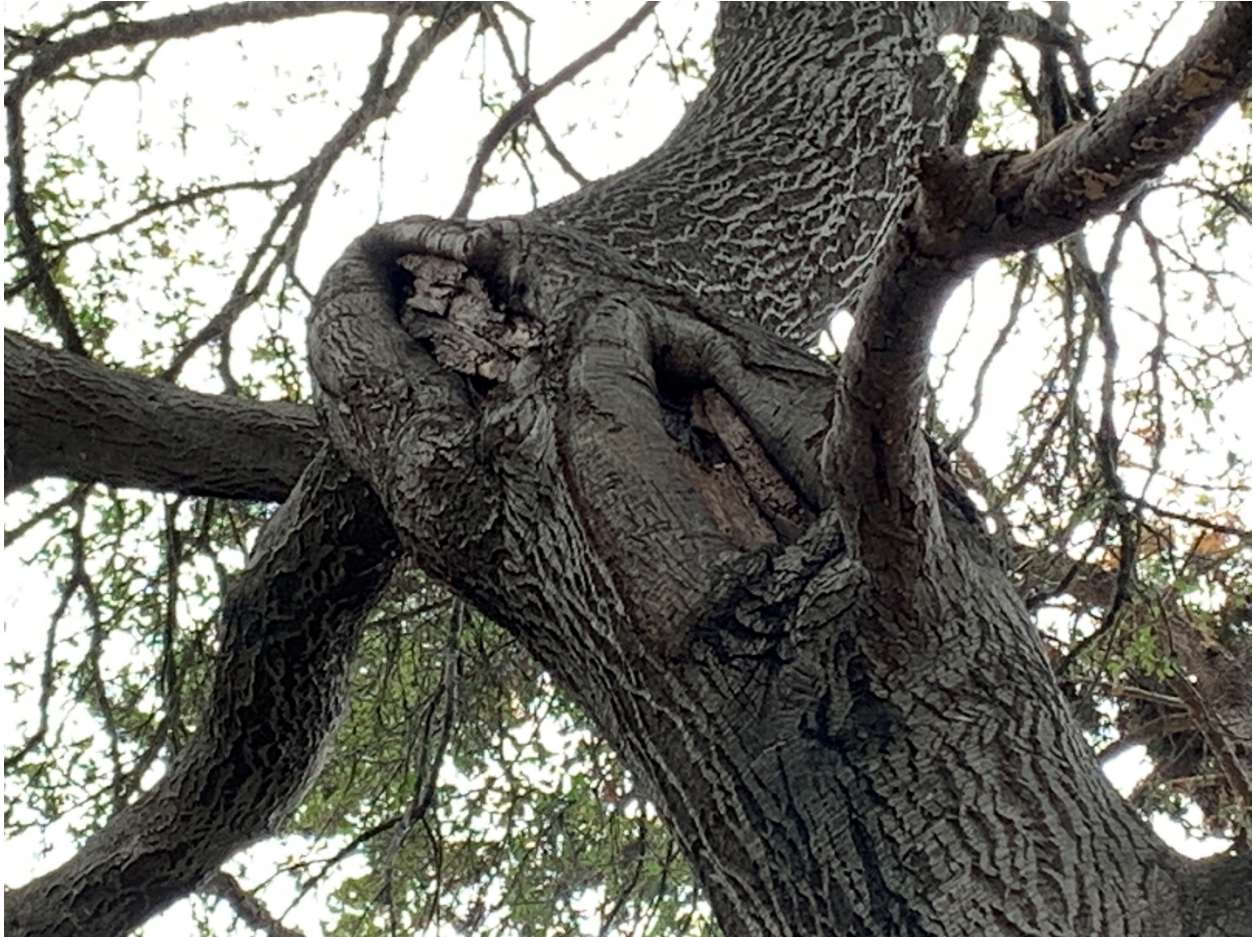
The oak tree has well-developed structural growth, with normal foliar canopy density for the species. There was some deadwood and decay on the tree, including two 16"X16" partially callused pruning scars creating cavities with some decay visible (Image #4).

Image #4 – Tree T46, coast live oak. The two pruning scar cavities are at 20 feet above grade. They do not appear to be structurally significant, but examination by climbing or crane to better determine the percentage of decay is recommended.

1. Obtain all necessary permits prior to removing or significantly altering any trees on site.
2. Remove trees recommended for removal.
3. Have coast live oak tree T46 inspected by climbing or crane, to determine if the degree of decay in the upper trunk is structurally significant.
4. Determine if design modifications can be made to preserve coast live oak trees T46.
5. Have a topographic survey completed to determine which coast live oak are on the adjacent property and which are "boundary" trees located on both properties.
6. Tree protection specifications will be required once final plan sets are completed.

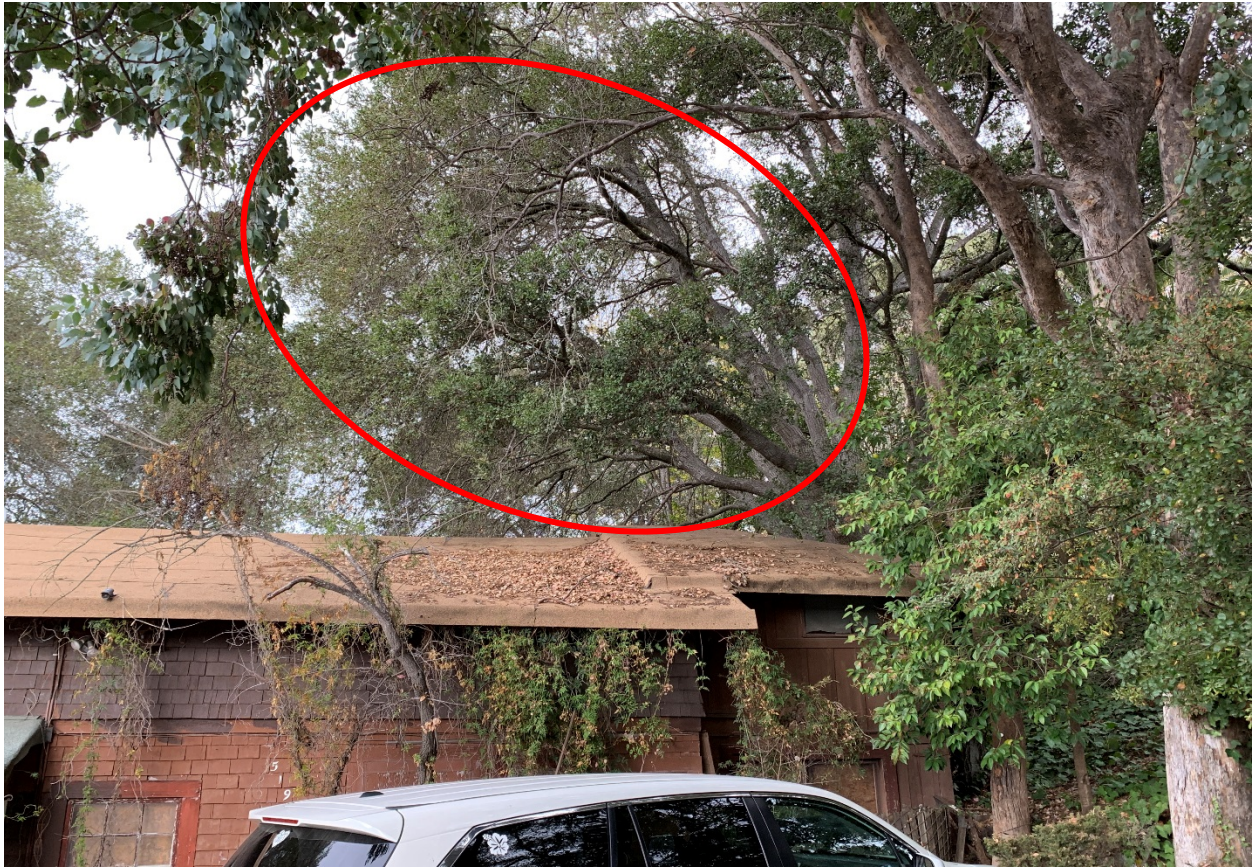
Image #5 – Trees T41 & T42, coast live oak (circled), with canopies overhanging the project limits. The trees were in fair condition. The property line is just beyond the parked car and home.

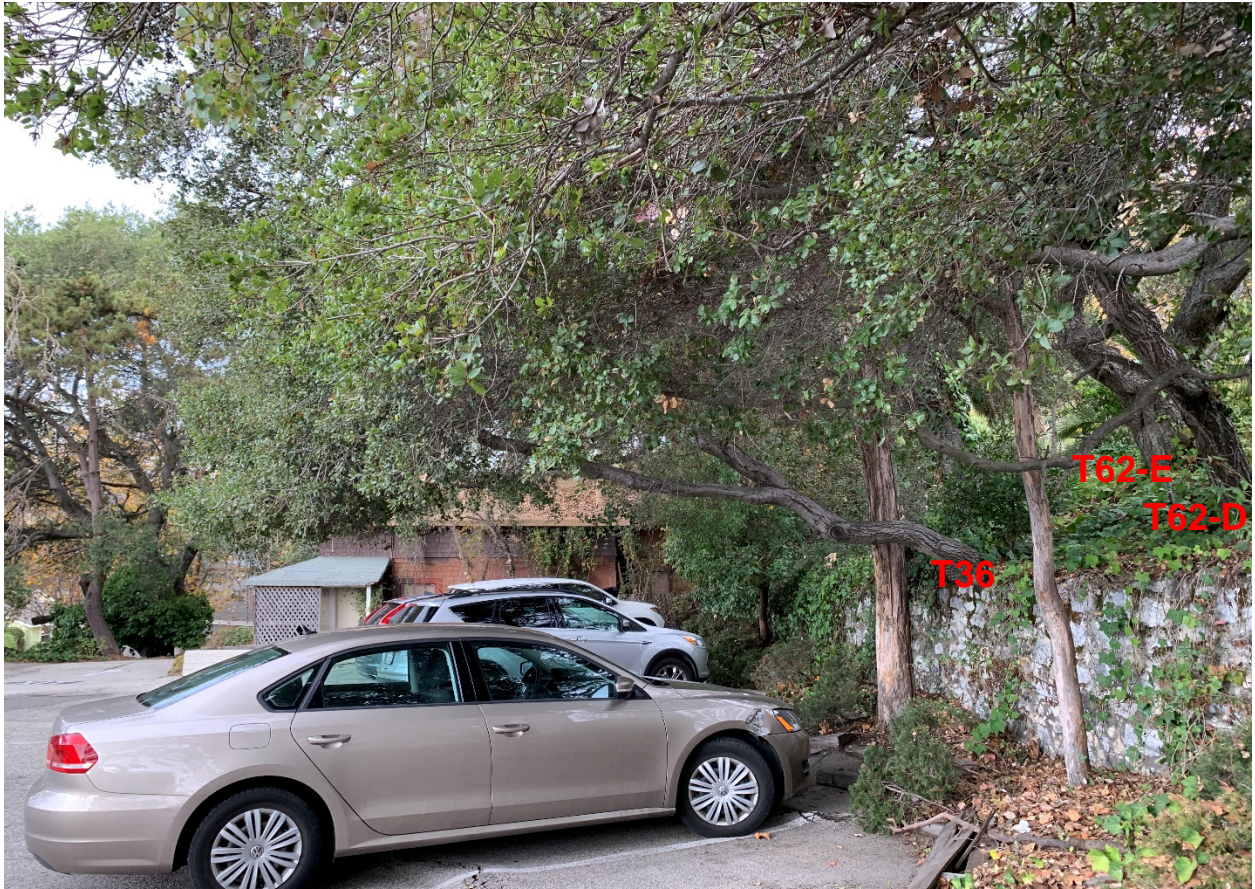
Image #6 – Trees T36, 62-D & 62-E. These oaks were in fair condition. Note overhanging canopies into project area.

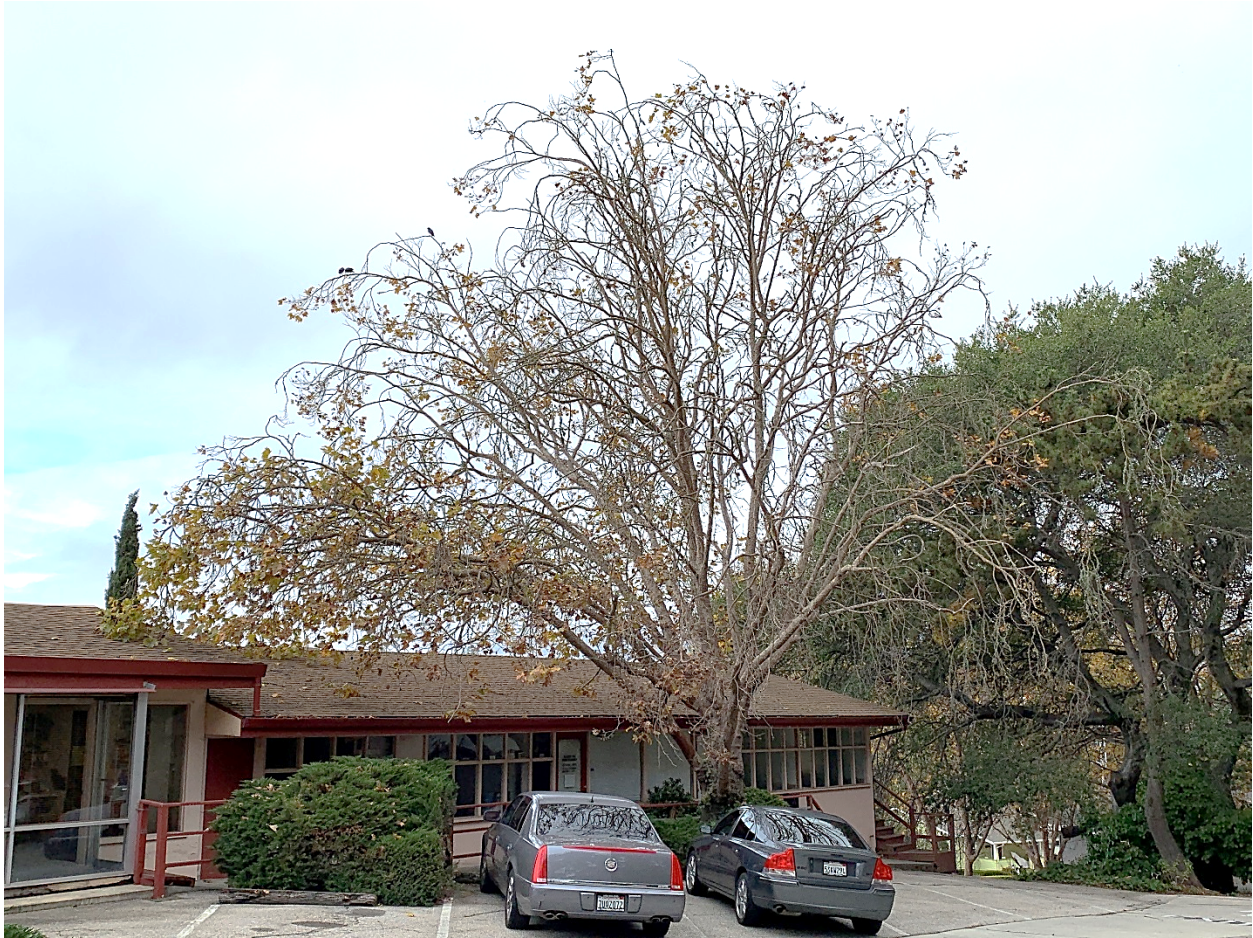
Image #7- Tree T43, London plane in fair condition, showing seasonal leaf drop.

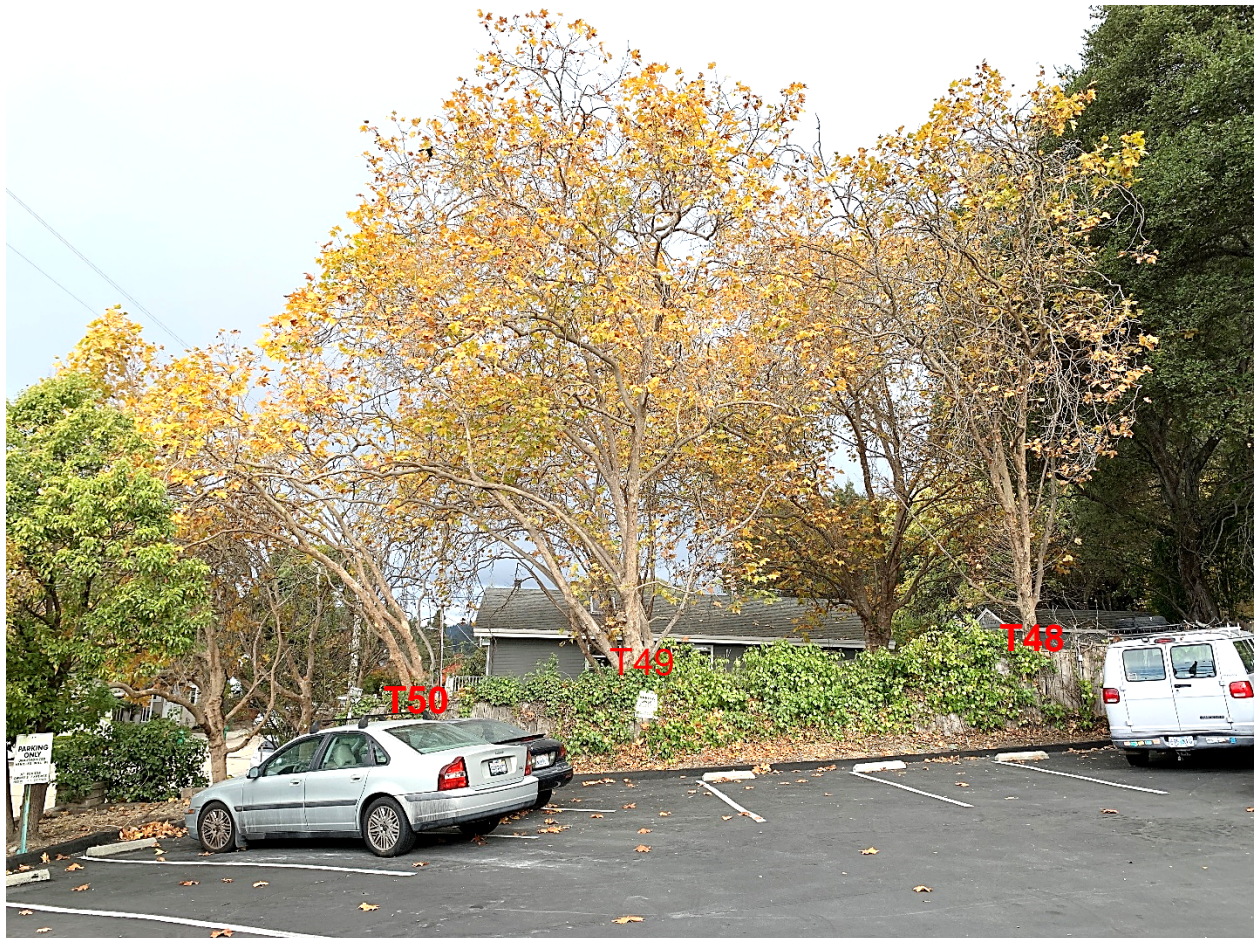
They were in poor or fair condition. Many had partial canopy dieback or unbalanced canopies with a weight bias to the west (Image #8).

Image #8- Trees T48 & T50 in poor condition and T49 in fair condition, London plane. Tree T48 has tip and limb dieback over 30-percent of its canopy and T50 has a significant trunk bow to the west, and tip and limb dieback over 25-percent of its canopy.

Several of the plane trees are lifting the asphalt driveway by surface root diameter expansion, and many trip hazards have been created.

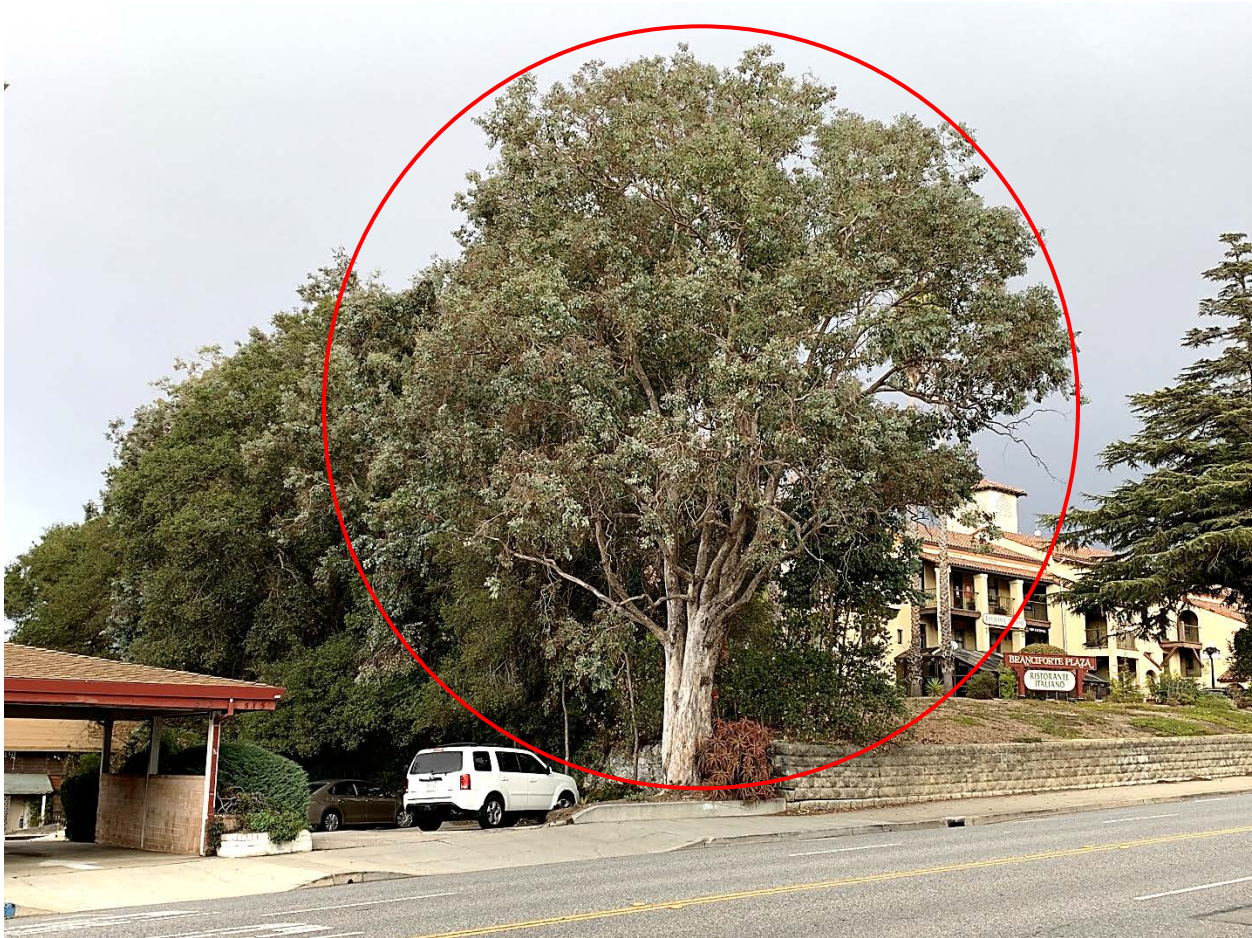
Image #9 – Tree T31, silver dollar gum (circled). The tree is in fair condition. Surface rooting is causing sidewalk and parking lot pavement lifting.

The eucalyptus are planted in a narrow 2-foot wide planting strip, and many have extensive surface rooting causing asphalt lifting, and creating numerous trip hazards.

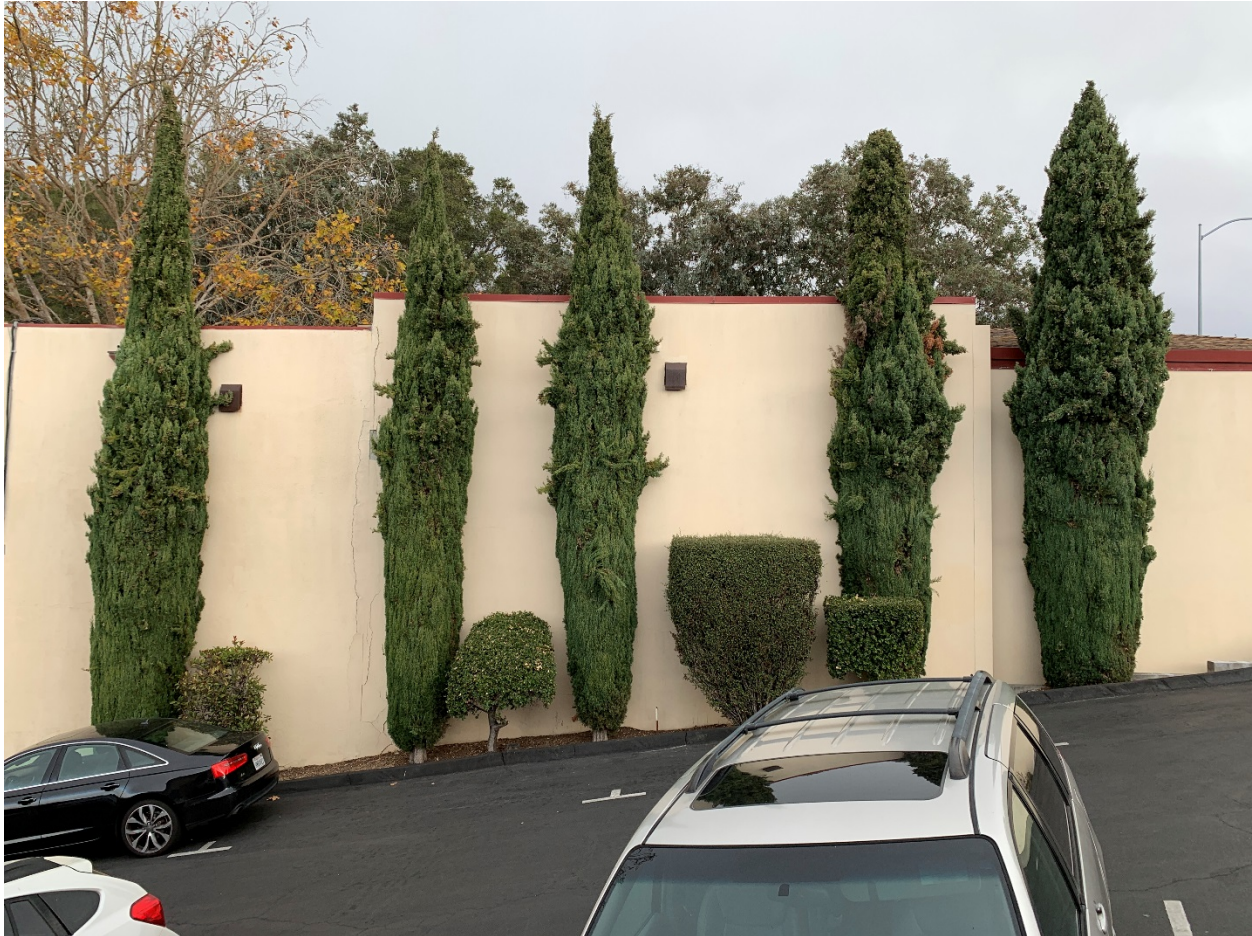
A row of maturing Italian cypress was planted against the commercial building on the west side (Image #10). The cypress are in good condition. It was not apparent if these trees are located on the subject property, or if they are part of the adjacent property at 501 Soquel Avenue.

Image #10 – Trees T57-T61, Italian cypress. The trees were in good condition.

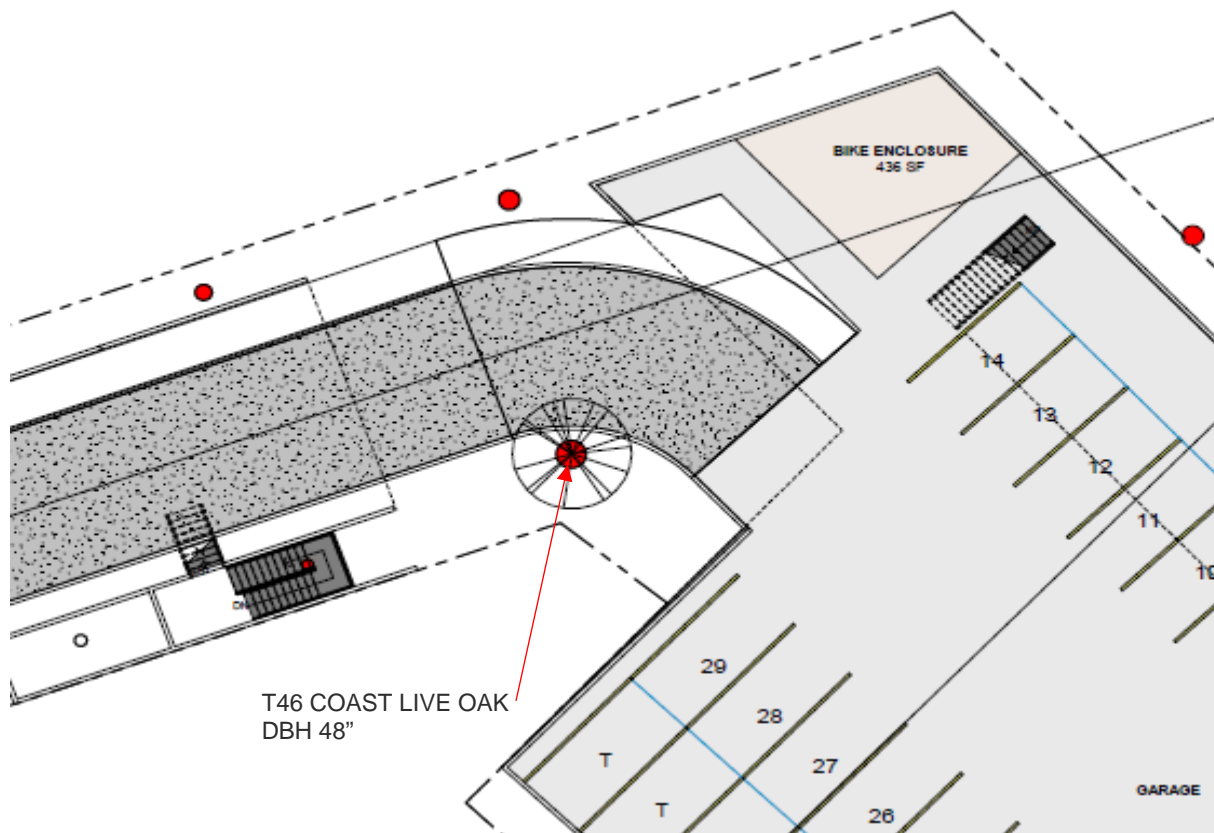
Excavation for Tree T46, coast live oak, (48" trunk diameter), as shown in the preliminary site plan, will occur within 1.5 feet of the tree. This distance is below minimum root loss tolerances, and within the trees critical root zone. As a result, the tree will lose over 30% of its rooting area, including anchoring roots necessary to keep the tree upright.

Image #11 – Tree T46, coast live oak. The proposed driveway edge is shown 1.5 feet from the tree trunk.

In order to retain this tree, excavation for the garage driveway must occur a minimum of 7 feet from the trunk.

If the roots along the driveway edge can be bridged with a pier and beam foundation or other construction method, where cutting of roots is minimized, root loss impacts would be significantly reduced, the proposed driveway footprint could be maintained, and the tree could be retained.
