Quantifying Potential Pollutant Discharge in Near Shore Central Coast

Rhodamine
Detection in
Municipal
Wastewater
Outfall Plumes
from the City of
Santa Cruz

Dave Martin, City of Santa Cruz, Environmental Compliance Inspector, PhD

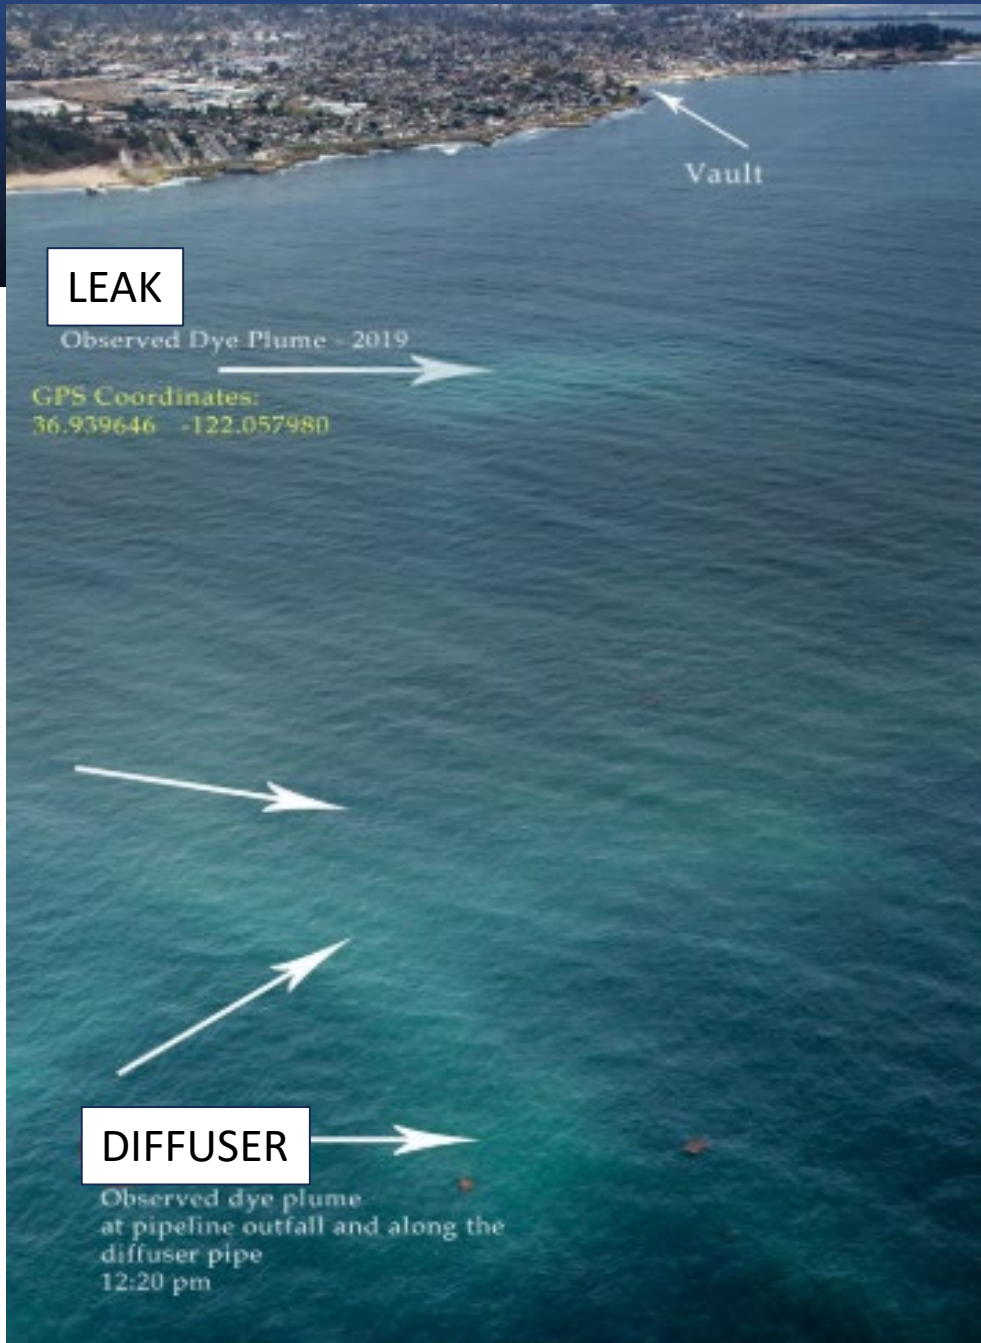
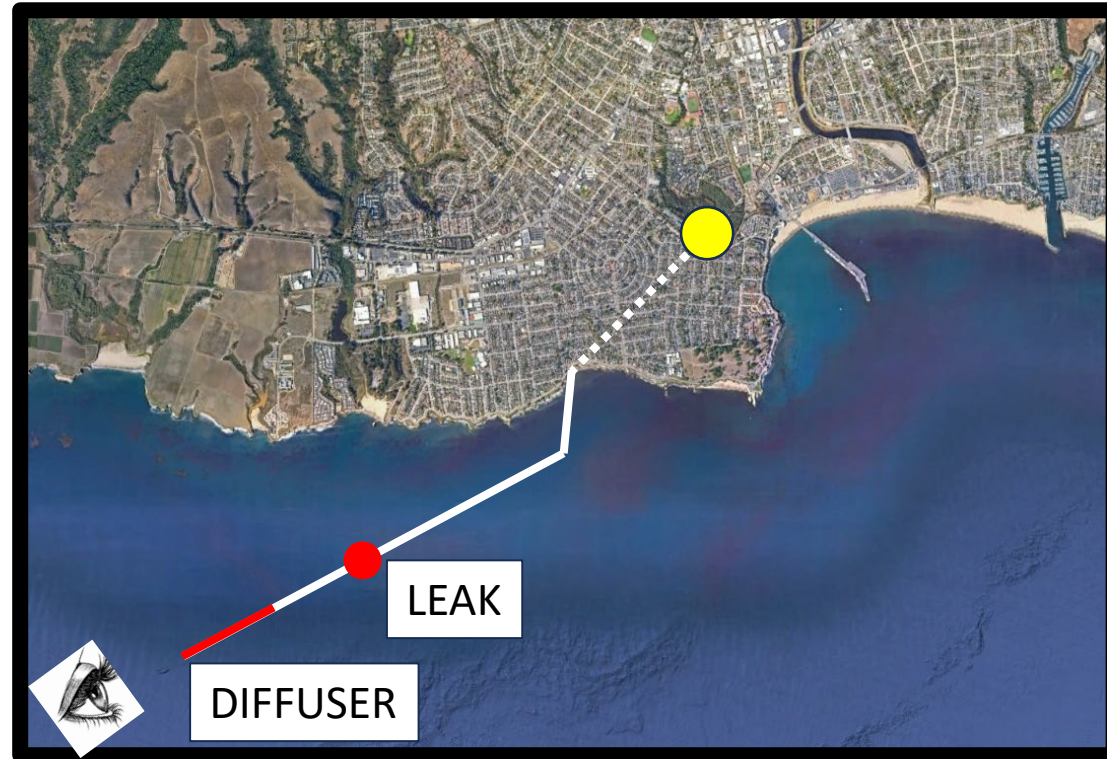
Aerial Observations of Plumes Using Dye

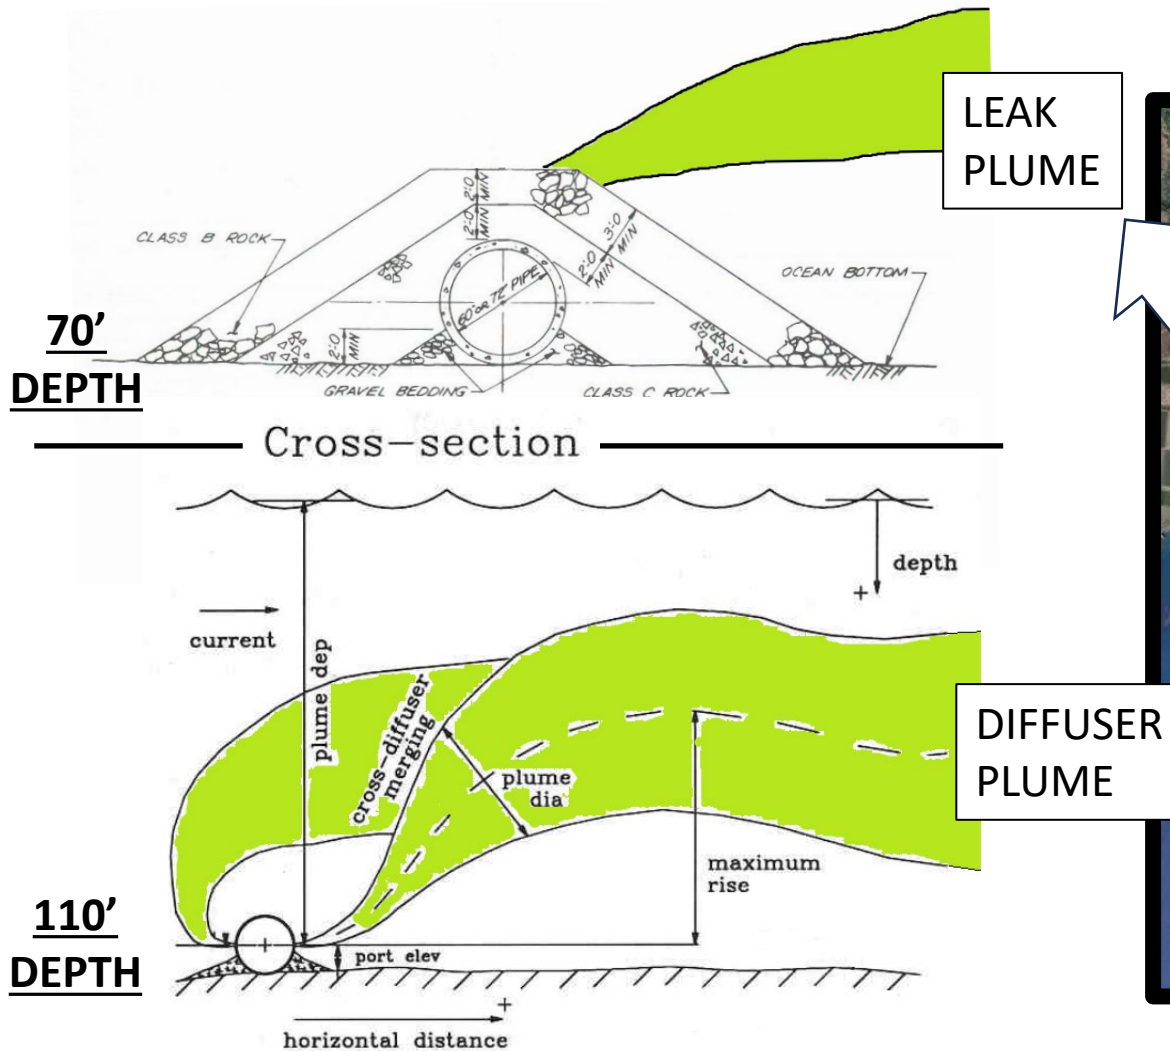
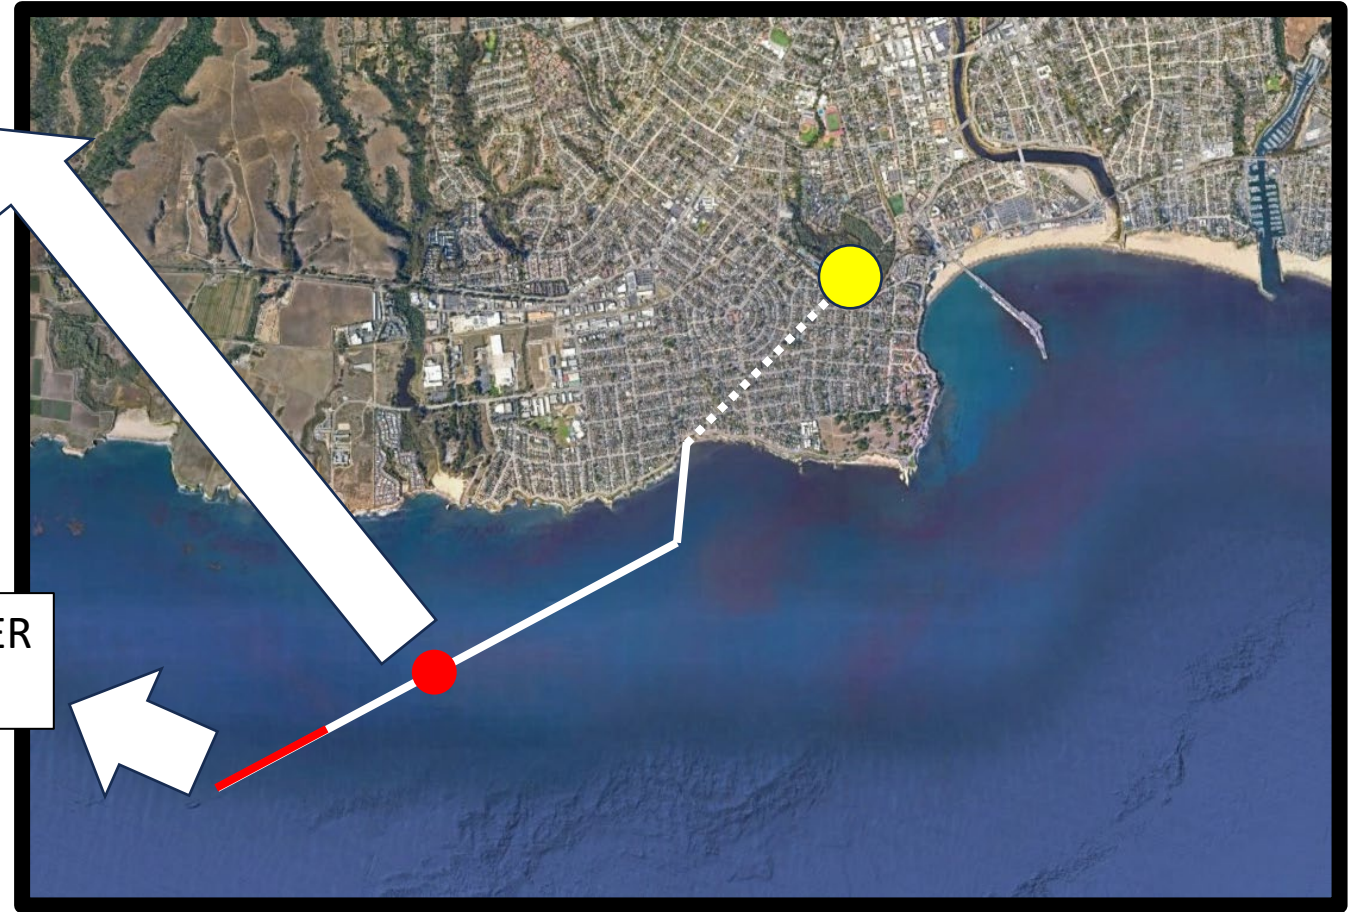
Outfall Construction and Expected Plumes

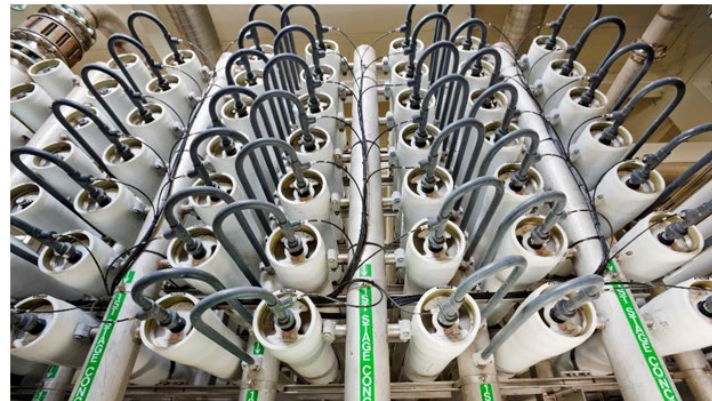
Recycling Final
Secondary Effluent

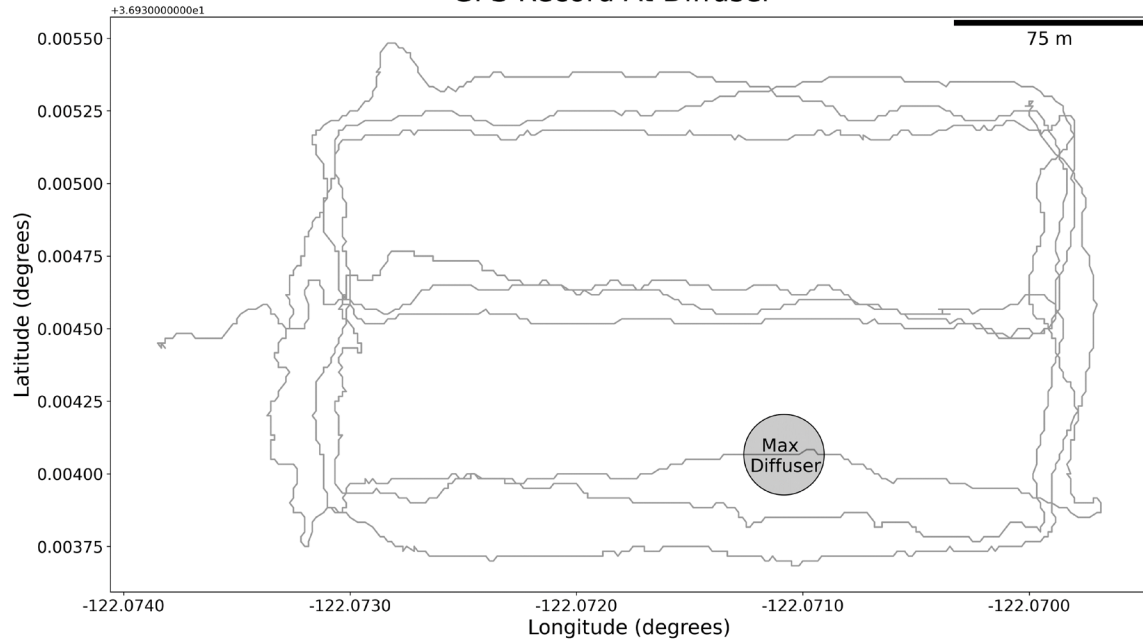
Ocean Surface
GPS Record At Diffuser

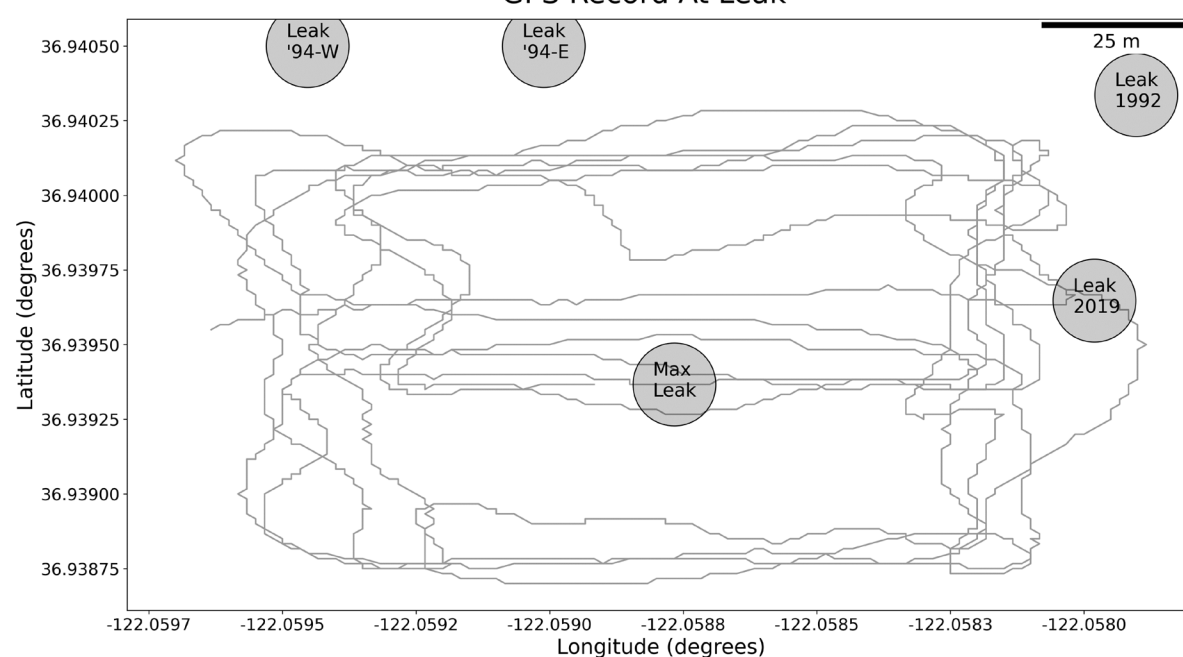
Ocean Surface
GPS Record At Leak

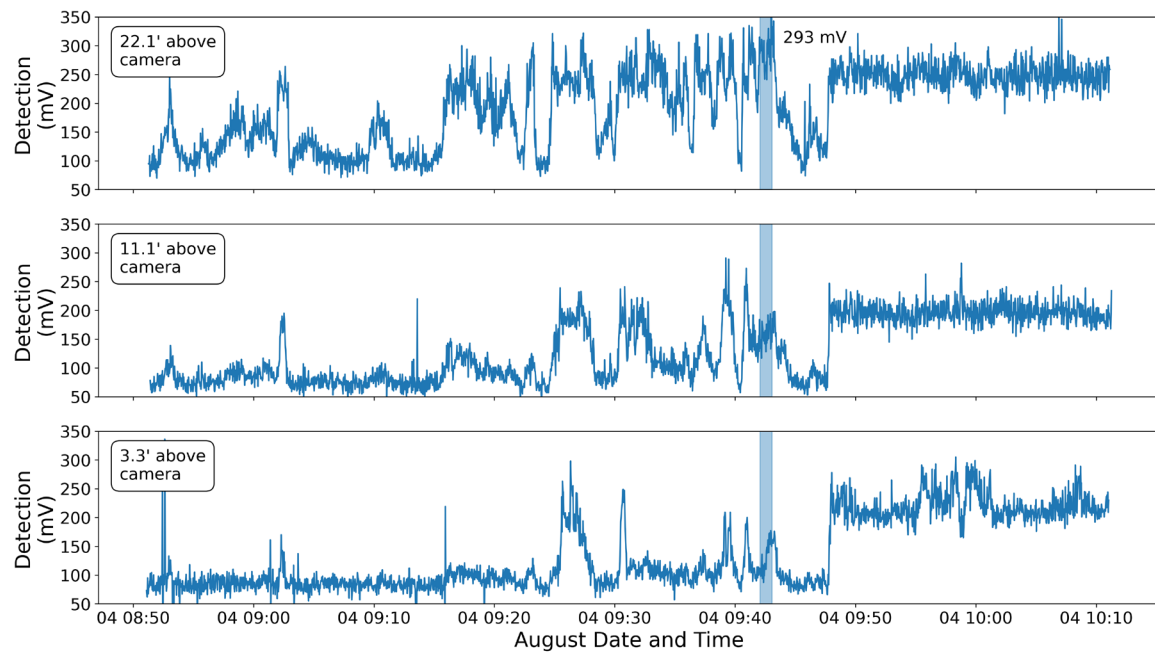
Fluorescence Detected at Depths

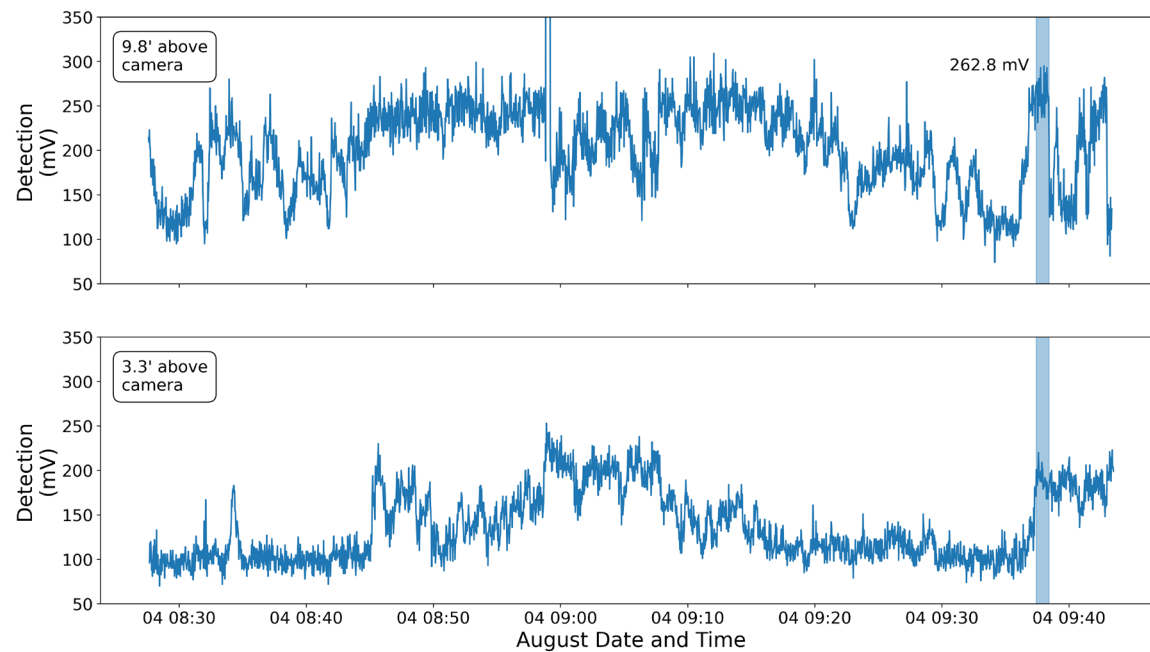
Fluorescence Detected at Depths

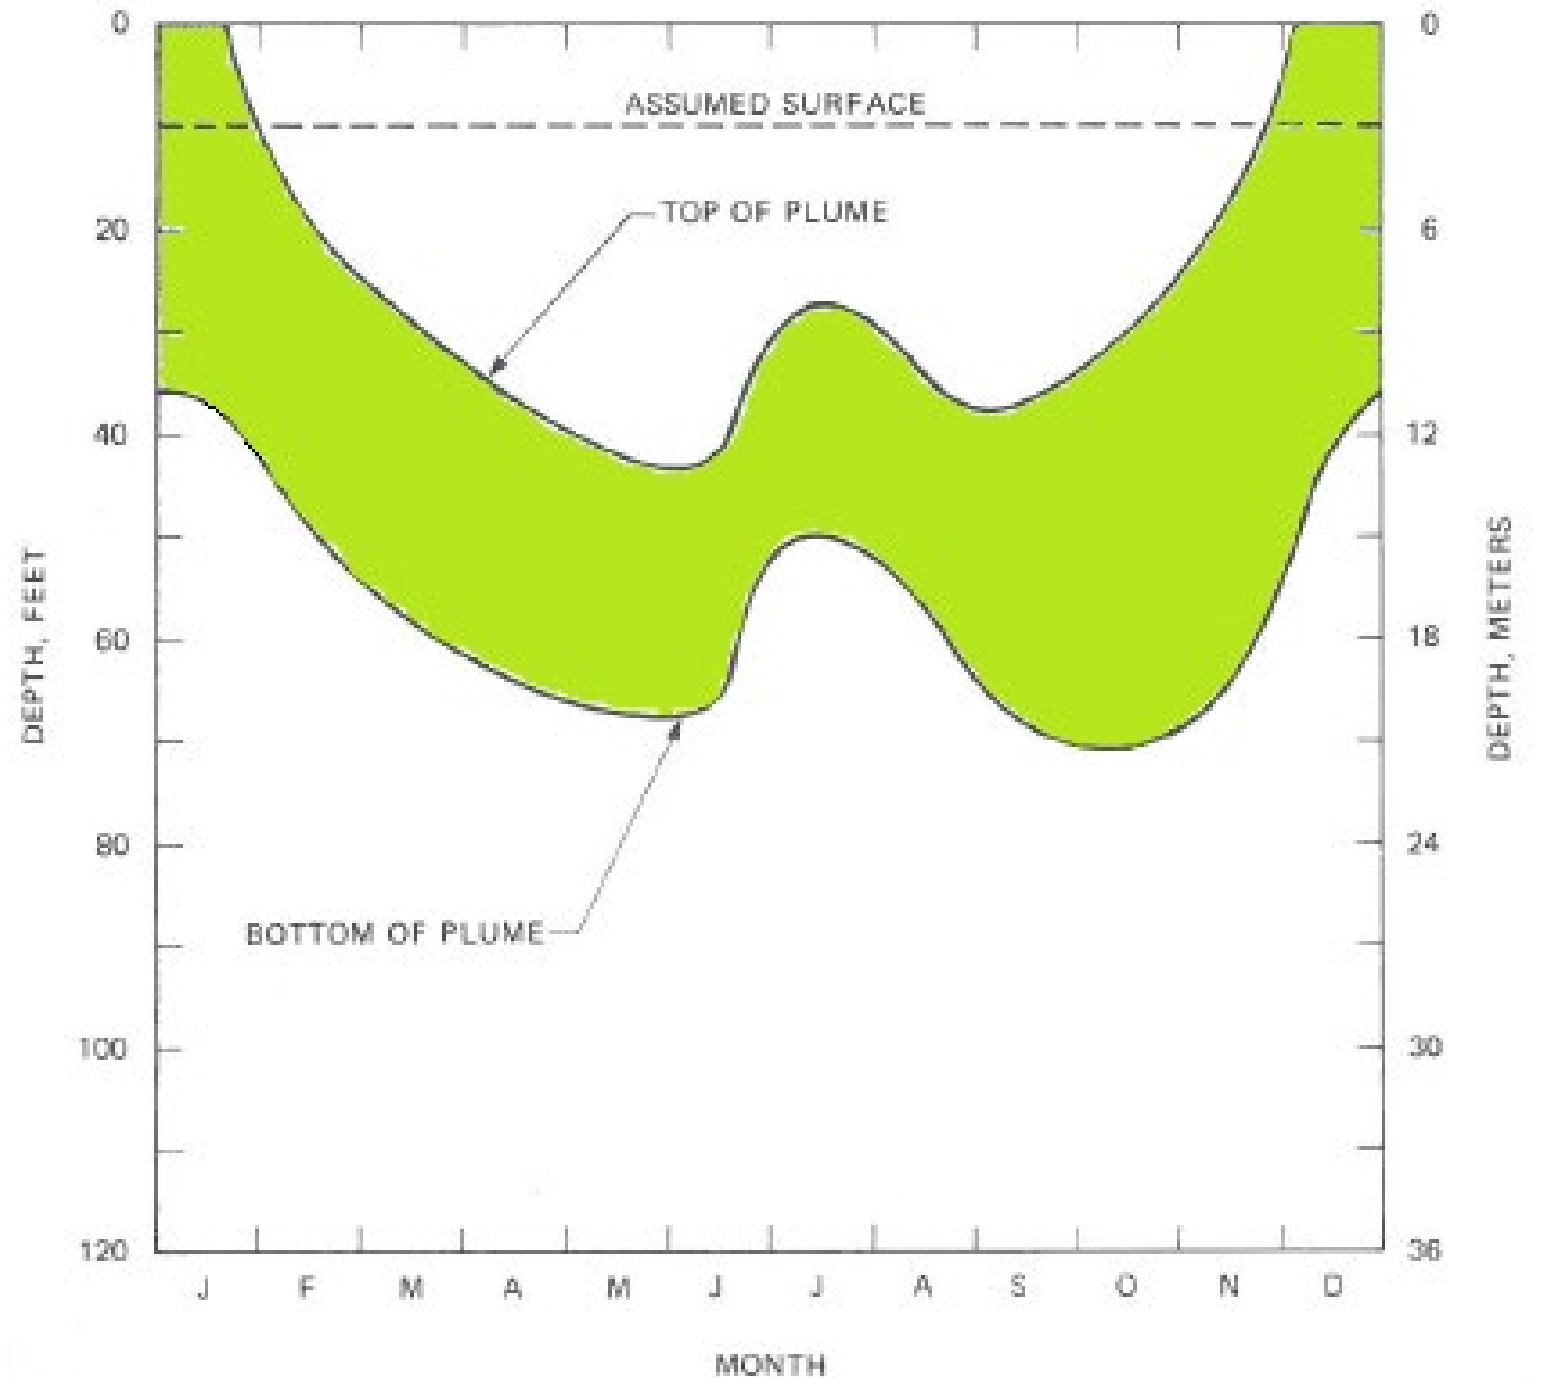
Problem with Visual Plume Observation
