TECHNICAL MEMORANDUM

PROJECT: City of Santa Cruz Habitat Conservation Plan, Lagoon Fish Population Sampling 2010

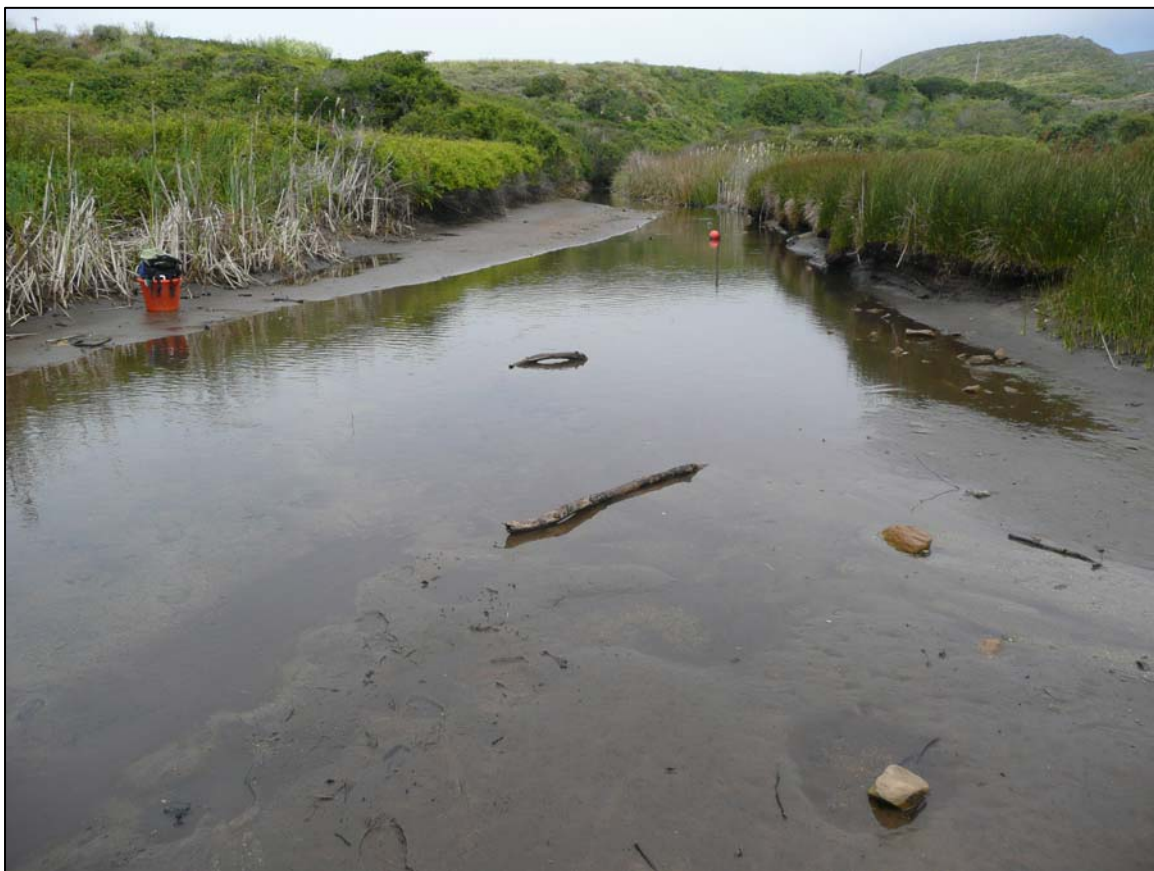
- Site Conditions
 - Mouth open, lagoon at very low stage with maximum depths 1 to 2.5 feet for each seine haul. Lagoon habitat limited to an area between the upper pond outlet and the neck (Figure 1). Flowing, stream-like habitat was present from the neck to mouth and upstream of the water quality station. There was evidence of multiple breaches at the mouth (Figure 2). City staff reported mouth was closed during visit on June 2, 2010. On the evening of June 23 (about 20:03), the mouth had closed (high tide was at 20:40) and the lagoon was about half full. Waves were washing over the sandbar into the lagoon. At 14:30 on June 24, the mouth was closed with the lagoon surface only a few inches below the sandbar. Water quality monitoring by the City and 2NDNATURE indicated that the lagoon had breached in mid-May slightly after monitoring began; was open through the end of May; closed, refilled and breached again in early June; was open for a couple of days; closed, refilled, and breached again just before the June 22 sampling date. The monitoring data shows the lagoon breached at least one more time in early July but was stable after mid-August (missing data between July 20 and August 17).

Figure 1. Laguna lagoon, June 22, 2010.

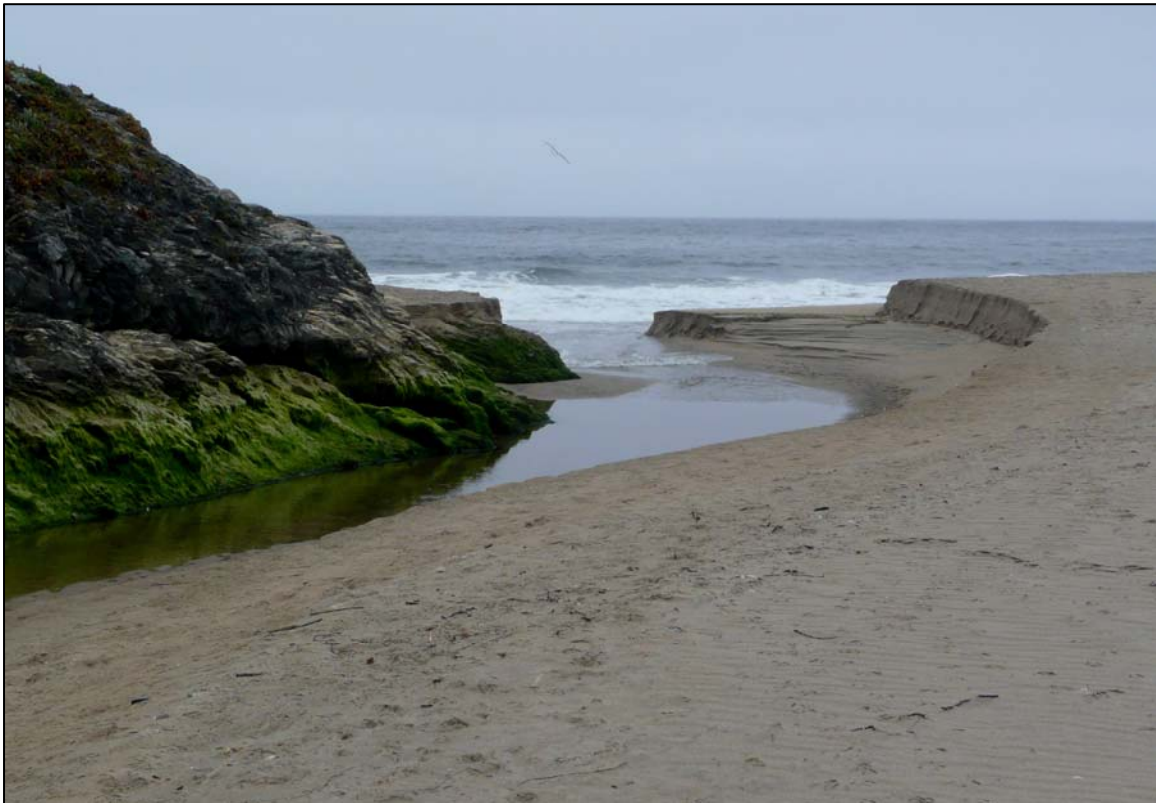
Figure 2. Mouth of Laguna lagoon, June 22, 2010 showing multiple breach terraces.

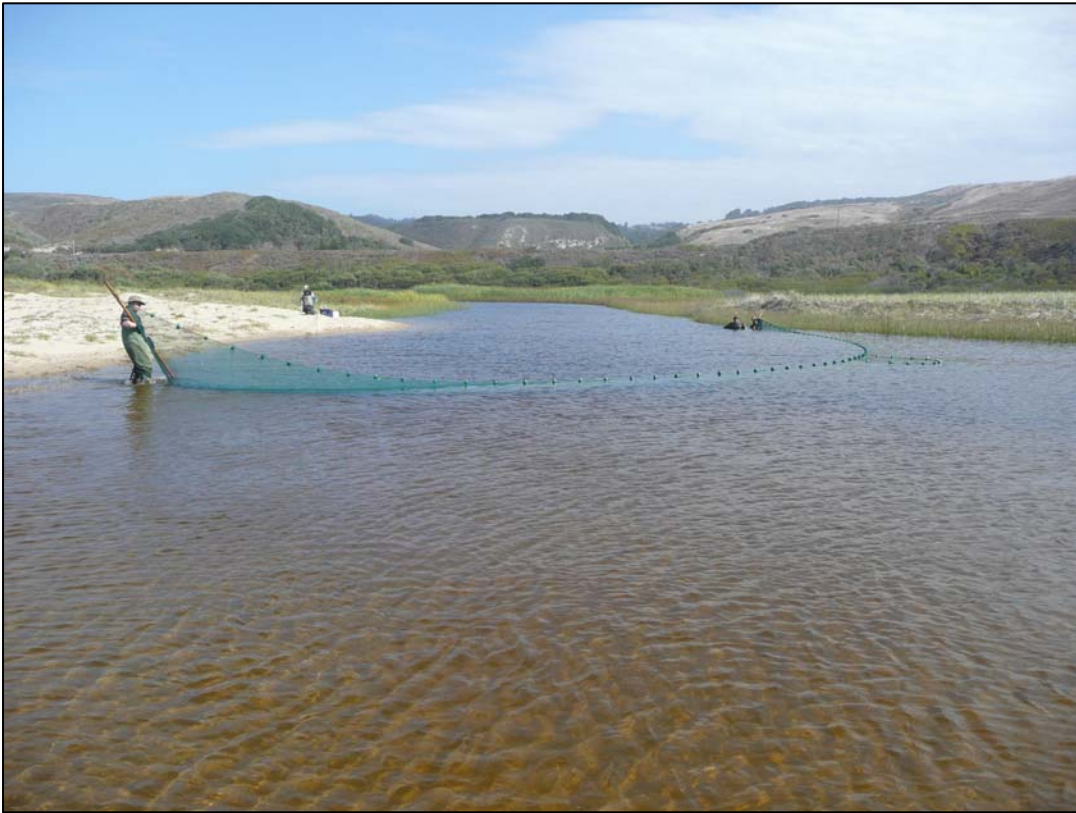
- Site Conditions
 - Mouth closed, stage high (Figure 4). Water quality monitoring by the City and 2NDNATURE indicated that the Laguna lagoon had filled and breached at least twice since the June 22 sampling event.
 - Depth to about 5 feet near mouth and up to about 7 feet near YSI site.
 - Temperature 15-17.5 C at surface
 - Visibility good.

Figure 4. Laguna lagoon, October 5, 2010.

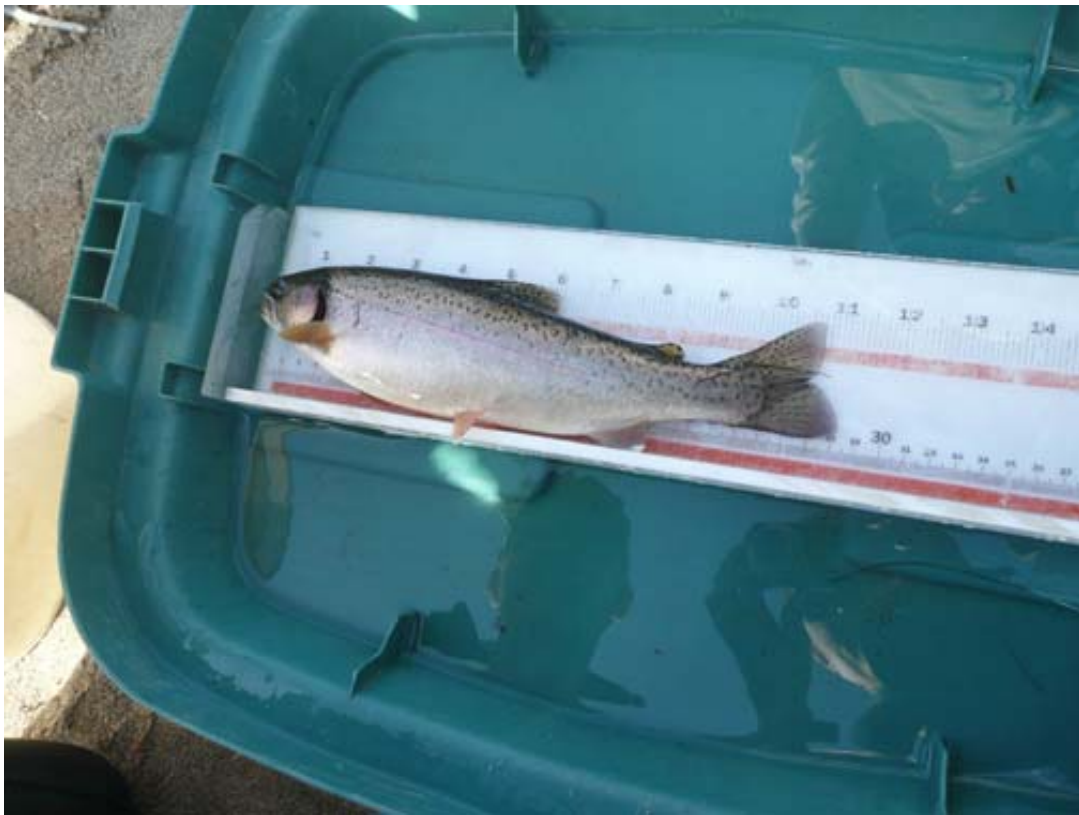
- Survey results
 - 100 ft. by 6 ft by ¼ inch mesh bag seine:
 - 6 hauls
 - Steelhead catch included relatively few fish of very large size. Steelhead ranged from 160mm to 250mm (FL). CPUE for steelhead was very low in the fall sampling (Table 3) although the presence of very large, fast growing, and healthy individuals indicates good rearing conditions. This is also consistent with density dependence in growth rates seen in nearby Scott Creek lagoon (Sean Hayes, National Marine Fisheries Service, personal communication). Scale samples were collected from 6 of these and age determinations were completed by Michelle Leicester of CDFG. Aged fish were 0+ and 1+ (Table 4). There was a mix of 0+ and 1+ fish, some of comparable size, indicating a diversity of life-history patterns. Given the unstable lagoon conditions in 2010 with numerous breach events, it is possible that there was a lot of movement between the lagoon and upstream areas. Hayes et al. (in prep.) found movement out of Scott Creek lagoon back upstream in the fall when water quality conditions in the lagoon deteriorated. All of the 0+ fish showed very good growth rates, reaching smolt-size in a single season. One individual, at 267 mm, showed extremely good growth (Figure 5), The 1+ fish have first year growth consistent with stream rearing,

Figure 5. *O. mykiss* from Laguna lagoon, October 5, 2010, 267mm 0+.

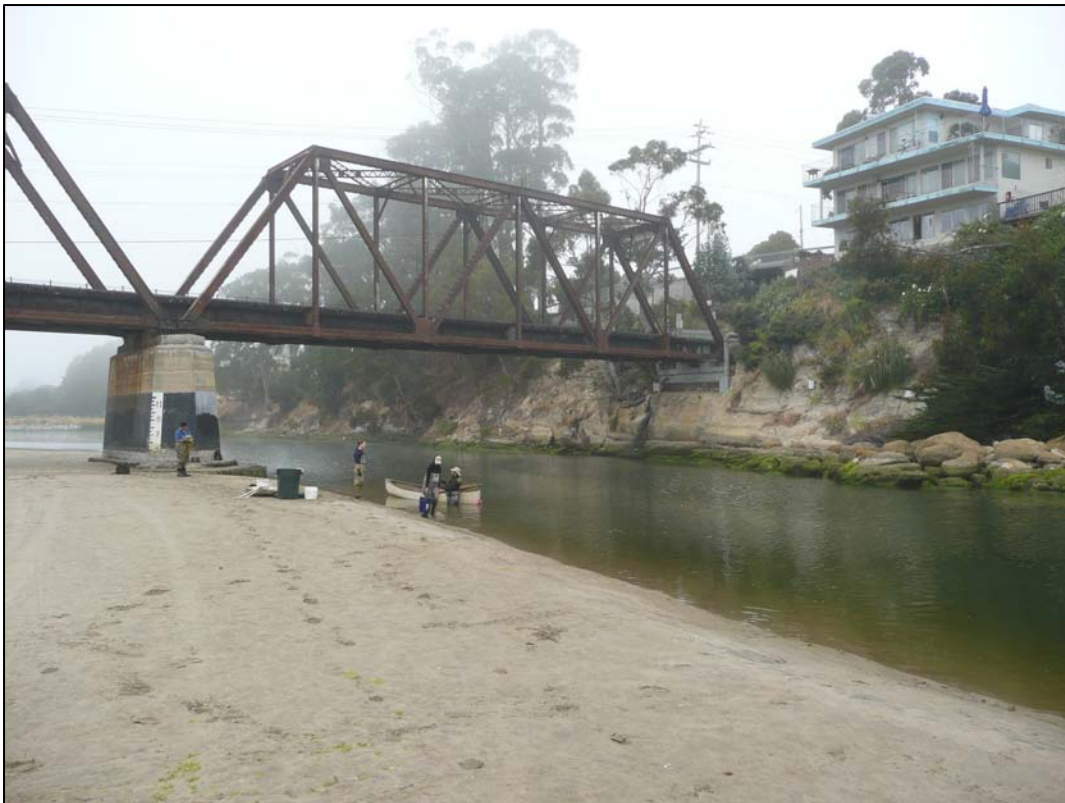
- Site Conditions
 - Lagoon open, stage low, visibility fair-good (Figure 6).
 - Salinity 2-4 ppt at surface and 29-30 ppt at the bottom;
 - Surface and bottom temperatures were 17-18°C;
 - Surface DO ranged from 5.7 to 8.7 mg/l and bottom DO was from 1.7 to 4.3.

Figure 6. San Lorenzo lagoon, June 23, 2010.

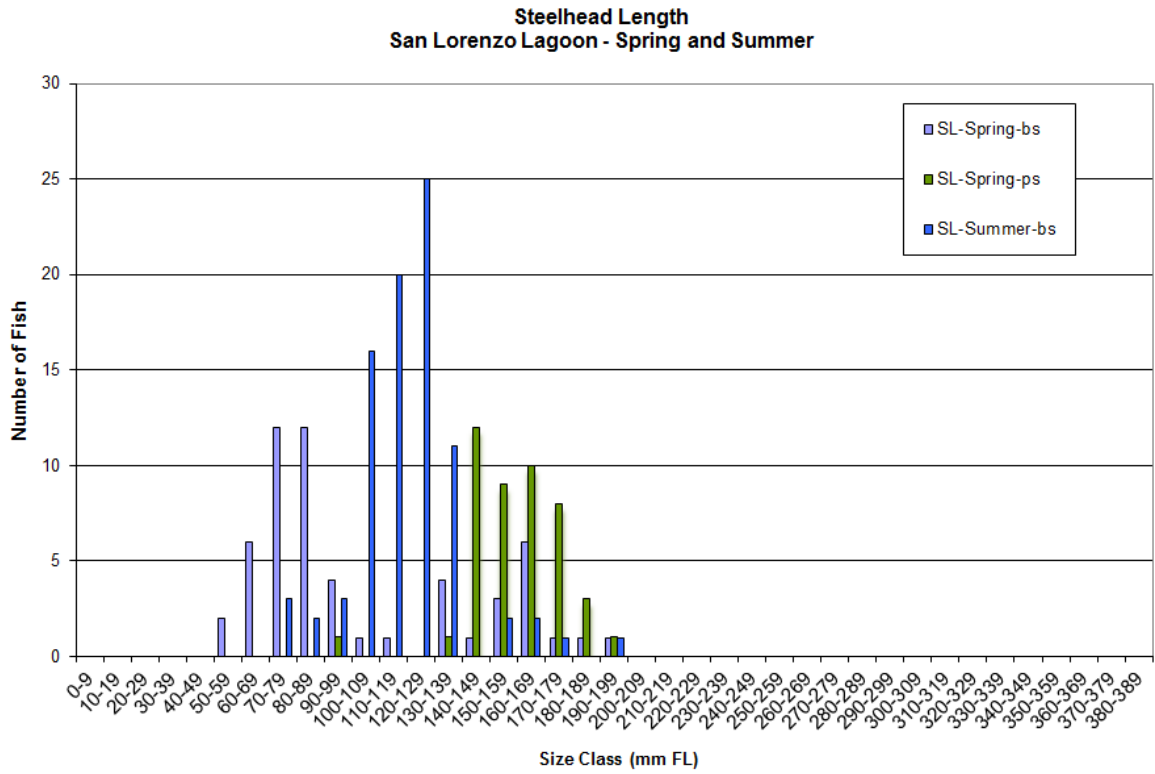
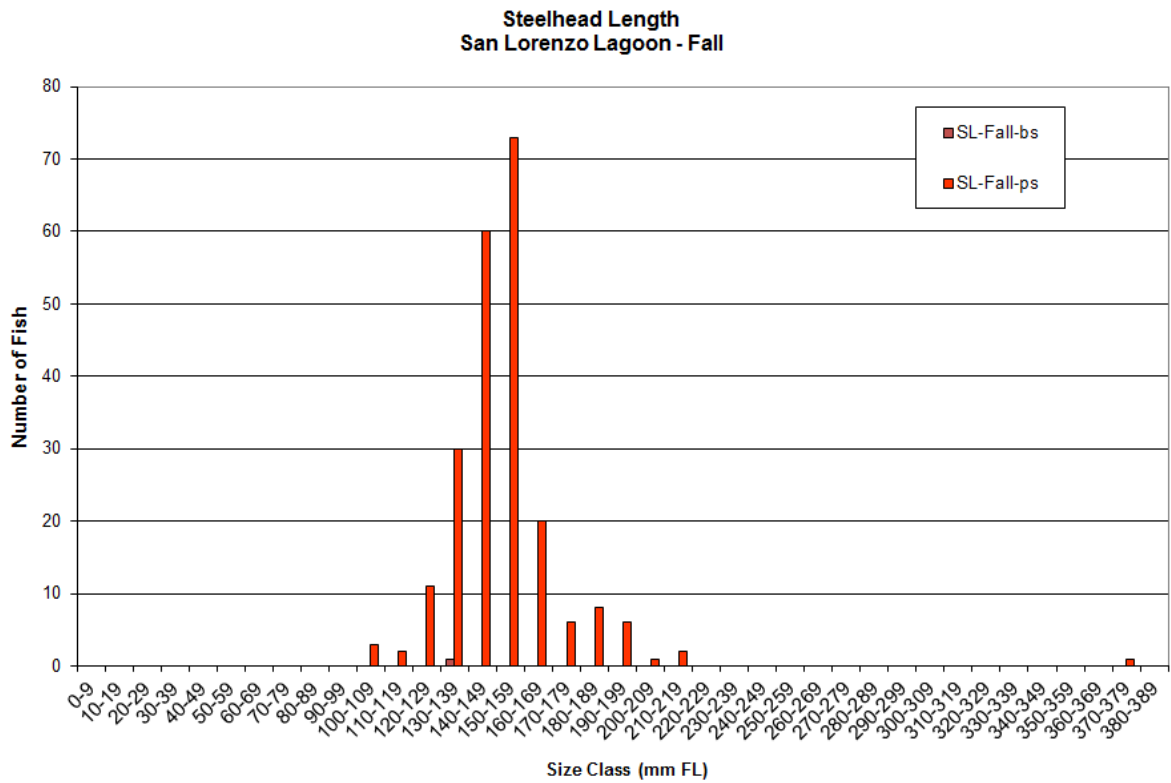
- Survey results
 - 100 ft. by 6 ft by ¼ inch mesh bag seine:
 - 10 hauls
 - Steelhead were moderately abundant around the railroad trestle and upstream of Riverside Bridge (Table 5). Two size classes of steelhead present: ~50-110mm and ~130-190mm (Figure 6). Smaller size class was downstream of trestle and upstream of Riverside, larger size class was around trestle.
 - Catch of other species diverse (Table 5).
 - 150 ft. by 8 ft by 1/4 inch purse seine
 - 2 hauls near railroad trestle
 - Steelhead moderately abundant, Catch per haul about three times higher than bag seine catch per haul at same location. All steelhead in ~130-190mm size range (Figure 7).

Figure 7. Steelhead length classes in San Lorenzo Lagoon.

- Survey results
 - 100 ft. by 6 ft by ¼ inch mesh bag seine:
 - 4 hauls near trestle and water quality monitoring site (site 3) in conjunction with test of Biosonics hydroacoustic equipment.
 - Large numbers of steelhead juveniles and topsmelt (Table 6). Steelhead were predominantly near site 3, and mostly in the 100-140 mm size class (Figure 7).

- Steelhead very abundant at trestle and upstream of Riverside. Catch per haul among highest for all sampling events (Table 8). Majority of steelhead in ~120-180mm size range (Figure 6). Scale samples were collected from 15 of these and age determinations were completed by Michelle Leicester of CDFG (Table 9). Aged fish were predominantly young-of-year (0+), with two 1+ individuals. Young-of-year ranged from 103 to 159 mm FL with one 216 mm individual. The largest 1+ fish (375 mmFL) had apparently spent time in the ocean. Five of the 0+ fish showed evidence of late summer reduced growth attributed to stress. The age data is consistent with other studies and assumptions that lagoons can provide excellent rearing habitat where steelhead juveniles can reach smolt size (~150 mm FL range) in a single season compared to two or more in stream-type habitats. All juvenile steelhead observed in the lagoon in the fall were large enough to be expected to smolt in the spring (Figure 6).

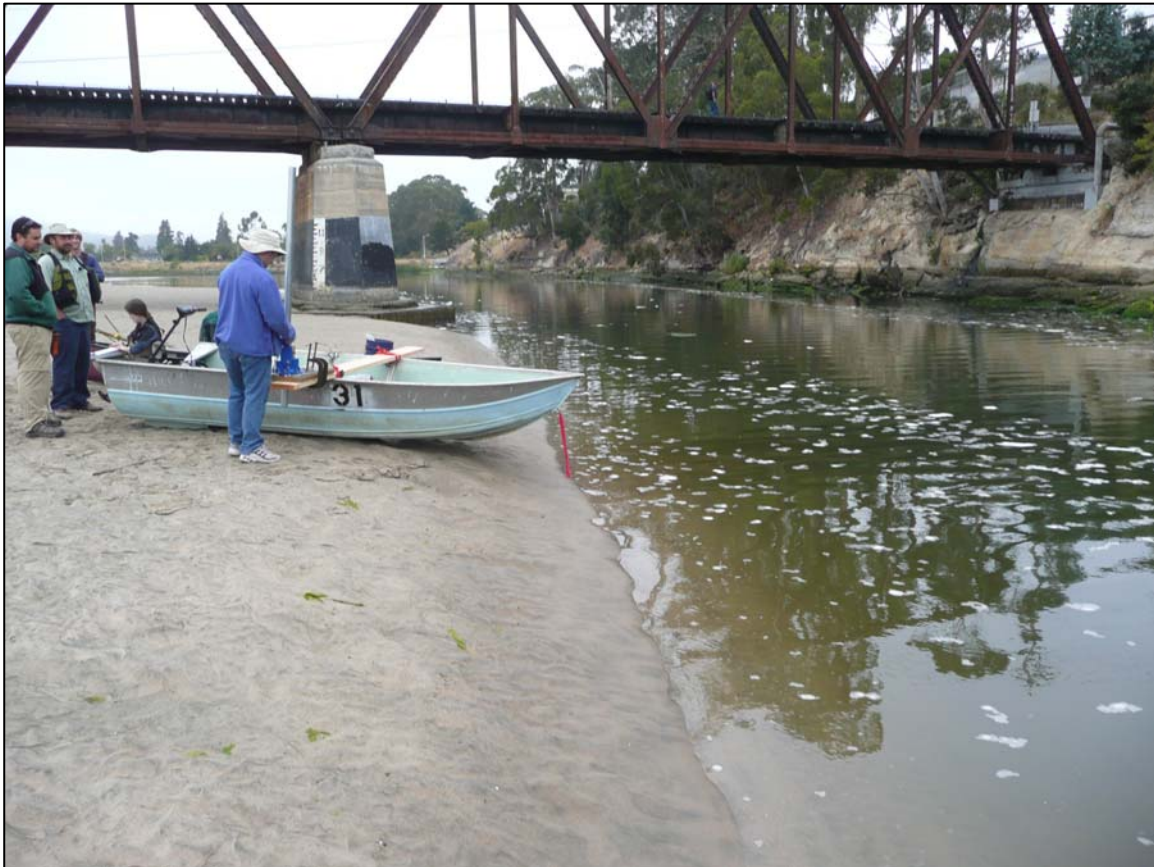
- Site Conditions
 - Lagoon open, breached night of July 20/21, stage low (Figure 8).
 - Water quality conditions reflective of recent breach with inflow of cold seawater at lower levels with warm lagoon/river water outflow at the surface.
 - Surface waters were warm (19.4-21°C), poorly oxygenated (4.9-6.6 mg/l), and moderate salinity (7.6-8.7 ppt). Bottom water was cool (15.5-16.2°C), well oxygenated (7.7-7.8 mg/l), and high salinity (27-28 ppt).
 - Water quality monitoring conducted by the City and 2NDNATURE indicated the lagoon had been mostly open since May 15 with two very brief periods of closure in early July and just before sampling on July 21.

Figure 8. San Lorenzo lagoon, July 21, 2010.

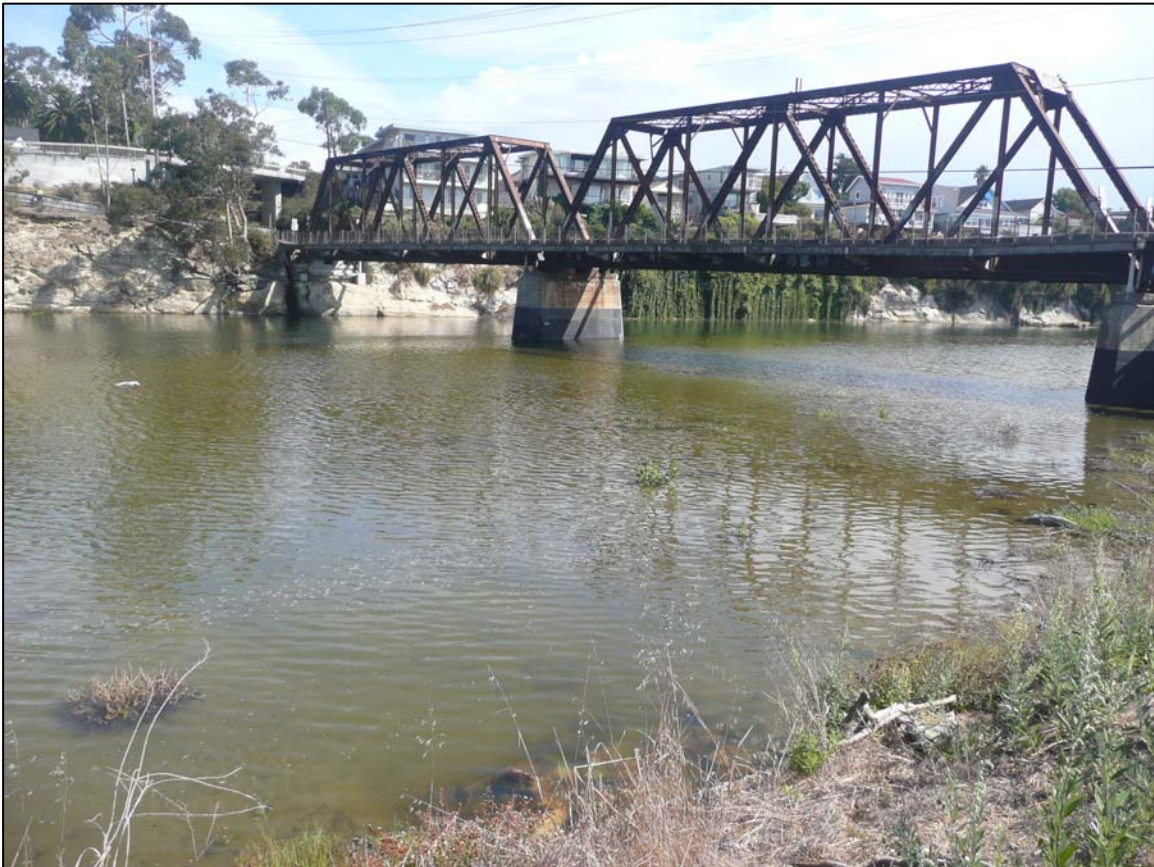
- Site Conditions
 - Lagoon closed, lagoon stage high (Figure 9).
 - Water quality monitoring conducted by the City and 2NDNATURE indicated repeated filling and breaching cycles of one to two weeks duration with some periods of open lagoon between cycles since July.
 - Salinity ~2-3ppt at surface and 3-12ppt at the bottom;
 - Surface temperature ~15-19°C, bottom temperature ~21-23°C.
 - Surface DO ~10-10.5 mg/l and bottom DO ~1.5-2 mg/l.
 - Visibility fair.
 - Sampling difficult due to high lagoon stage, lack of beach areas.

Figure 9. San Lorenzo lagoon, October 6, 2010.

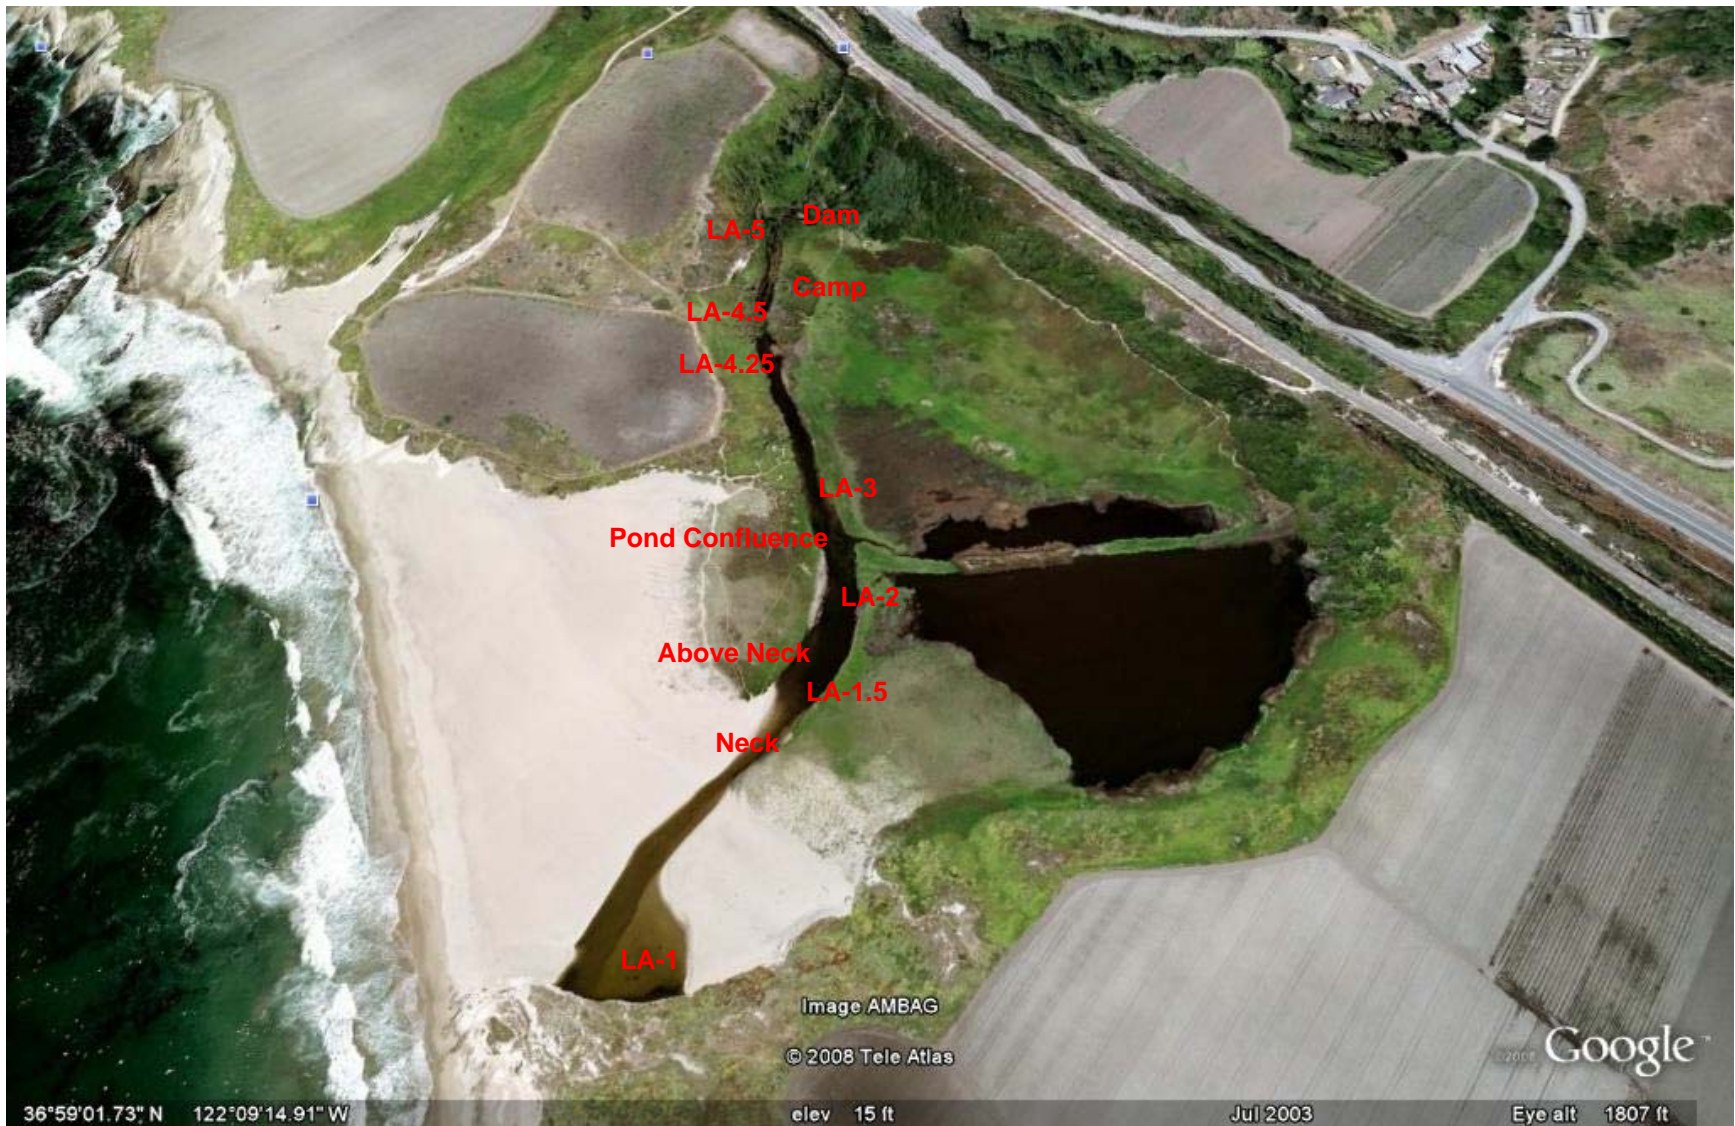
Laguna Creek Lagoon sampling sites.

Note: See Figures at end of document for sample site locations.
