Significance Diagram: 418 Front Street-West Facade

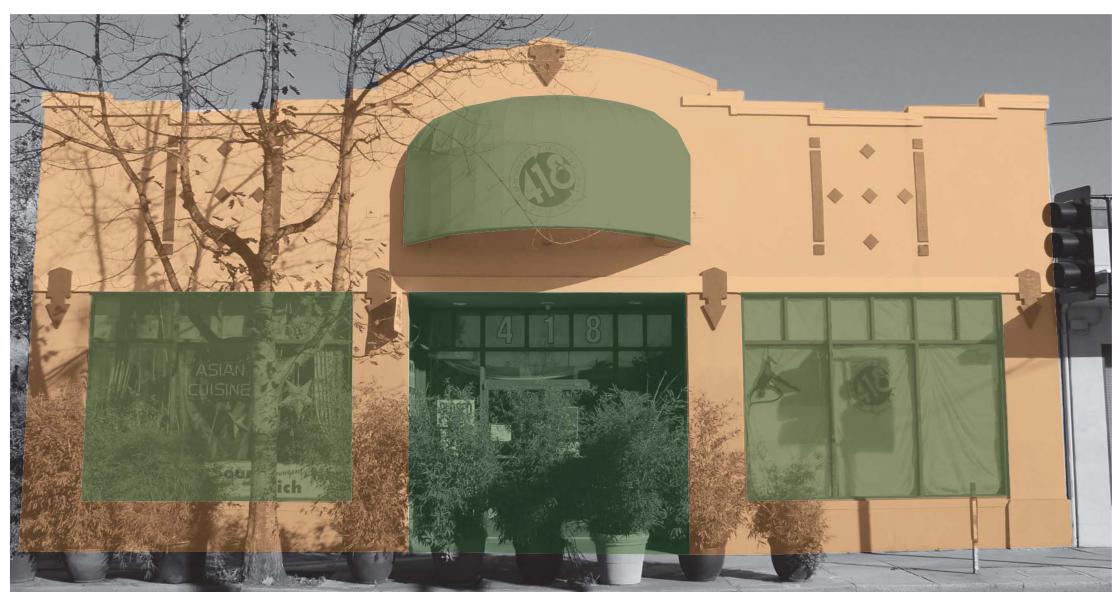
- The primary (west) facade retains its Mission Revival style design and character-defining composition, despite replacement of original windows and main entry door.
- Penestration contributes to the building's historic character, but components within the openings including muntins and glazing are non-contributing.
- The primary facade's stepped cornice and curved parapet are of primary signficance.
- Art Deco detailing is of primary significance.

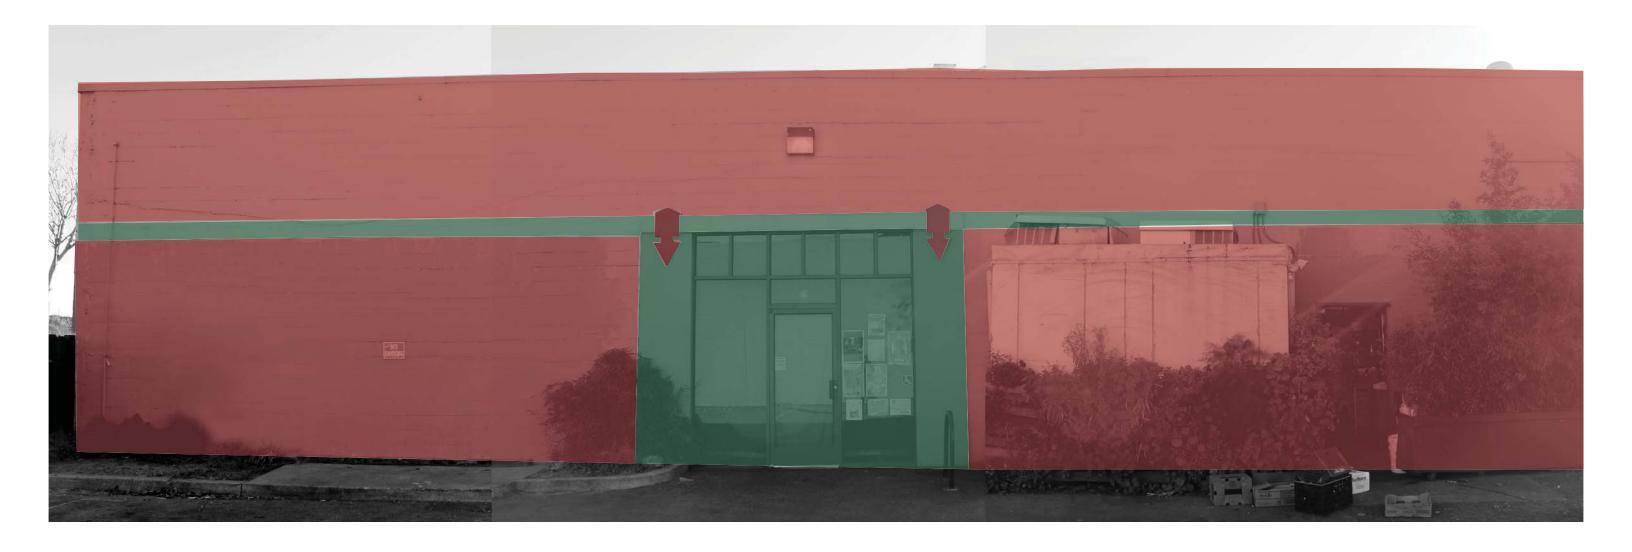
Significance Diagram: 418 Front Street-North Facade

- Opening, door frame, and plate glazing along north facade are non-contributing features that were added during renovation in 1992-1994.
- Arrowheads flanking opening do not correspond to a historic opening, but are associable to the building's original Art Deco detailing.
- The north facade appears to retain most of its original form aside from doorway alteration.

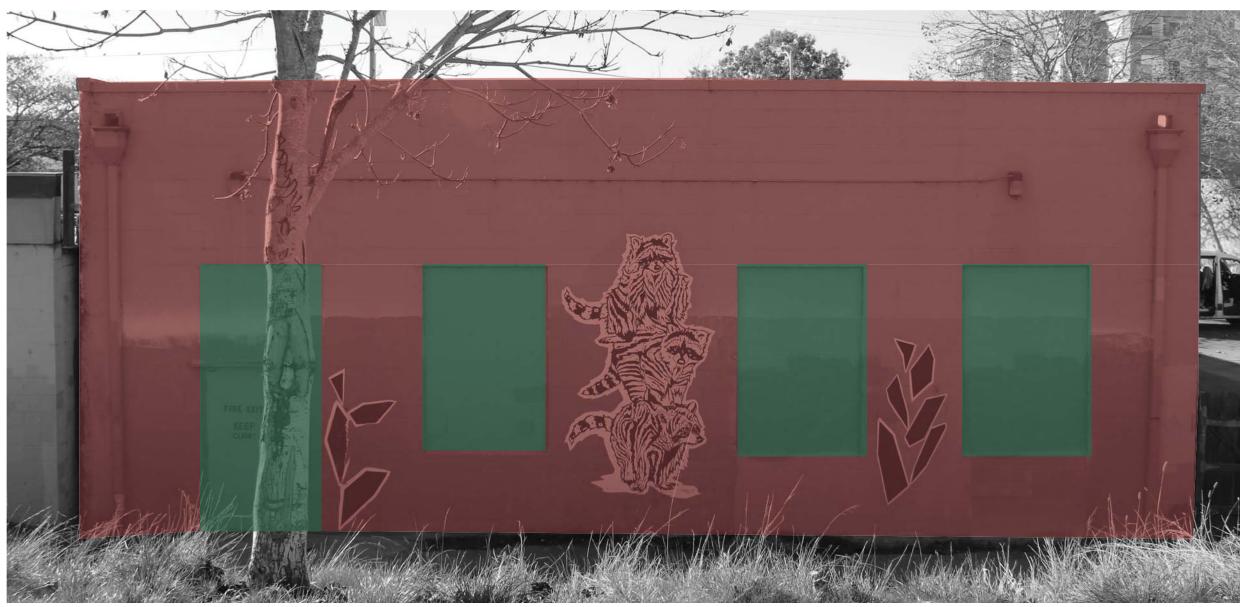
Significance Diagram: 418 Front Street-East Facade

- The rear (east) facade retains much of its original massing and design.
- Former window openings have been infilled with cmu and in one case replaced by a steel door.
- The location of the openings contributes to the building's character, but infill within the openings in non-contributing.

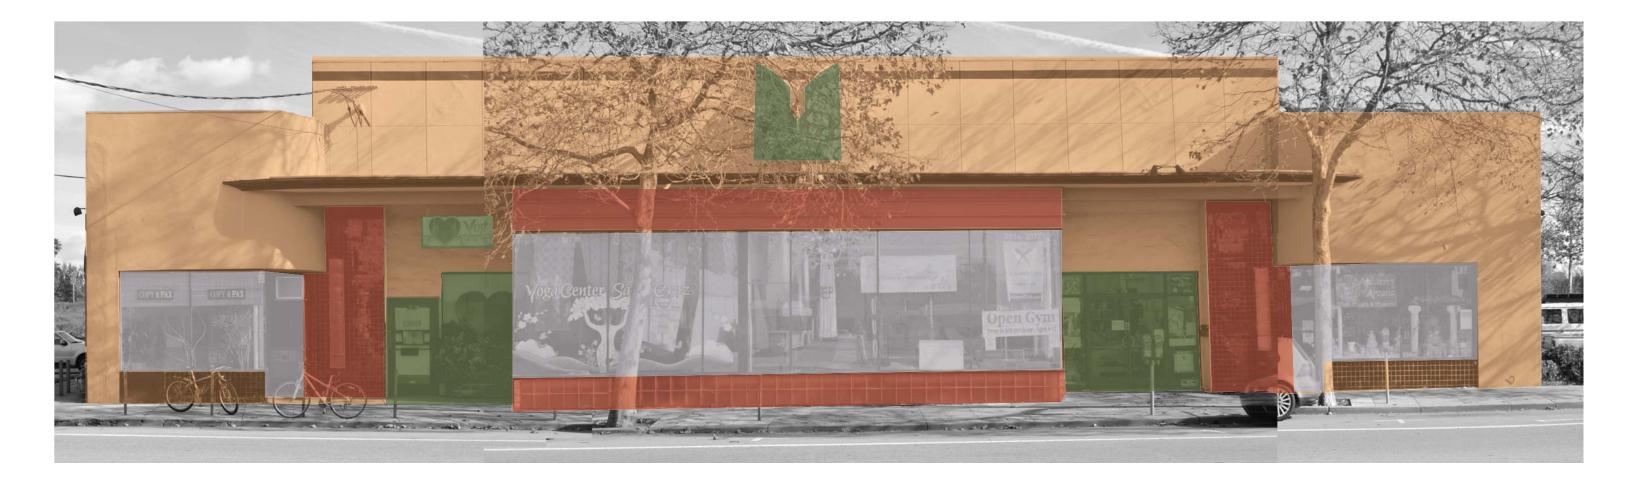
Significance Diagram: 428 Front Street-West Facade

- Articulation of the primary (west) facade's multiple surface planes is a primary, significant feature.
- Streamlined elements connect the primary facade's multiple surface planes and are of primary significance.
- Replacement display windows are contributing features.
- Recessed door ways and door components and signage at the top-center of the facade are non-contributing features.

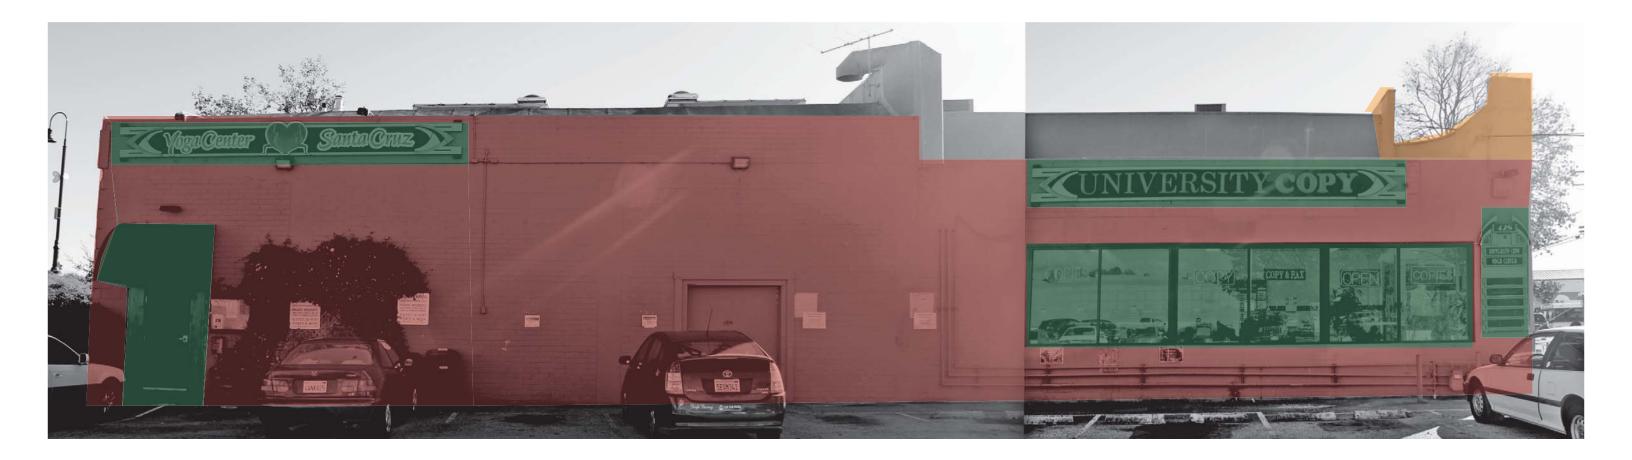
Significance Diagram: 428 Front Street-North Facade

- The north facade contributes to the building's overall character, but has undergone notable alteration.
- Windows added in 1987 are non-contributing features.
- A portion of the primary facade's signficant parapet line is connected to the north facade.

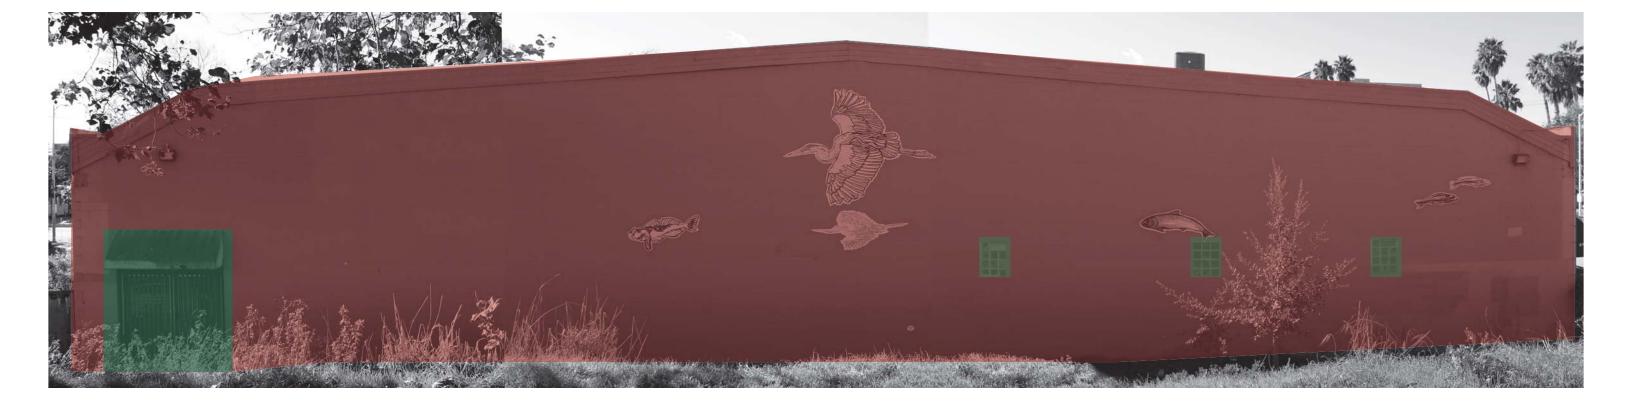
Significance Diagram: 428 Front Street-East Facade

- The rear (east) facade retains its orignal massing and roofline that corresponds to the building's framing.
- Glass block windows do not appear original and are non-contributing features.
- Door opening at southeast corner may be an original feature but does not contribute to building's character.

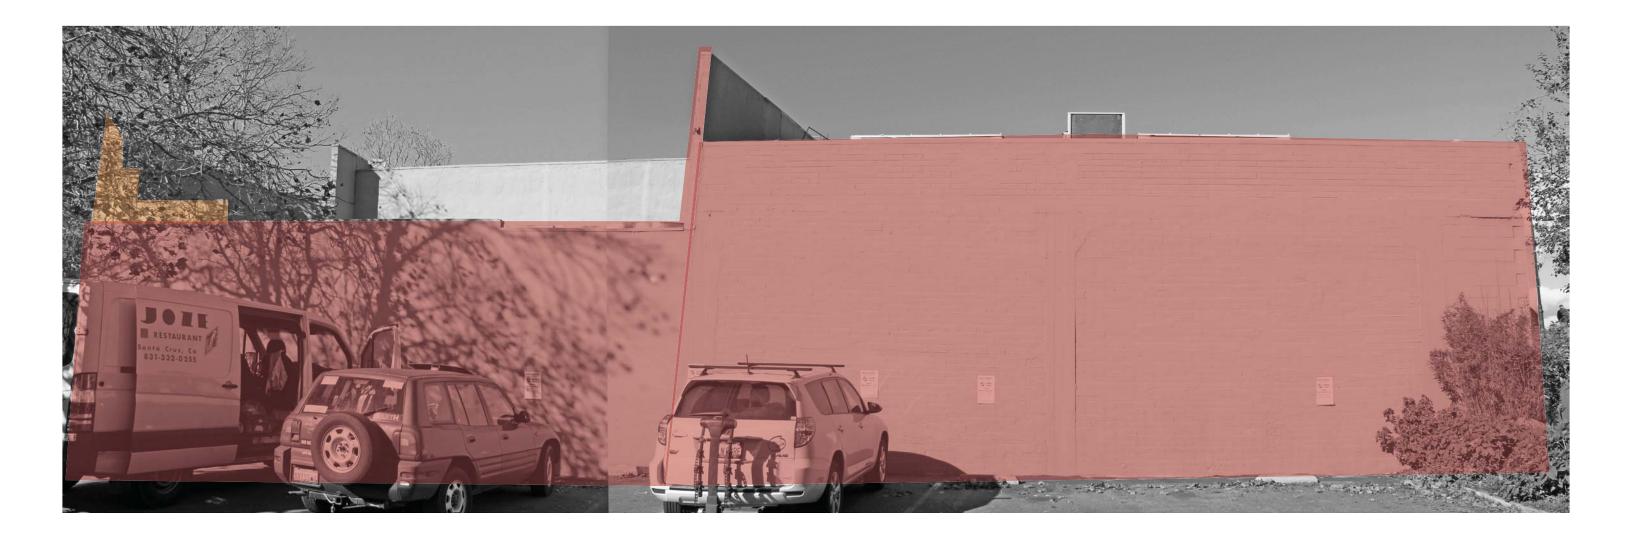
Significance Diagram: 428 Front Street-South Facade

- The south facade appears to have undergone little alteration.
- Meeting of building's main T-shaped and small square volumes are visible at this facade.
