THE WATERMARK AT SANTA CRUZ

Revised Pre-Application Submittal

May 15 2020

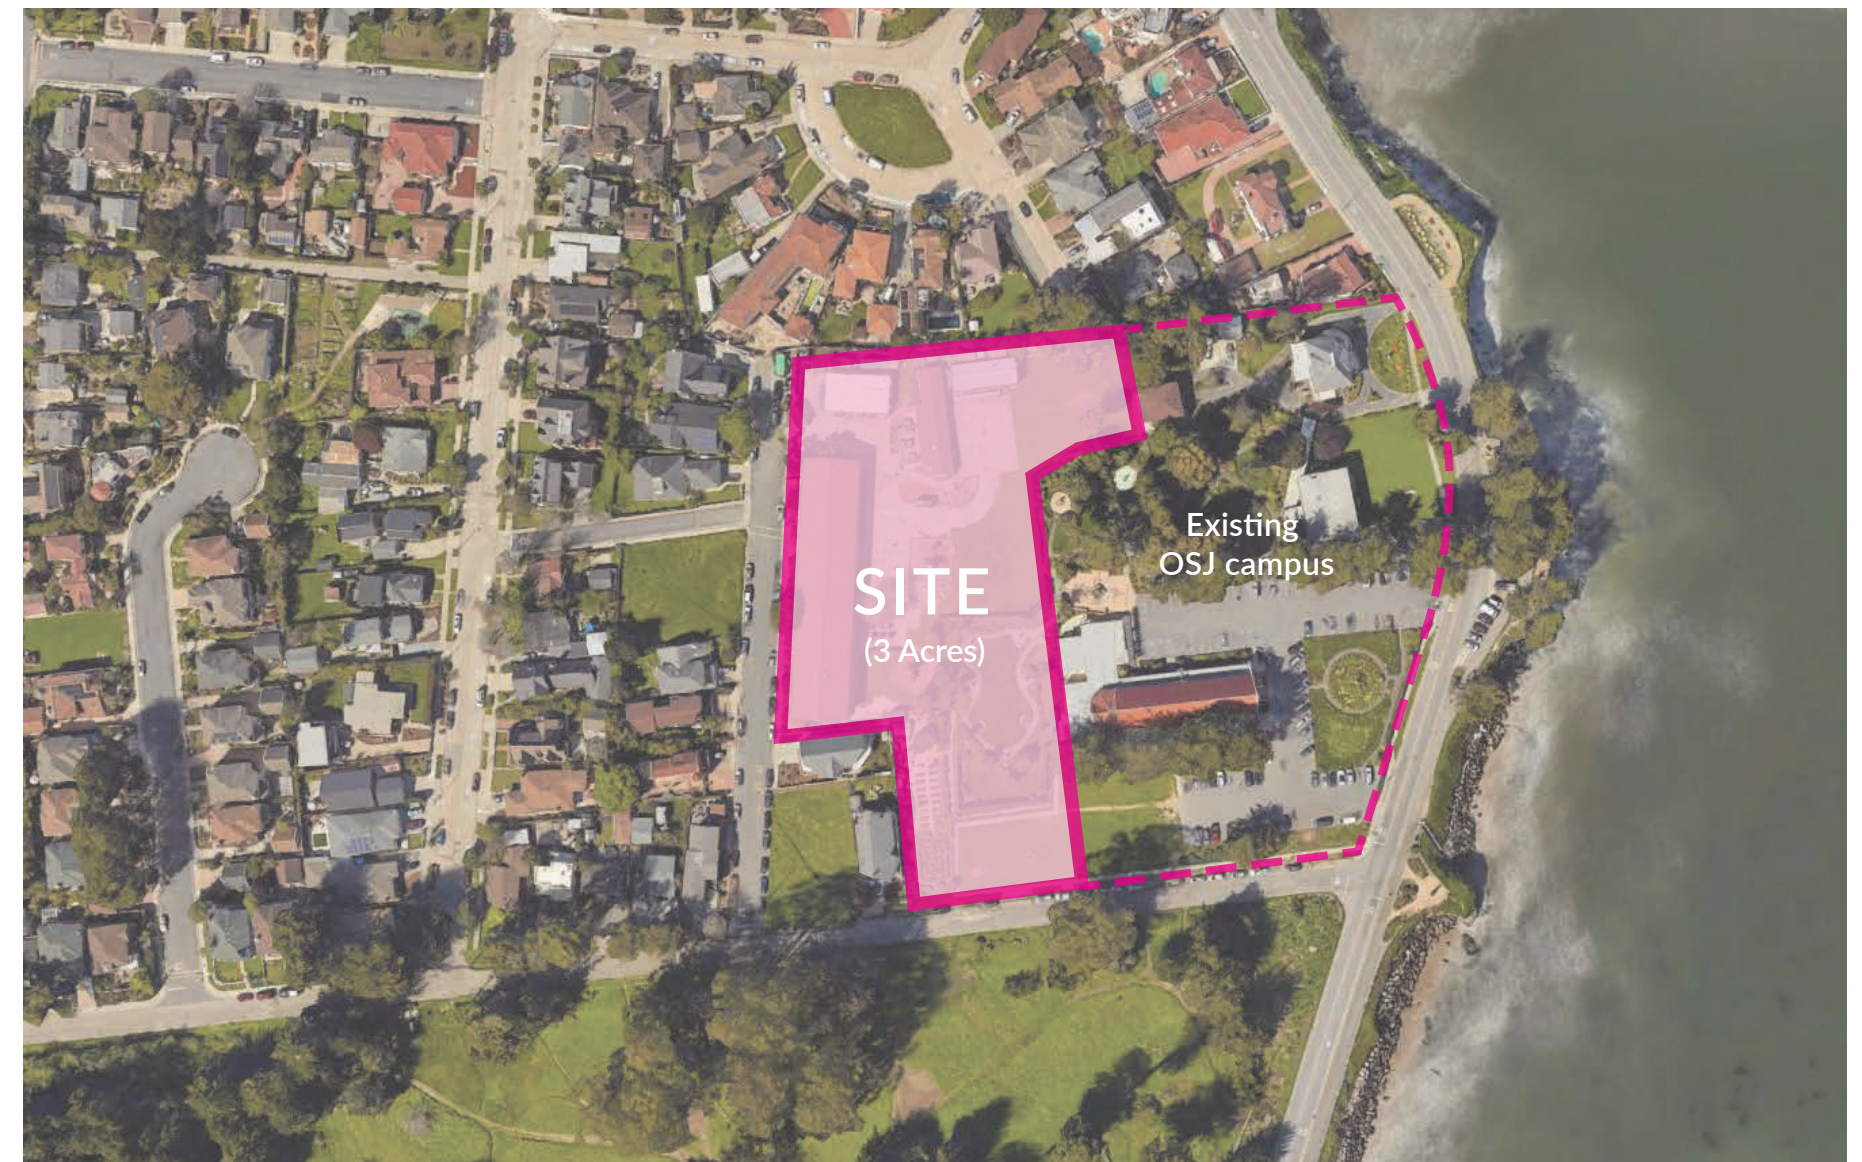
The Watermark at Santa Cruz is a proposed new senior living community located on an approximately 3-acre site steps away from the Pacific coastline in Santa Cruz, California. Situated on a property within the larger 6.6-acre parcel of Oblates St John campus at 126 Eucalyptus Ave.

The program consists of a new build, two story structure and one three story wing consisting of 92 units assembled into four categories:

- 13 independent living units (IL)
- 57 assisted living units (AL)
- 18 memory care units (MC)
- 4 inclusionary units (IU)

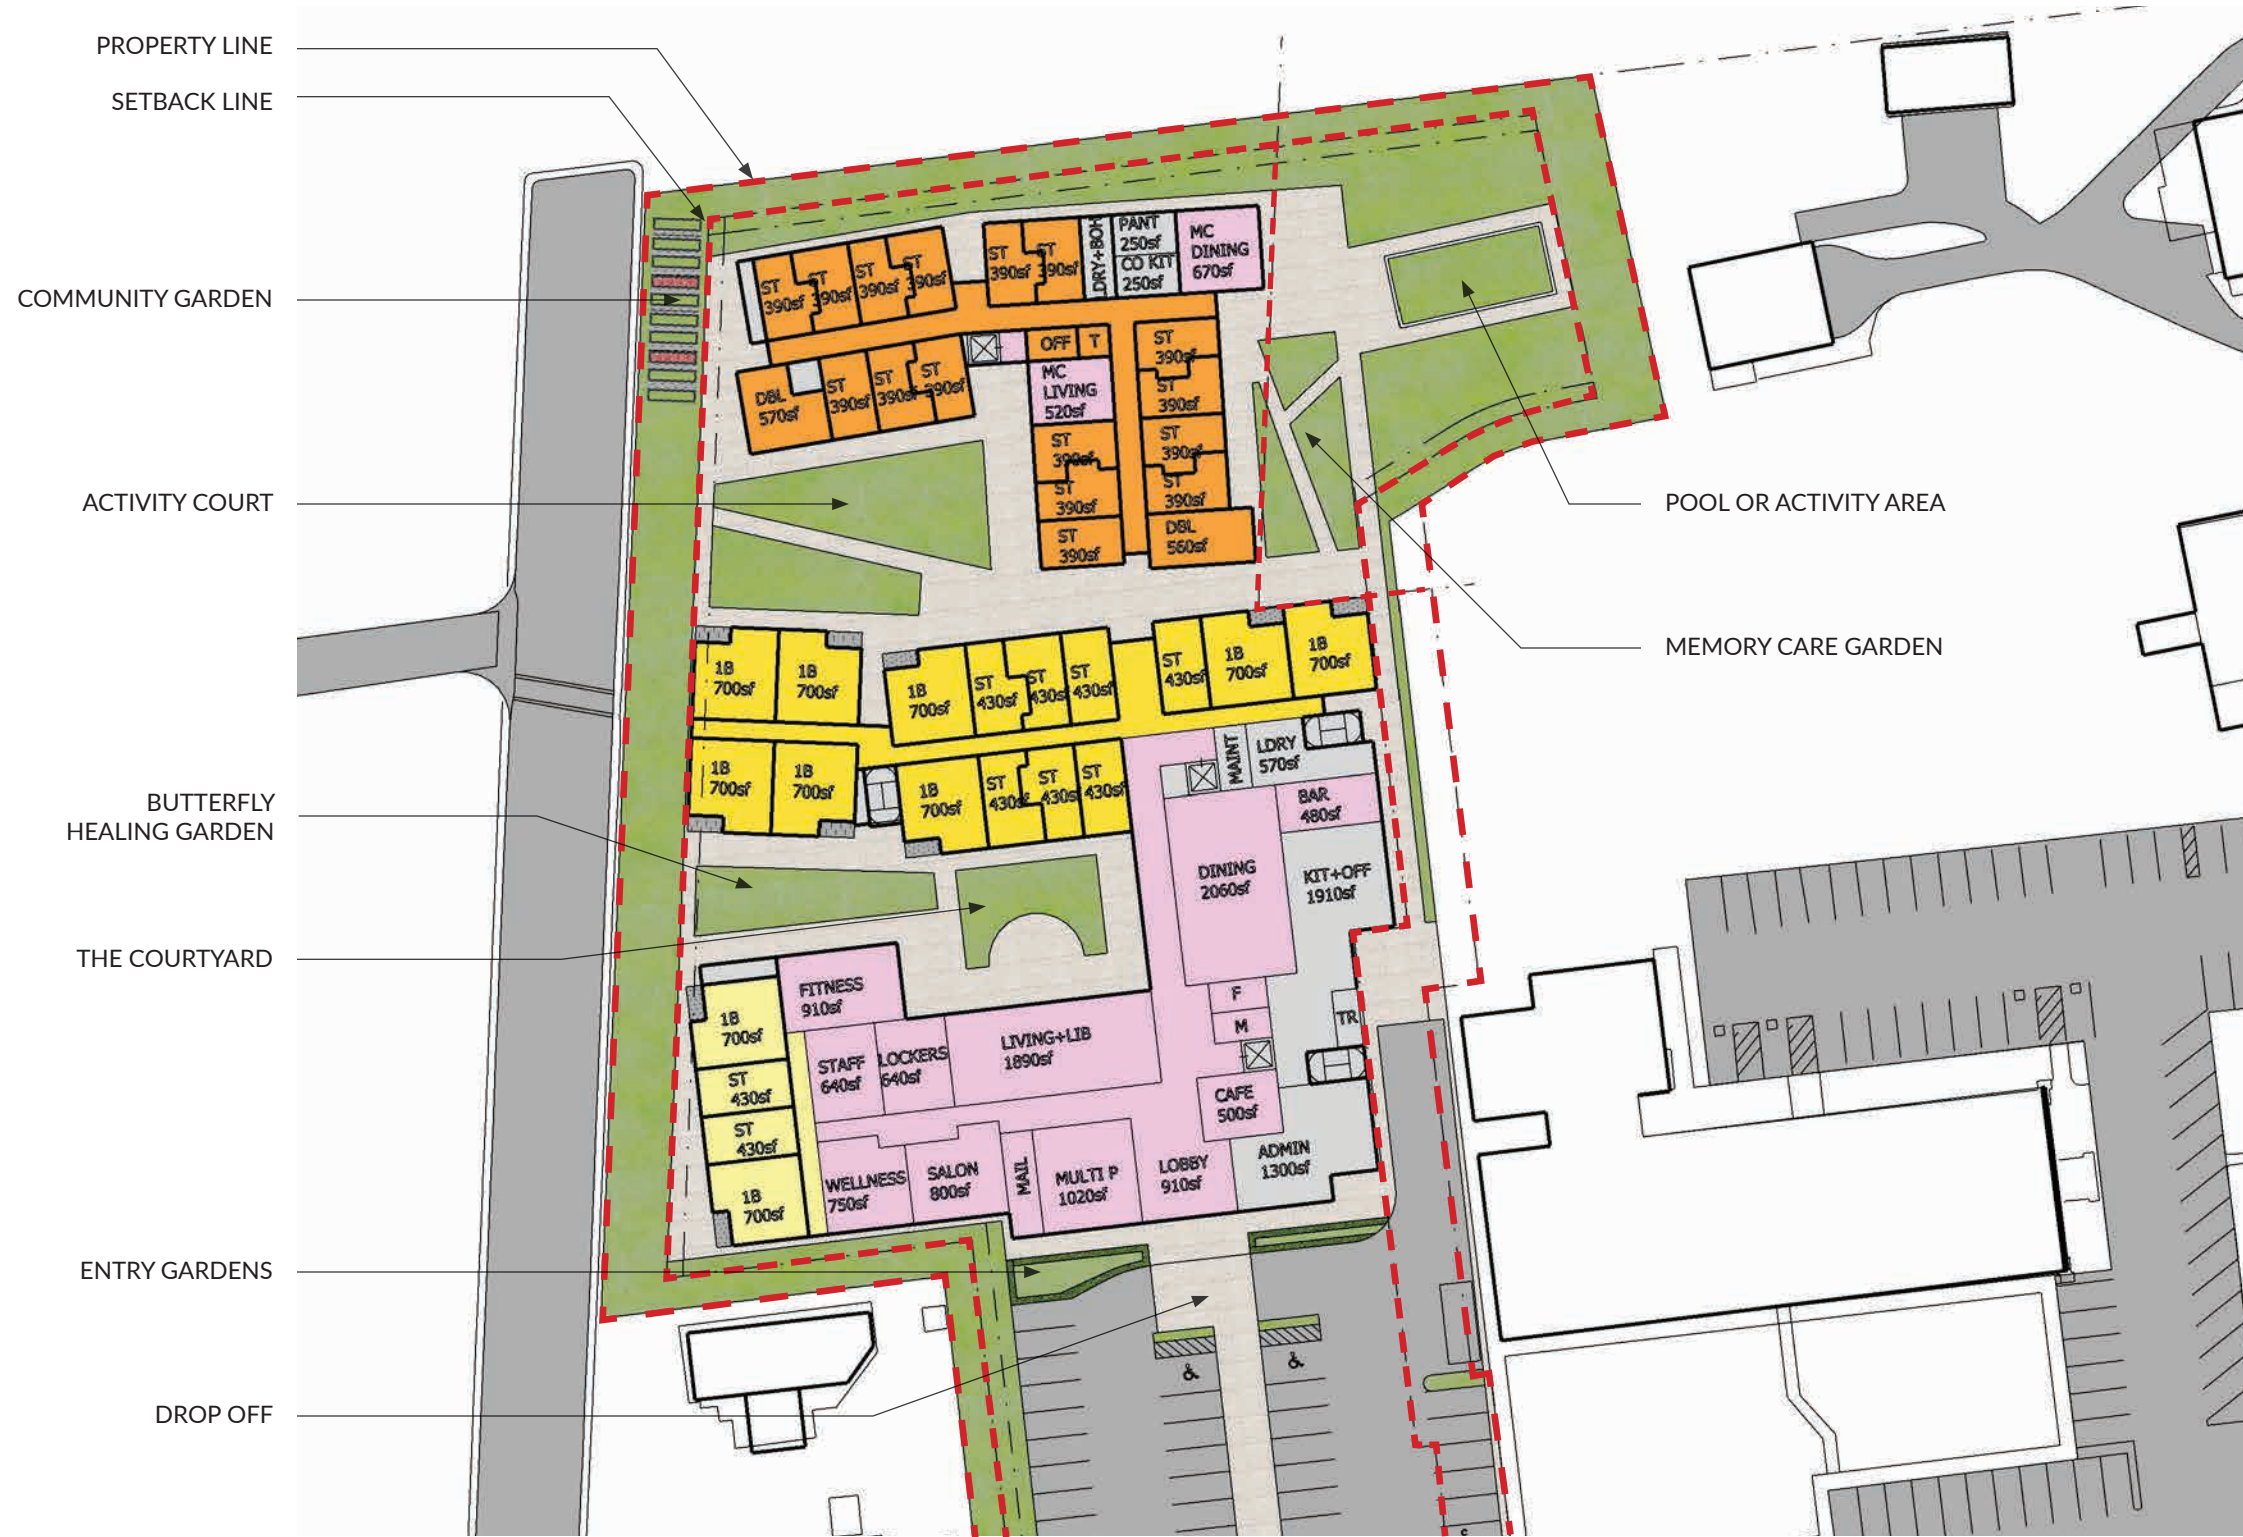
LEVEL 1 PLAN

Gross Floor Area: 43,870sf

ASSISTED LIVING UNITS	
STUDIO	7
1 BEDROOM	8
TOTAL UNITS	15

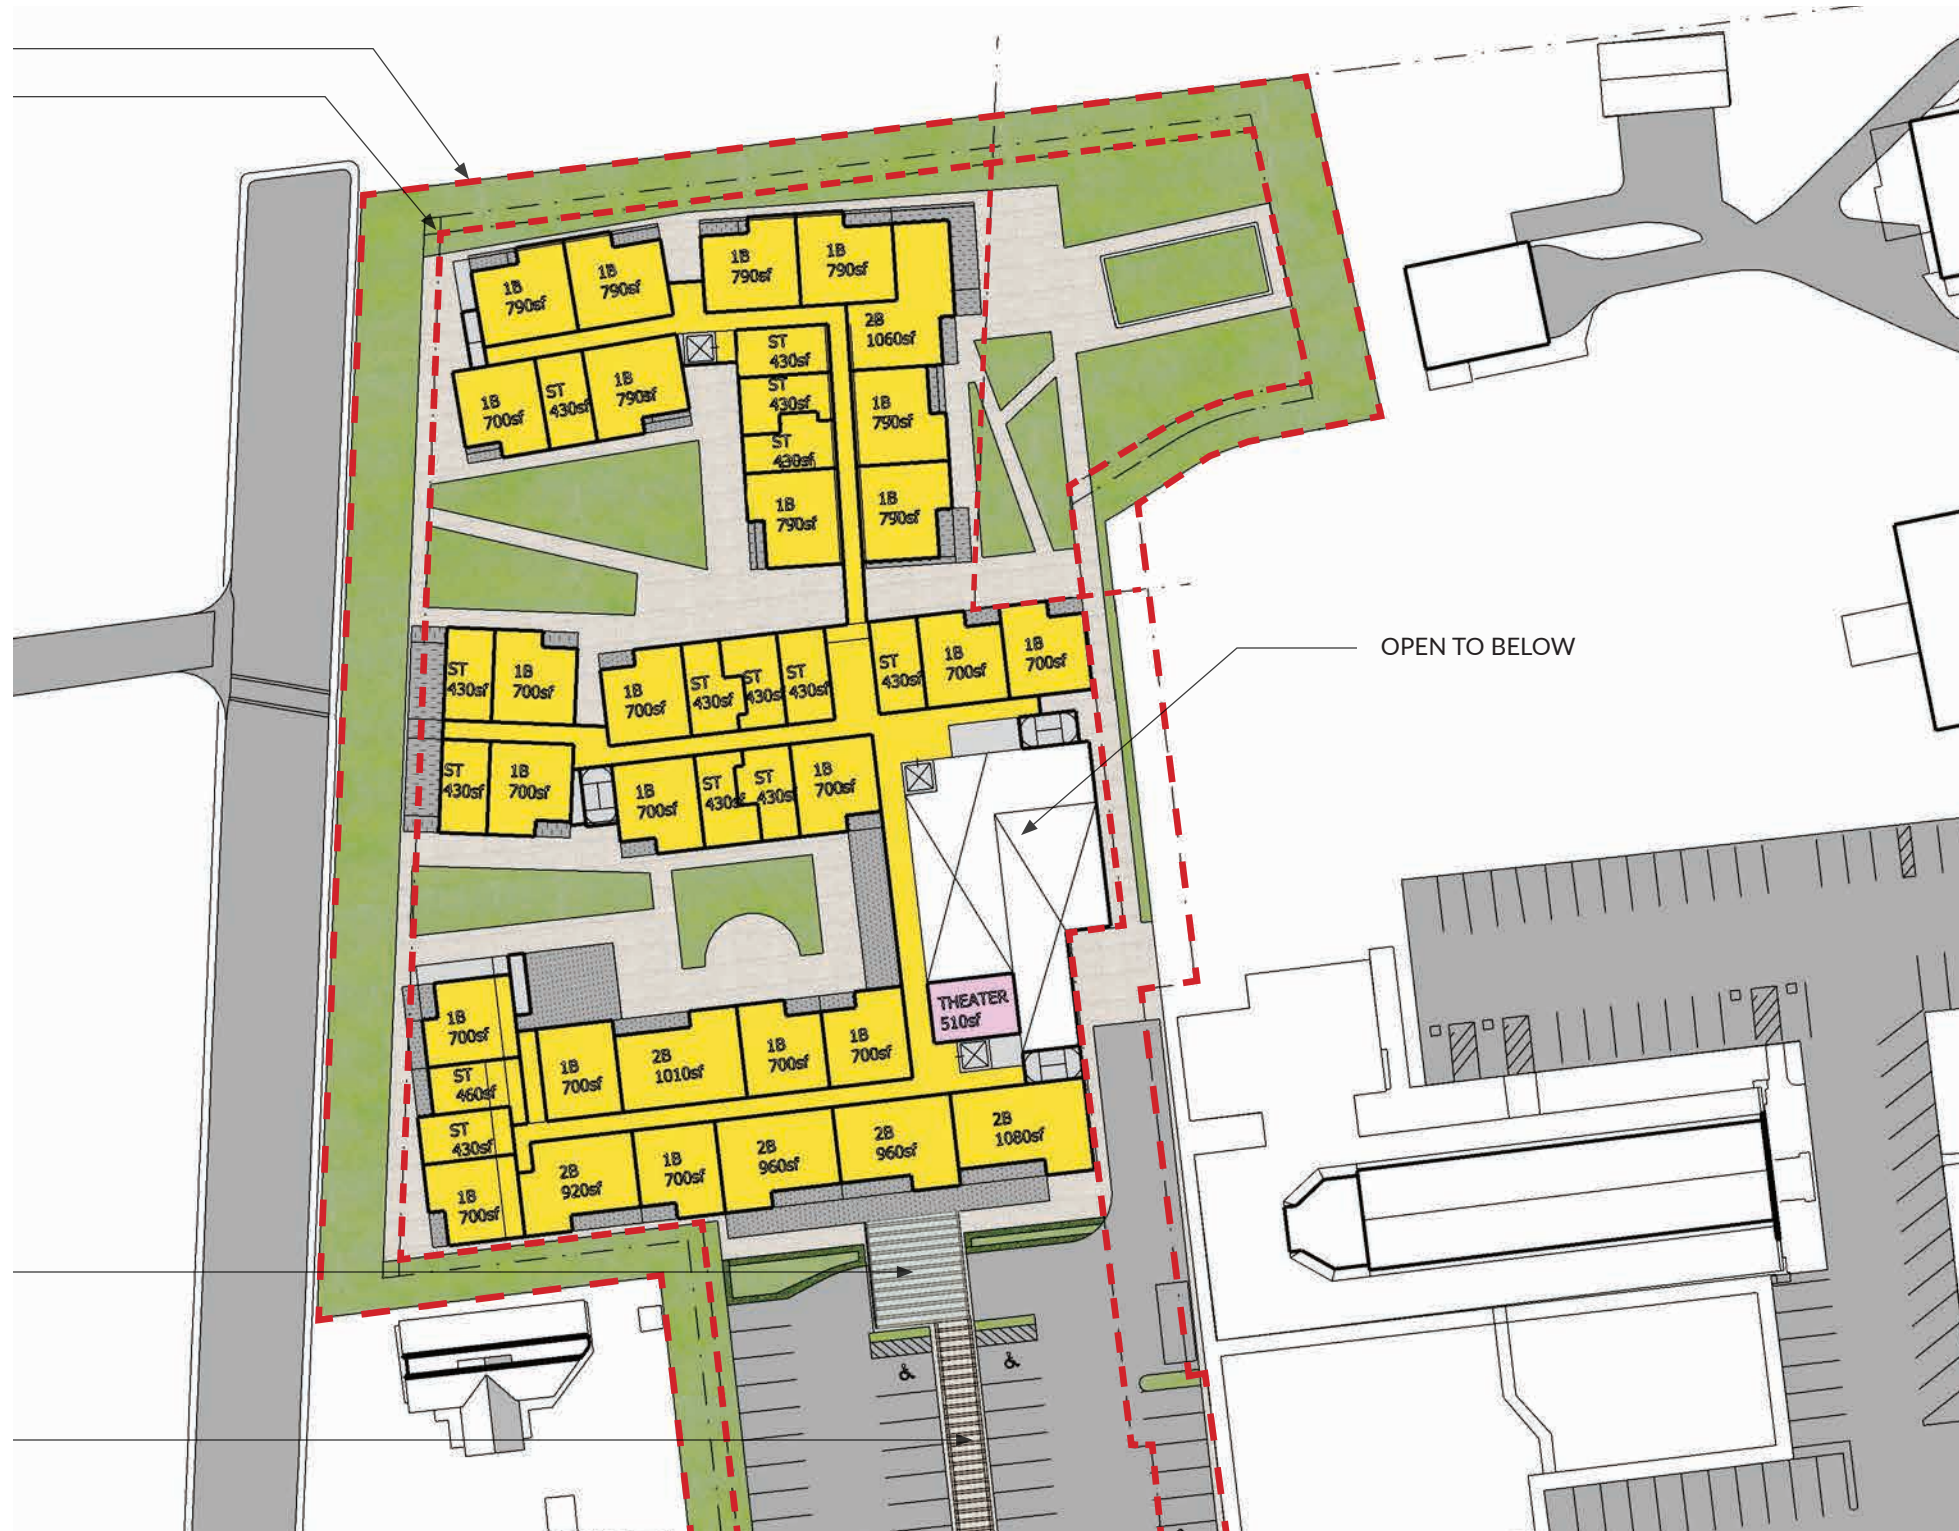
Gross Floor Area: 35,390sf

OPEN TO BELOW

PORTE-COCHERE
CANOPY

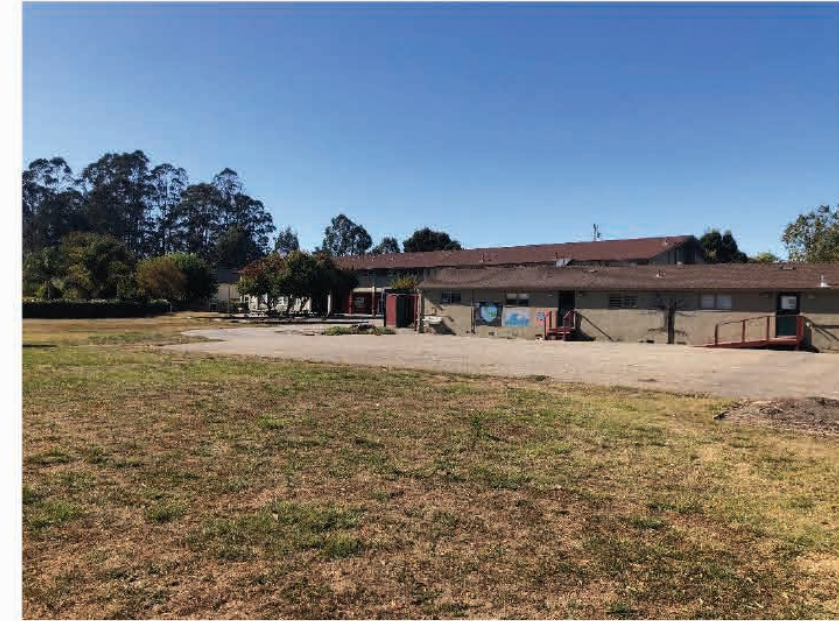
Top. Overview of the proposed Watermark at Santa Cruz Housing Project Site on the former Gateway School Campus at St. Joseph's Church.

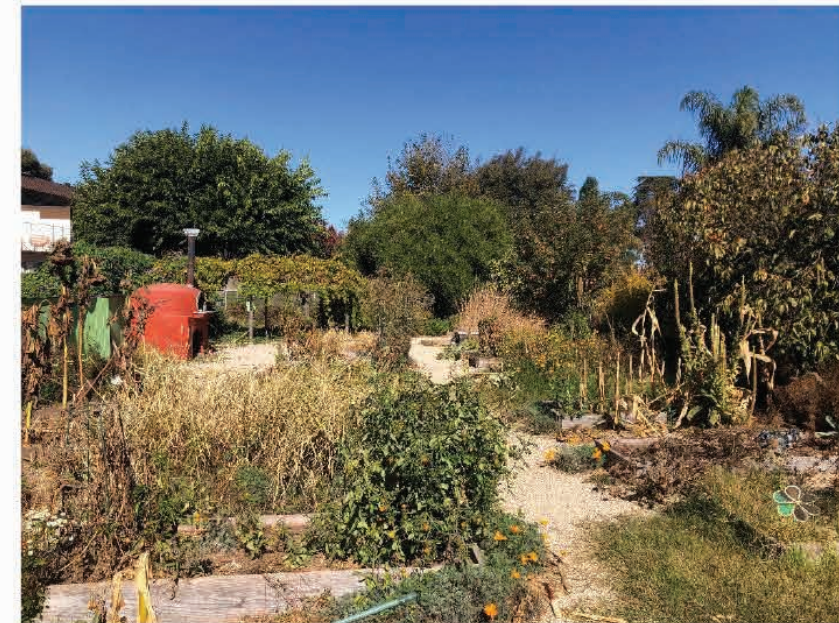
Bottom. Remnant Gateway School urban farm and garden on the Watermark project site.

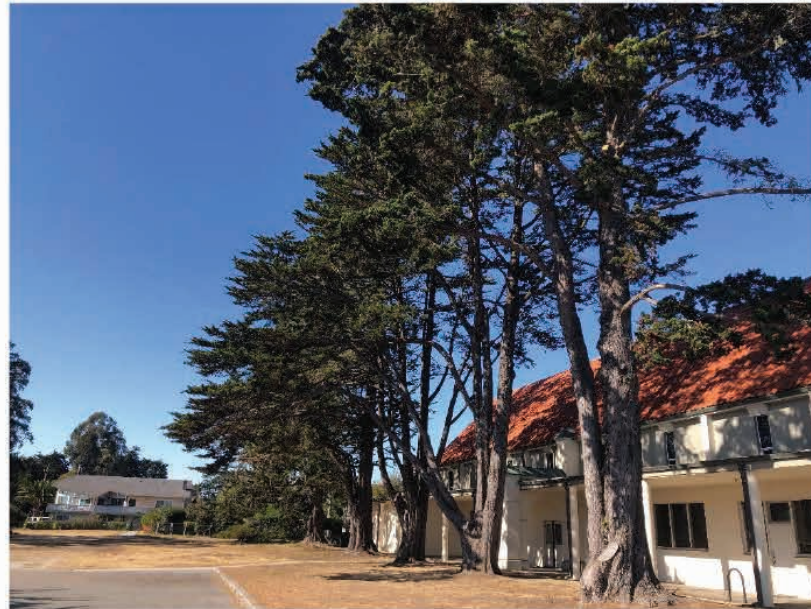
Top. Hedgerow of mature Monterey cypress immediately southeast of the proposed Watermark project site.

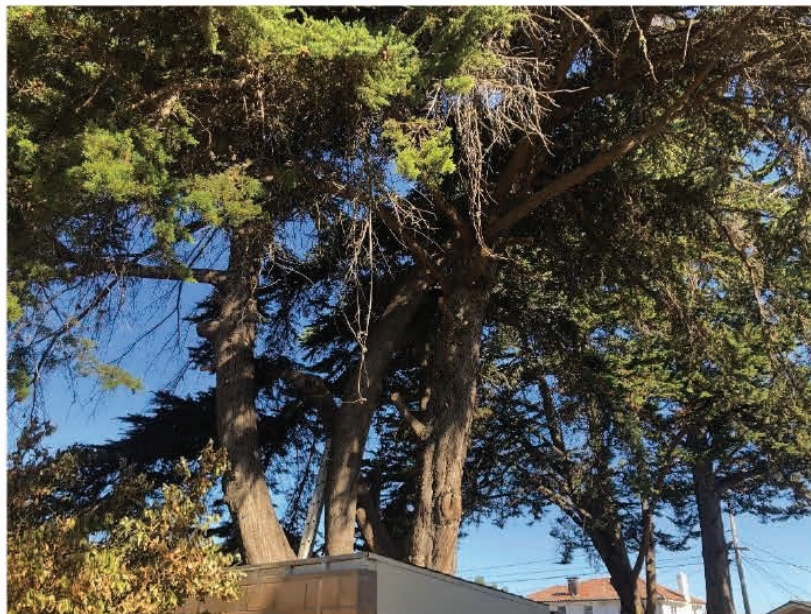
Bottom. Monterey cypress immediately northeast of the proposed project site on the St. Joseph's Church property.

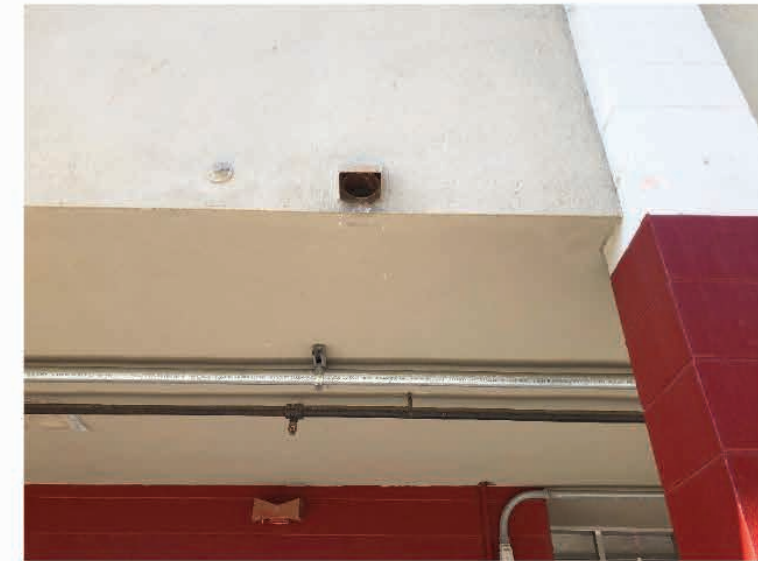
Top. Potential cavity roost for bats and/or birds in the former Gateway School building.

Bats may utilize mature trees or cavities in existing buildings and structures within the project site for roosting. Bat maternity roosting occurs typically between May 1 and September 1, and winter hibernacula (shelter occupied during the winter by a dormant animal) for many bat species are found between November 1 and February 15.

For any trees/snags and structures that could provide roosting space for cavity or foliage-roosting bats, the trees/snags and foliage shall be thoroughly evaluated to determine if bats are present. Visual inspection and/or acoustic surveys shall be utilized as initial techniques. If roosting bats are found, the biologist shall develop and implement acceptable passive exclusion methods in coordination with or based on CDFW recommendations. Exclusion shall take place during the appropriate windows (September 1 and November 1) to avoid harming bat maternity roosts and/or winter hibernacula.
