Phase I/II Environmental Site Assessment

Subject Site:
**113 Lincoln Street & City
Parking Lot
Santa Cruz, California**

Santa Cruz County
Assessor Parcel Numbers:
005-141-21, -11

Prepared for:
**City of Santa Cruz Economic
Development**
c/o: Bonnie Lipscomb
337 Locust Street
Santa Cruz, CA 95060

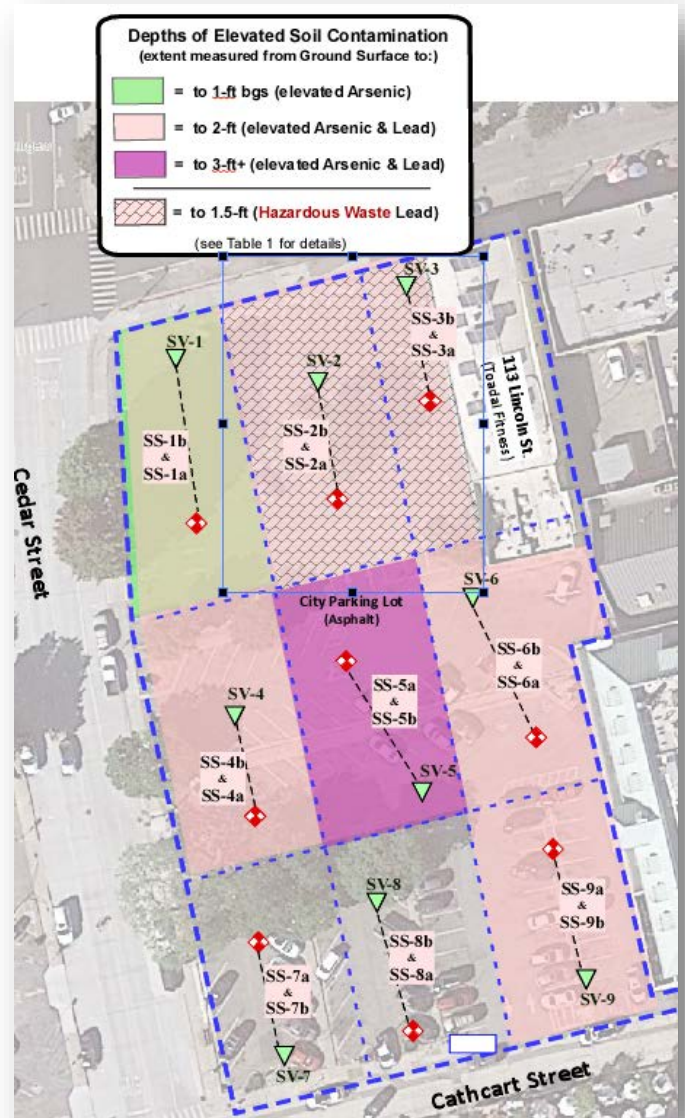
See Figure 5 for Enlarged Copy

Most of the elevated metal concentrations are characterized as “non-hazardous” and can be disposed of at a local, municipal landfill. However, much of the shallow soils across the Site exceeded residential (unrestricted) or commercial land use screening threshold limits and will need to be graded off and disposed of. Figure 5 (and the clip to the right) presents a plan view of the Site showing color-coded depths of soil that would need to be removed to achieve residential (unrestricted) land use thresholds (i.e., impacted soils by depth).

- 1) The nine (9), 2-point composite soil samples were broken up and individually analyzed for Lead and and/or Arsenic to evaluate whether one or both of the soil samples that made up the composite were impacted. The goal behind this additional “discrete” sample analysis was to delineate and/or eliminate sub-quadrants as areas of potential concern. And;
- 2) The deeper, 3-ft samples on hold at the laboratory were lab-analyzed as composite samples. The goal behind the additional “deeper” sample analysis was to further delineate the vertical extent of contamination.
 - Note that only one (1) of the nine (9) deeper soil samples (SS-5) contained elevated contaminant concentrations, which indicates that the vertical extent of contamination appears to be limited to less than 3-ft bgs.

Landfill Disposal: As noted above, most of the contaminant metal concentrations detected in shallow soil are characterized as “non-hazardous” and can be disposed of at a local, municipal landfill. However, two samples (SS-2 at 1.5-ft and SS-3 at 0.5-ft bgs) contained hazardous waste concentrations of soluble Lead and will be required to be disposed of at a Class 1 landfill (see brick -shaded quadrants on the attached Figure 5). In summary, this Phase II screening of shallow, on-site soils provides a preliminary overview of soil conditions. Additional horizontal/vertical delineation will be needed to provide accepting landfills with enough data to take these soils.

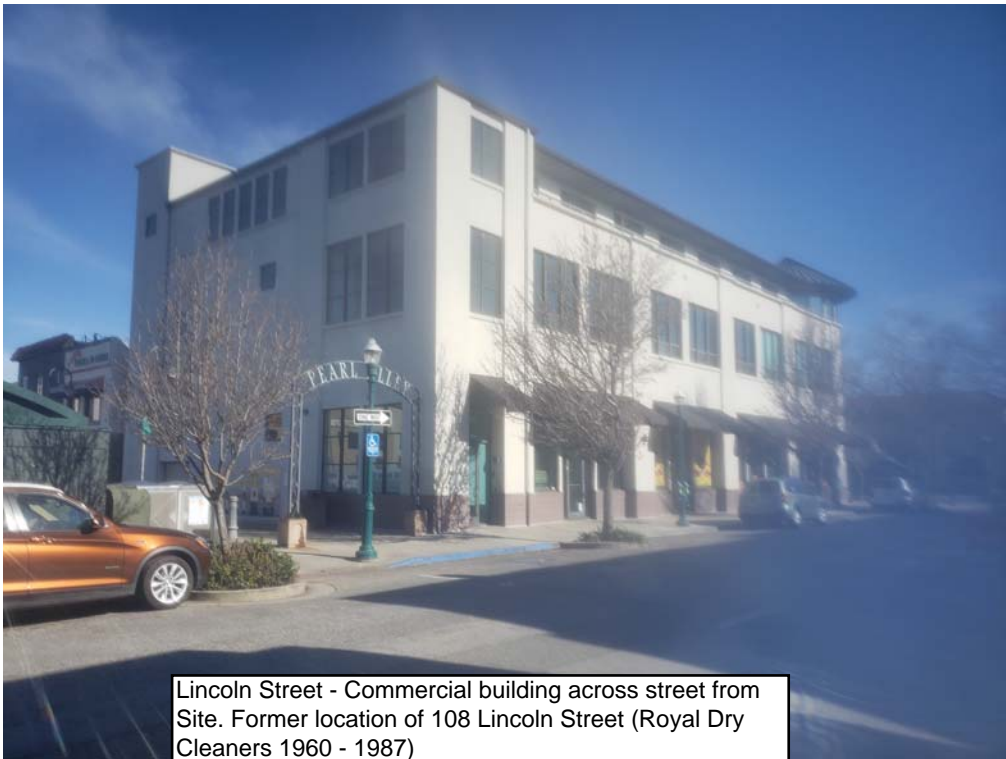
Lincoln Street - Commercial building across street from Site. Former location of 108 Lincoln Street (Royal Dry Cleaners 1960 - 1987)

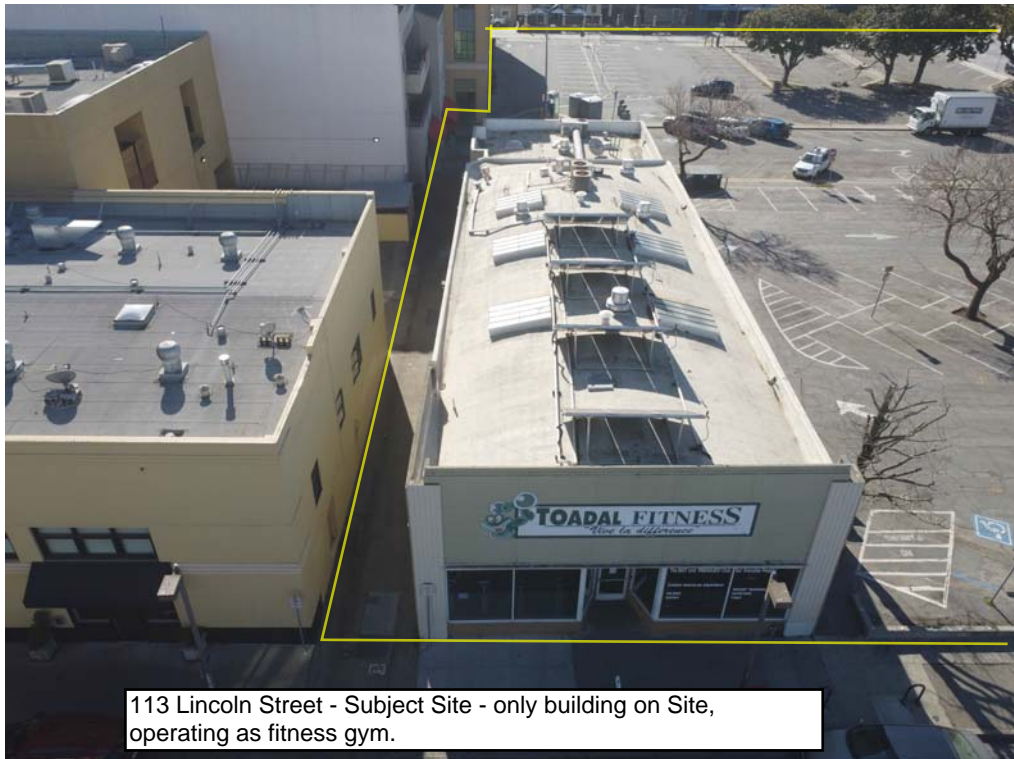
113 Lincoln Street - Subject Site - only building on Site, operating as fitness gym.

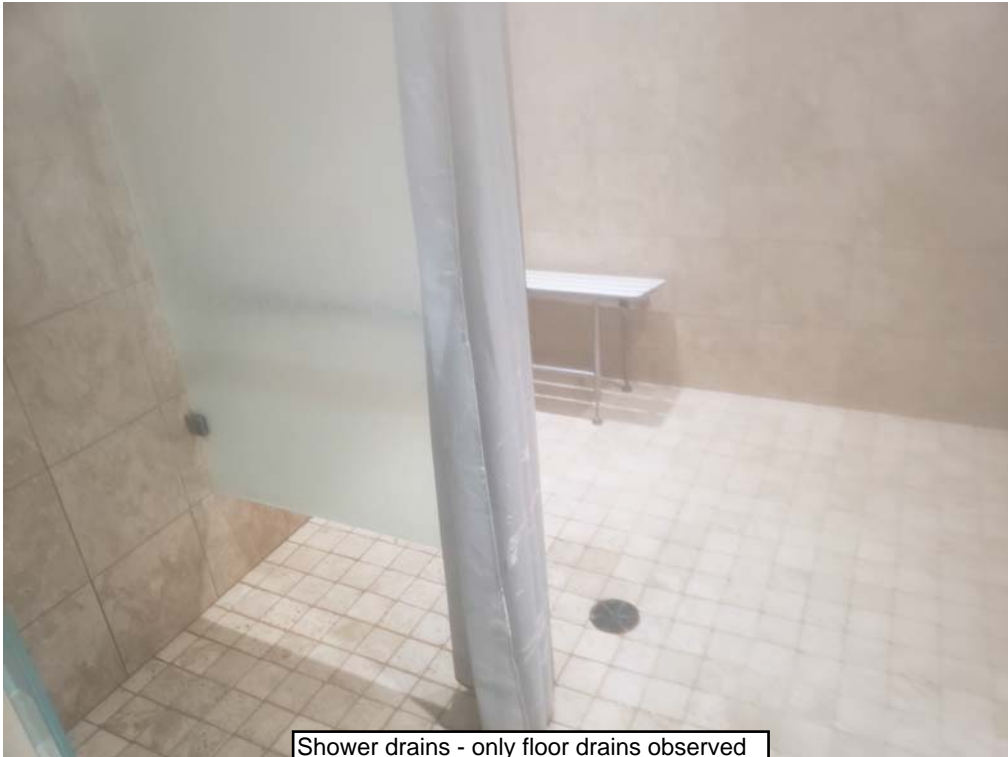
Shower drains - only floor drains observed
