Project No. SCR-1221.1

Subject: Slope Stability Analysis

Reference: 900 High Street APN 001-022-40 Santa Cruz, California

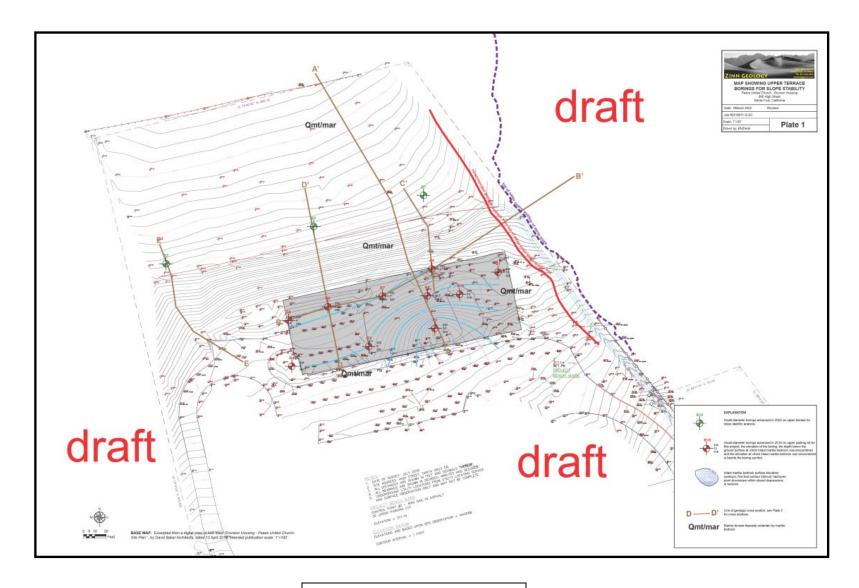
Figure 2

Subsurface conditions at the top of the slope were explored on February 11, 2022 with three (3) exploratory borings drilled 33 and 40 feet below grade. Our borings were advanced with 6-inch diameter tractor mounted drilling equipment. The approximate locations of our exploratory borings are indicated on our Boring Site Plan, Figure 2.

BORING SITE PLAN

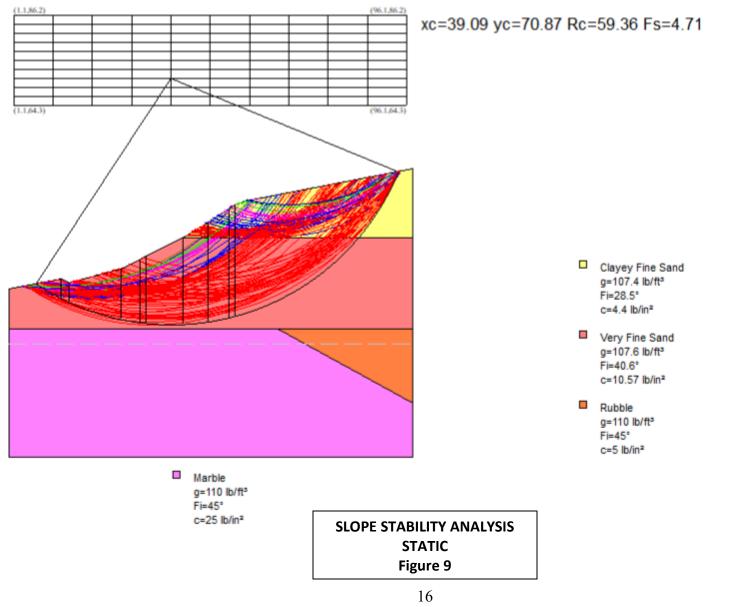
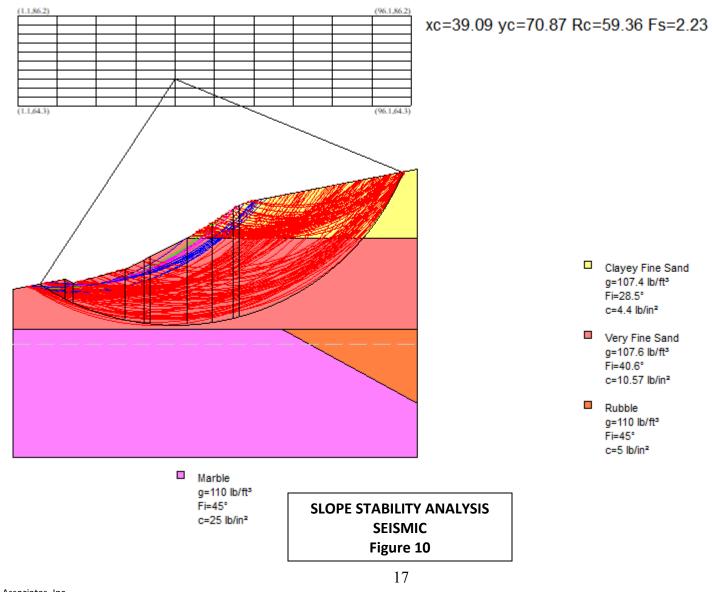
Three geologic cross sections were provided to us by the project geologist. The slope was modeled using the tallest, steepest section located above the proposed apartment building, which was Section C. See Figure 3.

Our analyses indicate the slope has a static (non-seismic) factor-of-safety of 4.7 and a seismic factor-of-safety of 2.2, both of which are well above the minimum factor-of-safety indicating a stable slope.

Graphical representations of our slope stability analyses are included on Figures 9 and 10, attached.

The slope was analyzed using the computer program STABL for Windows, Version 2.0, developed by Geotechnical Software Solutions, LLC. STABL is a computer program for analysis of slopes by limit equilibrium methods.

Soil strengths for the terrace deposits were determined from in-situ direct shear tests performed in the laboratory. The strength of the marble was estimated. The maximum considered peak ground acceleration of 0.75g was factored using reductions presented in the Recommended Procedures for Implementation of DMG Special Publication 117. This value was further factored to account for the relationship between slide depth and slope height. A seismic coefficient (Ky) of 0.4 g was used for
