State of California — The Resources Agency
DEPARTMENT OF PARKS AND RECREATION
PRIMARY RECORD

*Resource Name or #: (assigned by recorder) 1815 Mission St.

c. Address: 1815 Mission St.

*P3a. **Description:** (Describe resource and its major elements. Include design, materials, condition, alterations, size, setting, and boundaries)

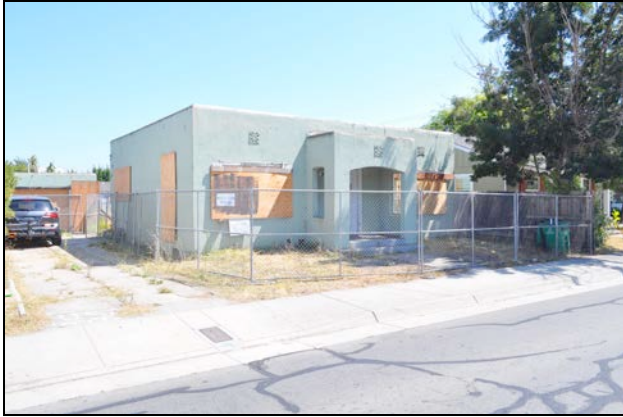
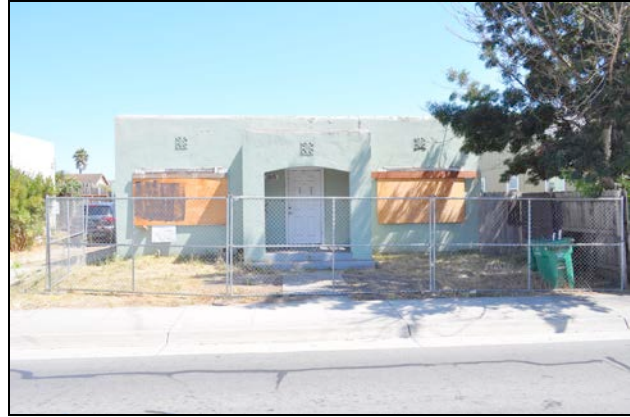
Figures 1 and 2. Left image shows the front (north) and east elevations viewed from the street. Right image details the front (north) elevation with arched porch. All windows and doors have been replaced.

- Estimated Date, Circa-1926: Construct house and garage in the Mission Revival style.
- Estimated Date, Circa-1980s: Replace multi-pane wood casement windows with vinyl-clad sash windows.
- Estimated Date, Circa-1990s: Remove rear elevation entrance. Replace windows on side and rear elevations. Replace front entrance door.

- 2. Design:** *the combination of elements that create the form, plan, space, structure, and style of a property.* The window replacements, rear elevation modifications and entrance modification have compromised the integrity of design.

- 4. Materials:** *the physical elements that were combined or deposited during a particular period of time and in a particular pattern or configuration to form a historic property.* Window and door modifications have compromised the integrity of materials from their original design.

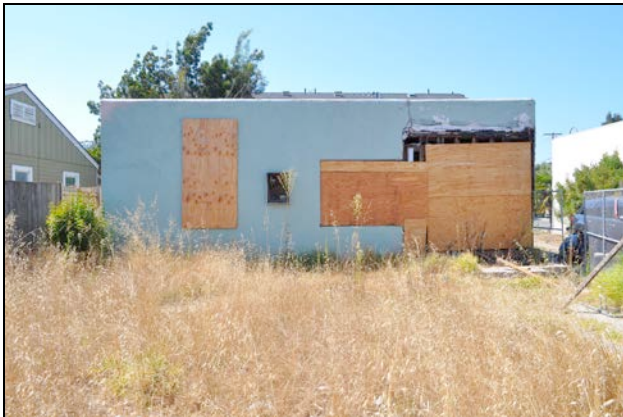
Figures 3 and 4. Left image views the rear (south) elevation, showing the extremely poor condition of the building. Right image details the detached garage.

The subject house is a modest example of the simplified Mission Revival style. In addition, the building has been subjected to alterations, including fenestration modifications in original and new openings and entrance modifications to the front and rear elevations. In its present condition, the building on the subject property is not an outstanding example of architectural design or a construction methodology. The building is not the work of a master architect, nor does it possess high artistic value. The subject property is not eligible under this Criterion.
