Santa Cruz Wharf Engineering Report

October 8, 2014

Engineering Evaluation Summary

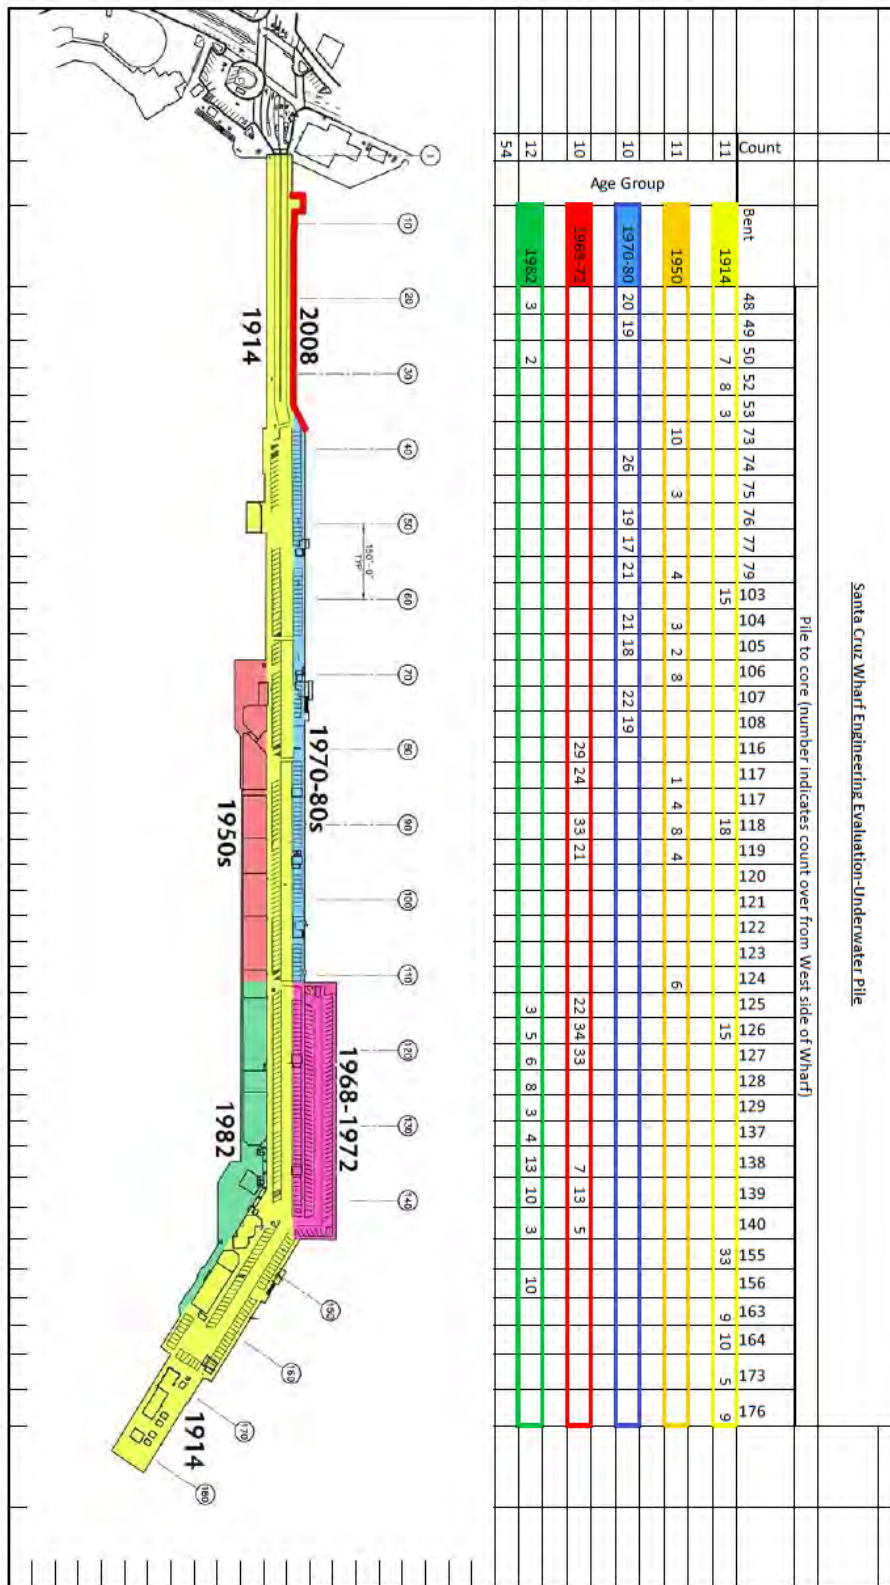
Figure 1-2: Years of Construction-Pile Core Locations

- Extract cores from each age class of piles (see Figure 1-2) on the Wharf (years of construction: 1914, 1950, 1968, 1970s, 1982).

Pile cores were taken to determine the interior condition of the pile, and detect the presence of marine borers (Teredo) not visible from the exterior. 50 pile cores, total, were taken comprised of 10 cores from each age class (year installed) at representative locations on the Wharf, shown on Figure 1-2 and Attachment 1C. No evidence of marine borers were found in the cores, however the Wharf maintenance crew has

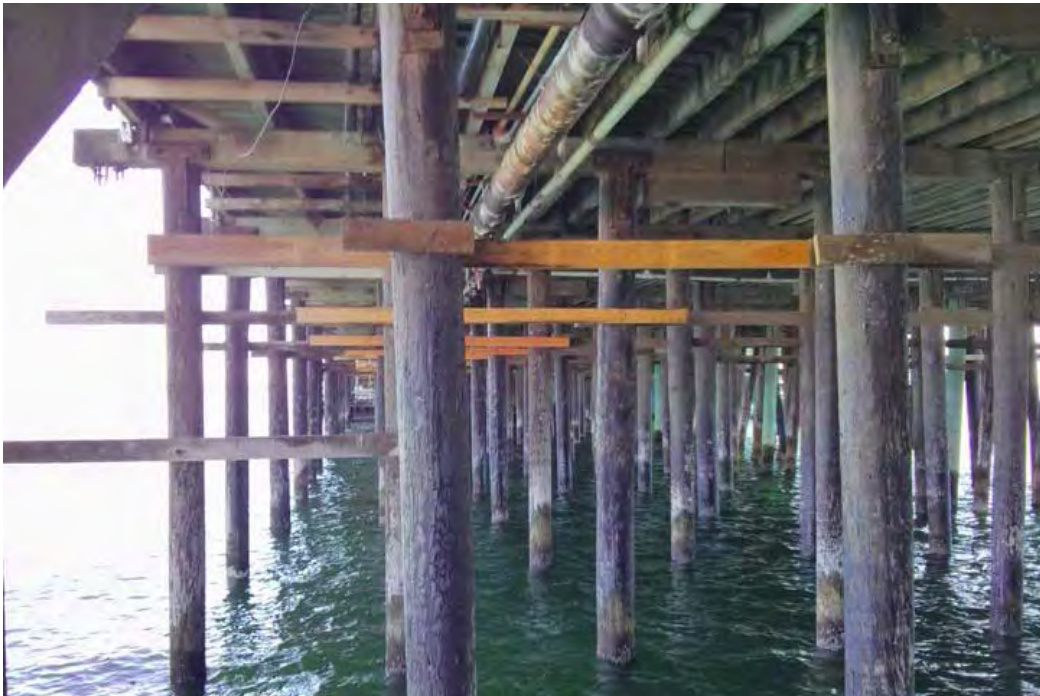
Photo 1-1: Typical Wharf Pile Bent and Structure

The piles support the Wharf structure constructed of timber members described below (see Photo 1-1):

- 12 x 12 inch pile cap beam (“caps”), spaced at 15 ft. centers of the pile bents
- 4 x 12 inch beams (“stringers”) at 24 inch maximum centers spanning bents
- 3 x12 decking laid flat continuously
- 2 inch asphalt paving on top of decking on road and walkways.

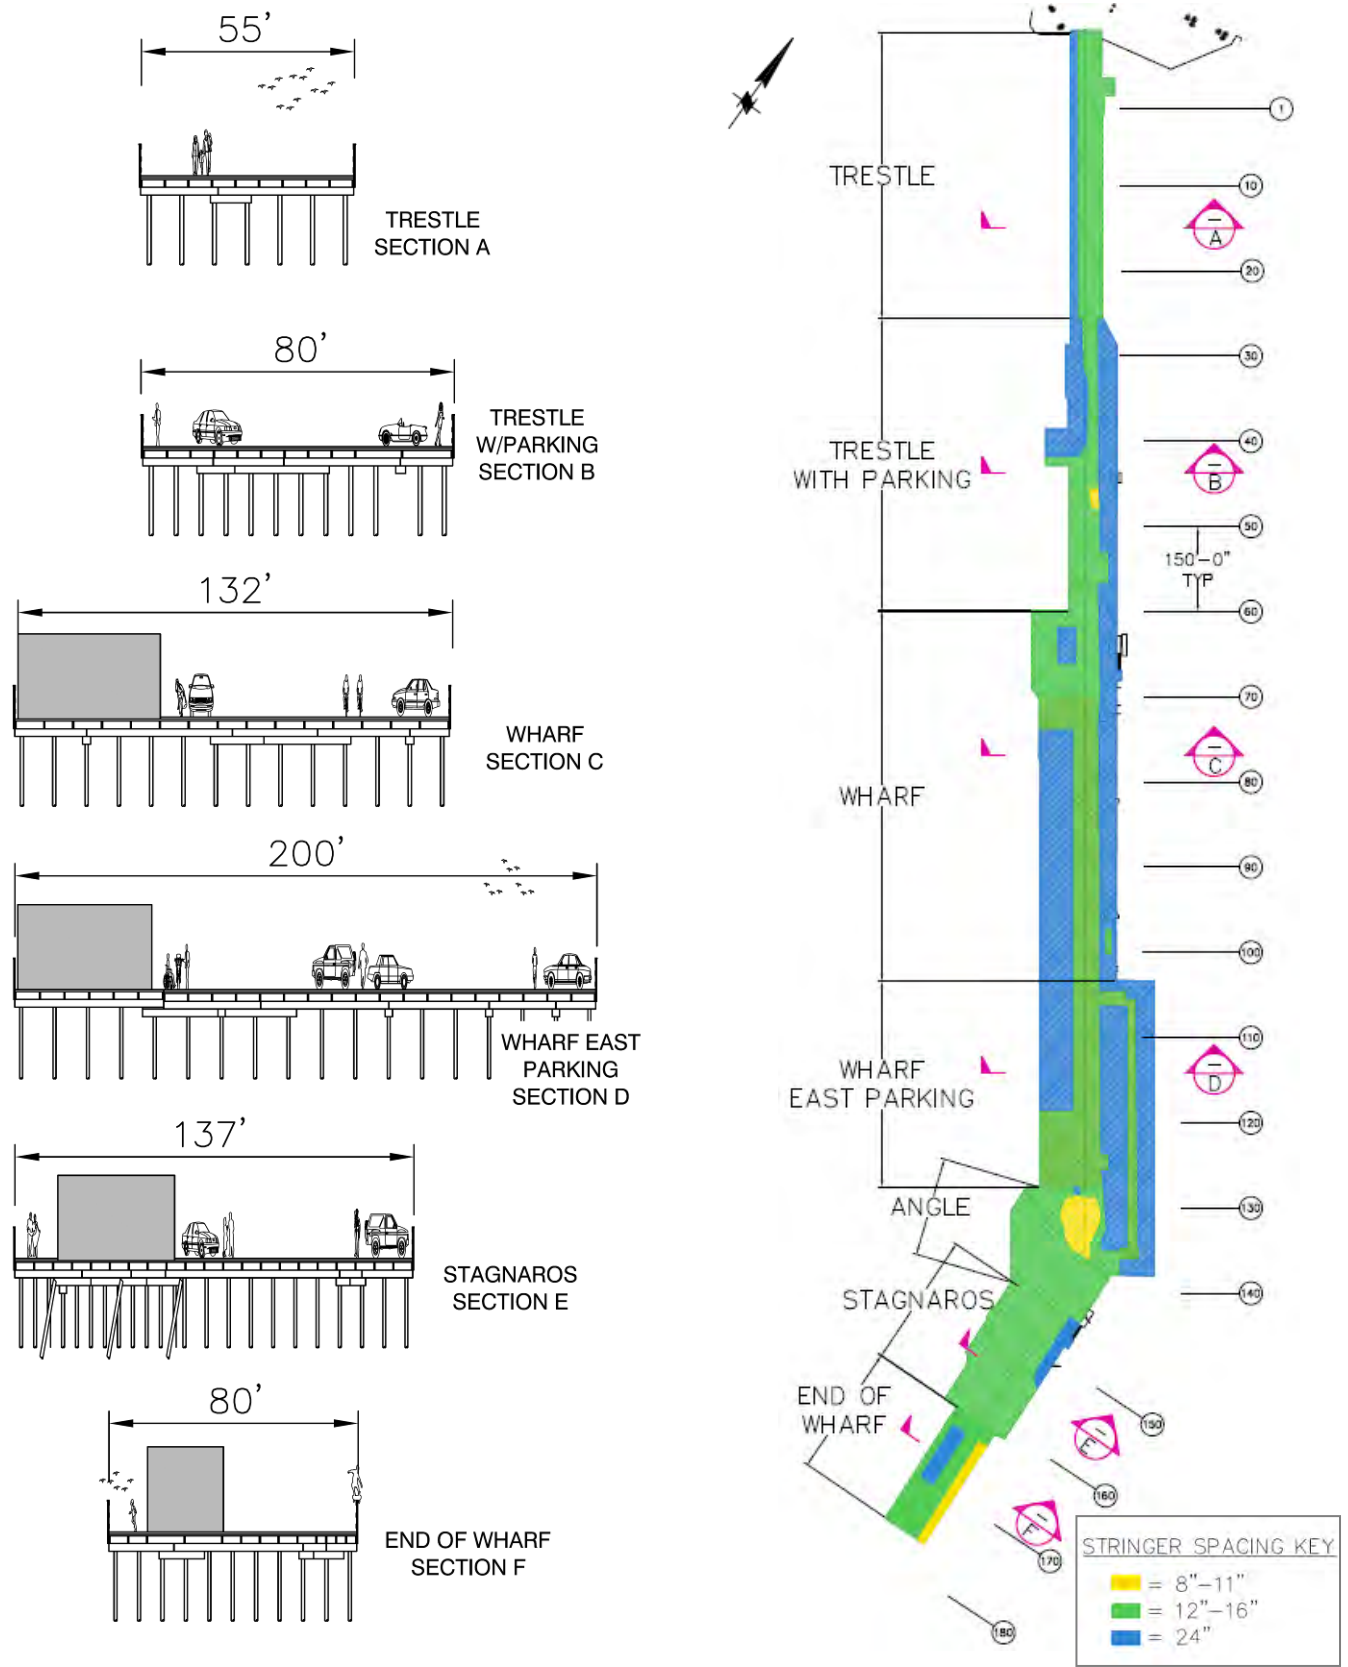
Figure 2-1: Structural Evaluation – Layout Summary Plan

The structural evaluation of the Santa Cruz Wharf includes assessment of the condition of the existing structural members and analysis of their capacity to safely support the imposed loads (weight, waves, earthquake, etc.). In addition, analyses were performed to inform the Master Plan design. The condition of the structure is good; due to the quality of original construction and continuous maintenance. There are some areas of deterioration, primarily due to water leakage below the deck and vehicle overload in parking areas. Figure 2-1 and Figure 2-2 show overviews of the structural sections and substructure damage on the Wharf, respectively. A summary of recommendations include:

- Replace deteriorated stringers, decking, and caps
- Installation and improvement of connections to stringers and caps
- Reduce large vehicle access onto the Wharf and mark restricted areas
- Retrofit turnaround areas to increase the load capacity and test existing wharf timbers to if higher load capacity is sought
- Design the new East Promenade for a 36,000 lbs. axle load

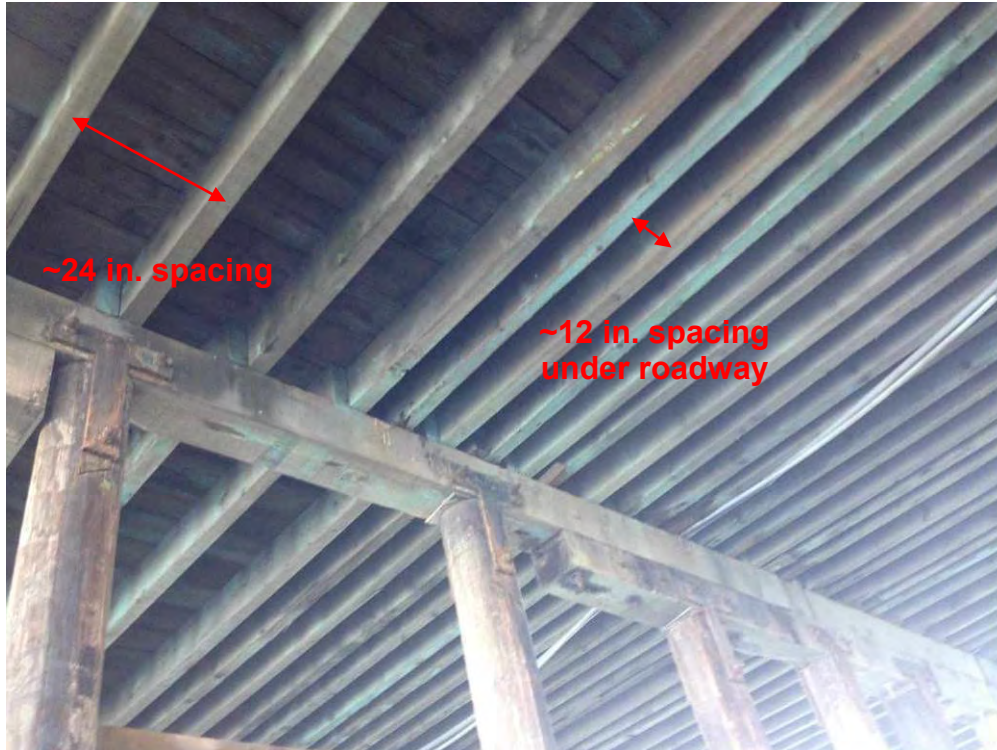
Photo 2-10: Varying Stringer Spacing Under Wharf

Stringer size and spacing varies at locations on the Wharf. Beneath buildings and the parking areas stringers are 4x12 at 24 inch centers. In the roadways there are 4x12 with 6x12 added, the spacing is typically 10-12 inches on center, and in some locations 16 in. centers. This provides additional weight capacity in the road. The Wharf staff maintains a maximum spacing of 16 inches on center for replacement, as observed during the inspection. Photo 2-10 shows an example of stringer spacing under the Wharf.

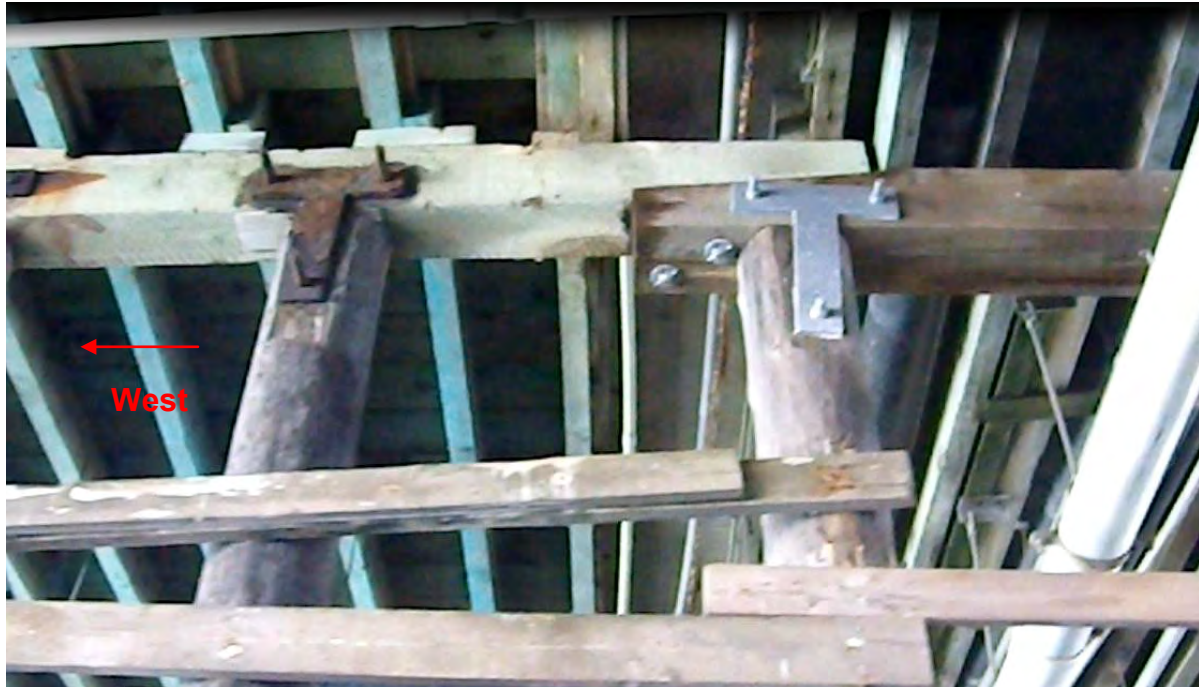
The west side of the Wharf structure beneath most of the buildings is raised approximately 6 inches above the main deck. This transition is shown in Photo 2-11 and Photo 2-12. The transition occurs between bents 97 and 145A, corresponding with the west expansion of the Wharf in the 1950s and 1980s.

Photo 2-11: Cap/Deck Transition – Bent 99 (Piles 8 and 9)

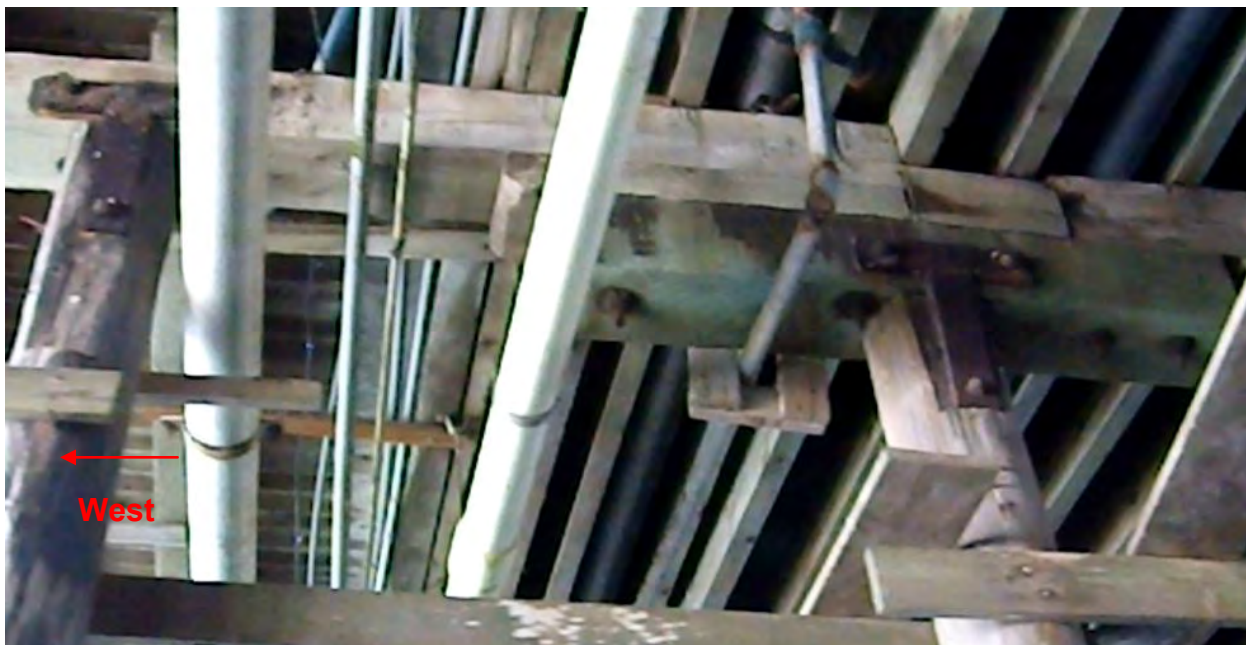
Photo 2-12: Cap/Deck Transition – Bent 125 (Piles 7 and 8)

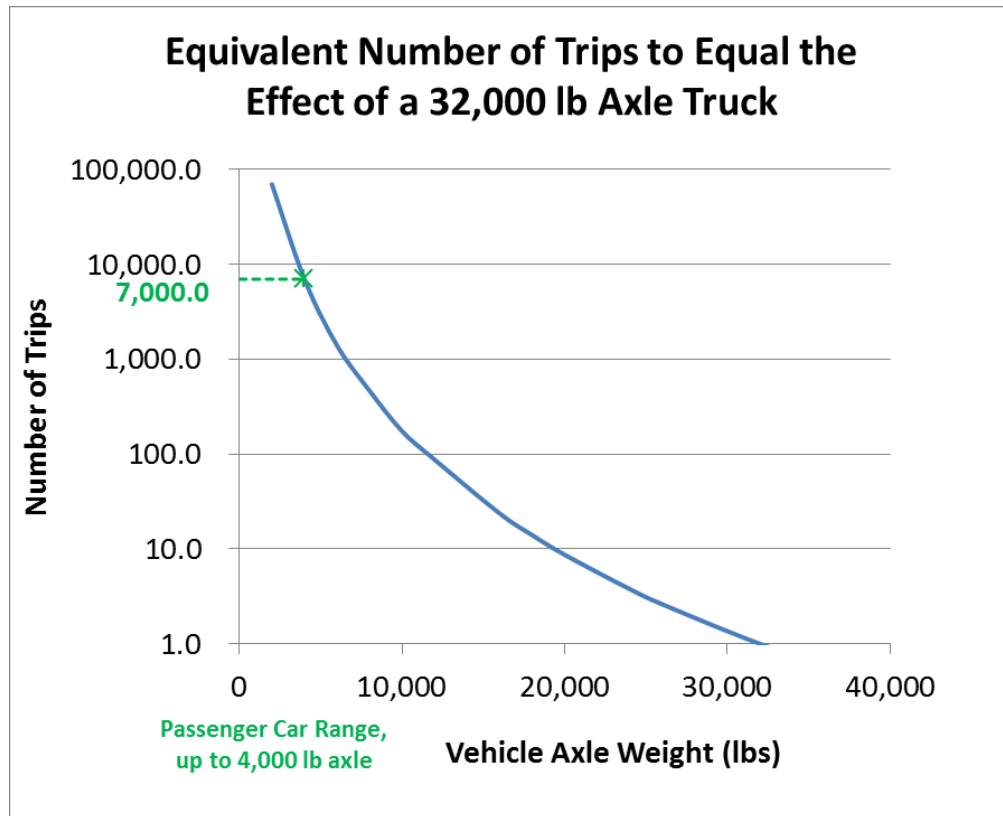
Figure 3-1: Equivalent Number of Trips

It can be seen that the damage caused by a large truck single trip (32,000 lb. axle) is equivalent to thousands or tens of thousands of passenger vehicle trips.

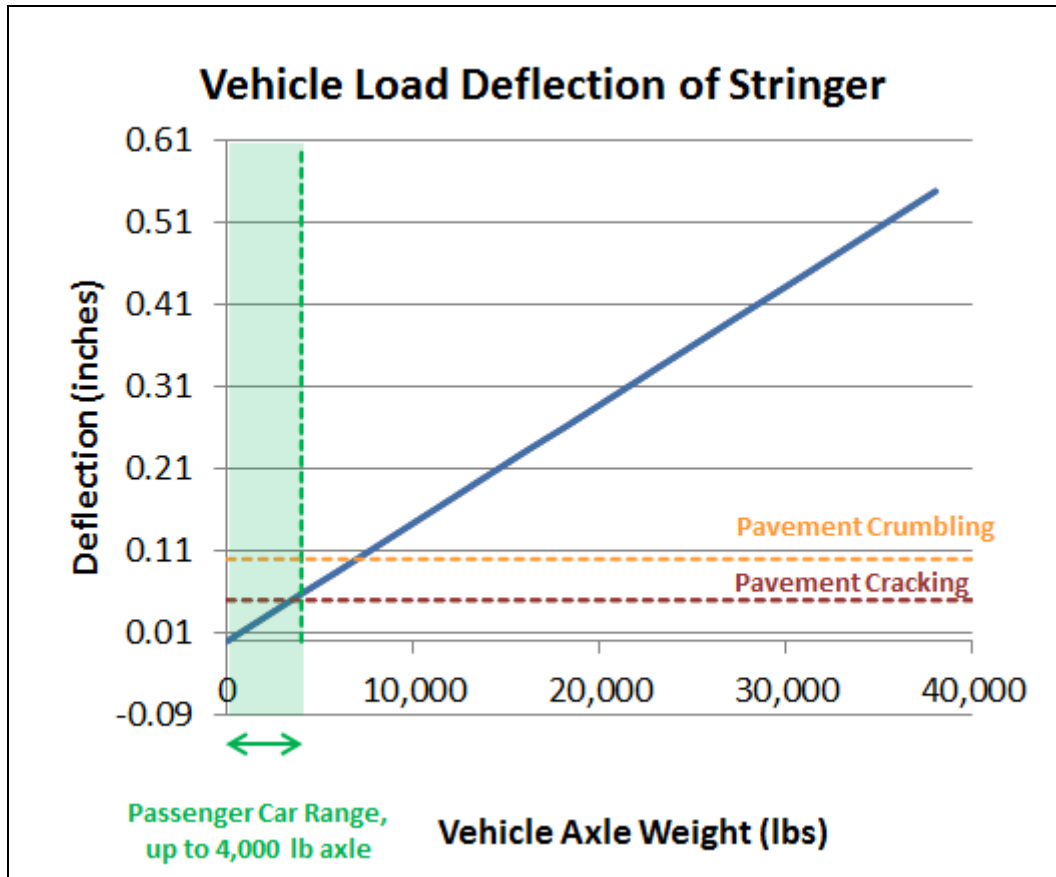
Figure 3-2: Deflection of Stringers for Vehicle Loads

It can be seen that for the range of passenger car axle weights, the deflections are generally less than the cracking deflection. However, the design trucks with axles of around 30,000 lb. cause deflections larger than the cracking deflection and pavement crumbling deflection of 0.1 inch.

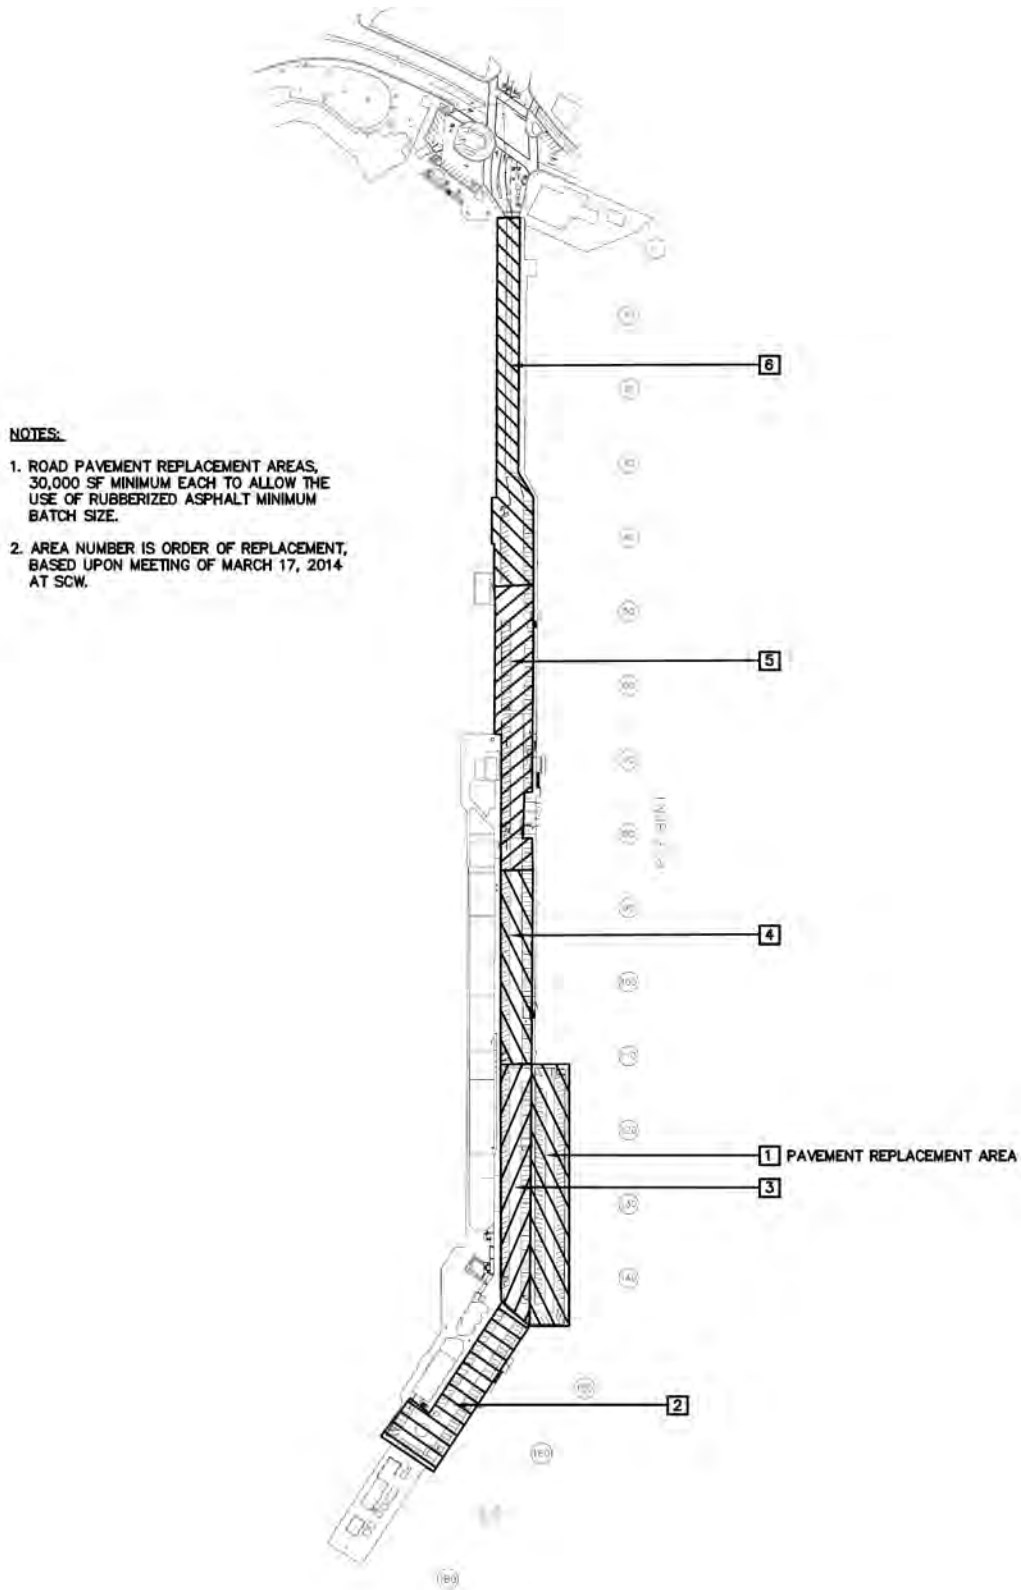
Figure 3-7: Pavement Replacement Schedule of Areas

As noted above, the existing pavement has deteriorated to a condition that cannot practically be maintained and should be replaced. The replacement cannot likely be performed at a single time and will have to be performed in sections to allow the Wharf to remain in service during the repaving and as funding allows. To utilize rubberized asphalt a minimum batch size of approximately 30,000 sf of asphalt would have to be ordered for the plant to produce the material. Considering these two factors, a plan to minimize disruption and allow efficient re-pavement of the Wharf was developed with the Wharf Staff. Figure 3-7 shows the schedule of priority for replacement of the pavement. It is estimated that each of the 6 areas would require 6-12 weeks to complete the work which would involve the following major tasks:

- Consider rubberized asphalt in place of conventional asphalt.
 - Install by phases in the areas shown on Figure 3-6
2. Install drain inlets in vehicle area to treat runoff with media filtration to address water quality

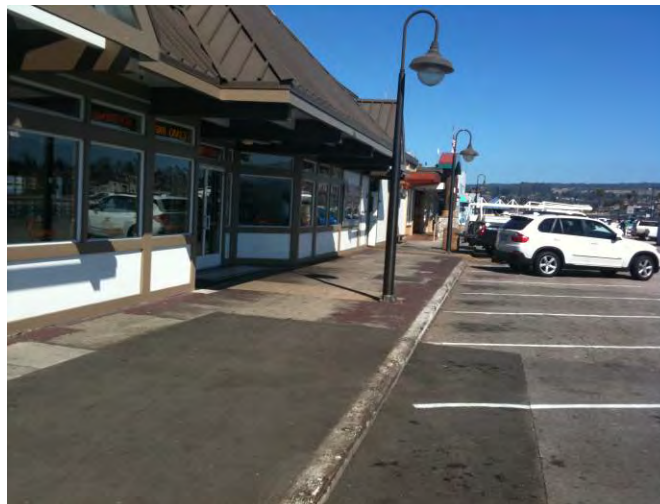
Photo 4-3: Walkway at Buildings

The supporting substructure is in fair to good condition and adequate to support the walkway loads. Areas that have deterioration were identified and are presented in Section 2 of the report. Figure 2-2 shows an overview of these areas and Attachment 2B shows detailed locations. There is significant deterioration in some of the stringers and the pile caps beneath the sidewalk, in front of the buildings. This area is the joint between the original 1914 wharf construction and later additions after the 1950s, (see Figure 1-2). The east side of this joint is the edge of the original wharf that was exposed to the weather. It now shows softening and rot in locations. Photo 4-3 shows a patch in this location where the substructure was exposed for repair.

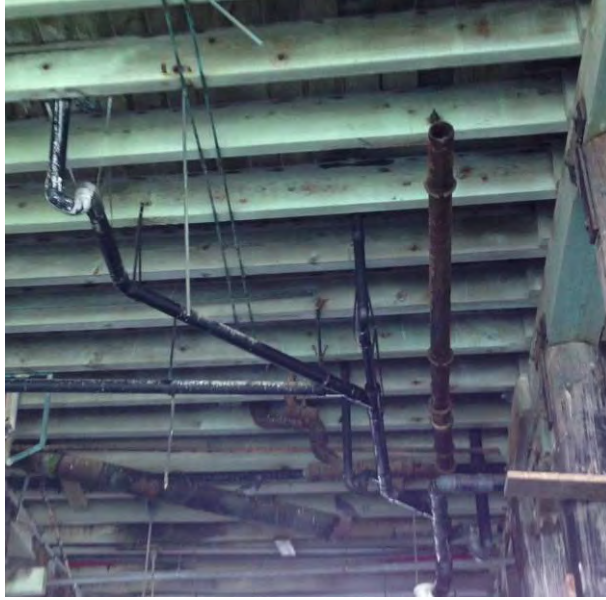
Photo 5-1: Sewer Lateral at bent 92 and Abandoned Cast Iron Line

1. Remove all abandoned piping beneath the Wharf.
2. Replace all mild steel hangers with hot-dipped galvanized or stainless steel.
3. Require pressure tests performed on all new laterals installed on the Wharf.
4. Perform monthly inspections for leaks of the sewage system for leaks along the entire Wharf during times of highest demand – typically 11 AM – 2 PM.
5. Perform inspections for leaks of the sewage system within 3 days (wave conditions permitting) after major wave storm events where wave crests have been observed within 5 feet of the Wharf deck.

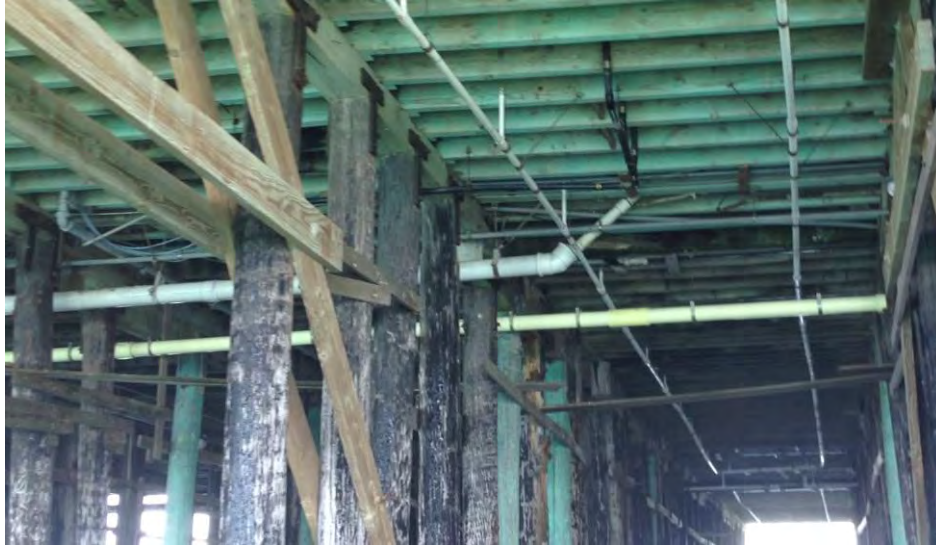
Photo 5-3: Cleanout at High End of Gravity Line

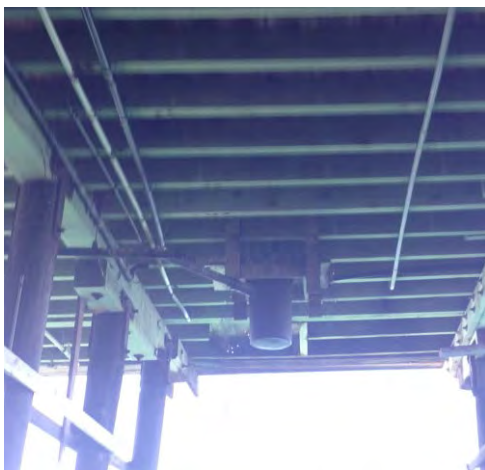
Photo 5-4: Pump at Lifeguard

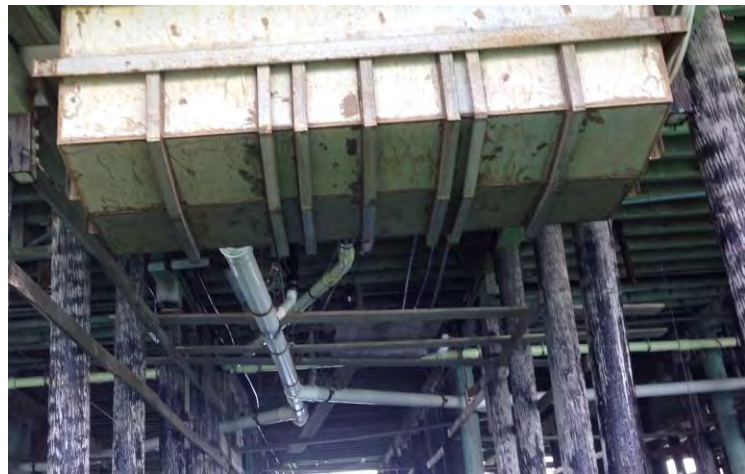
Photo 5-5: Sewer Pump Station at Bent 86

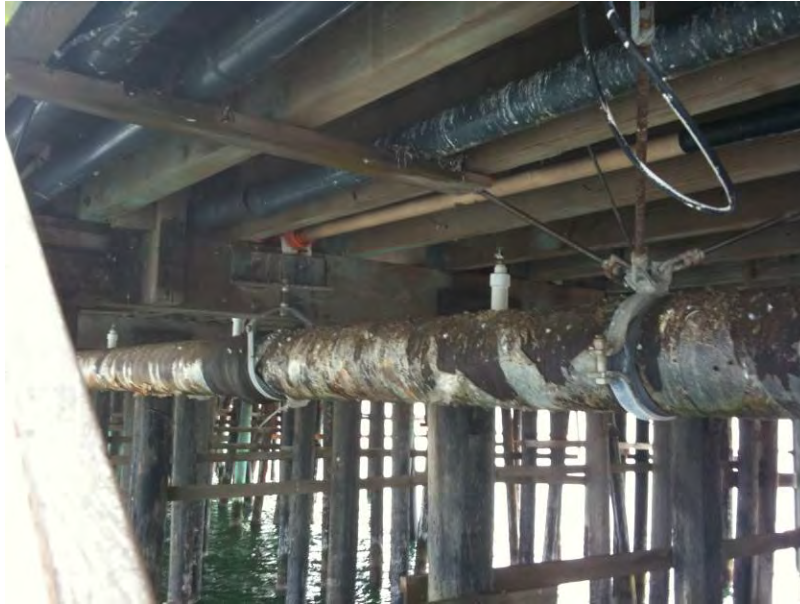
The ductile iron municipal water main below the Wharf is 10" (see Figure 6-1 and Photo 6-1) from the point of connection in Beach Street to bent 132 where it reduces to 6" and again reduces to 4" at bent 160. The municipal water main supplies seven hydrants along the length of the Wharf near bents 2, 37, 74, 90, 109, 131, and 160. The average hydrant spacing is 380 feet with the largest spacing between bents 37 and 74 at about 640 feet. The water main supplies the wet fire sprinkler systems that protect the substructure and buildings on the Wharf. Table B105.1 of the California Fire Code requires 7,250 gpm of fire flow for the 71,000 square feet of Type V-B buildings and allows up to a 75% reduction for buildings with sprinklers (1800 gpm minimum fire flow). The Wharf has a robust water supply available. Hydrant flow test show static pressures above 110 psi with 5,800 gpm available at Beach Street and over 3,000 gpm (41% reduction) available to hydrant distribution along the Wharf.

Photo 6-1: 10 Inch Ductile Iron Water Main Near Bent 70

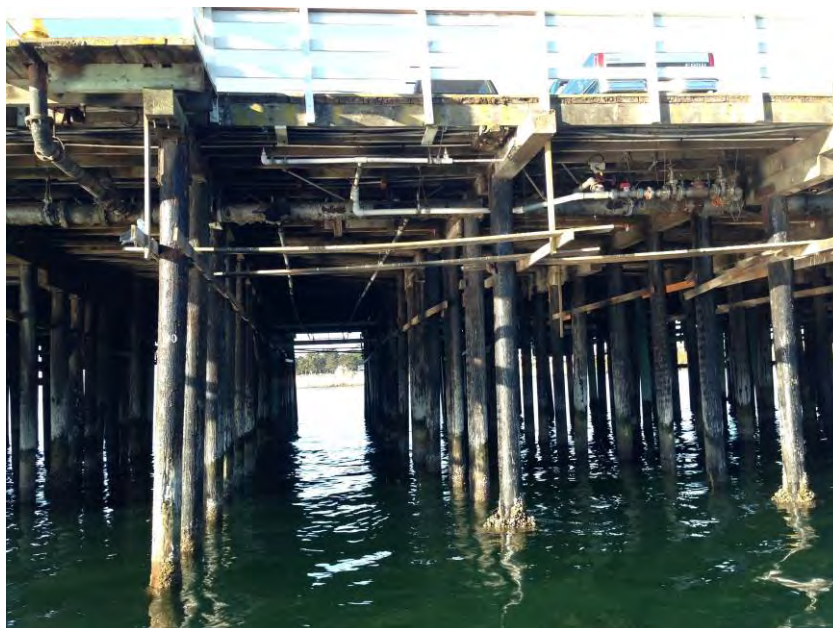
Photo 6-2: Fire Hydrant Bent 90

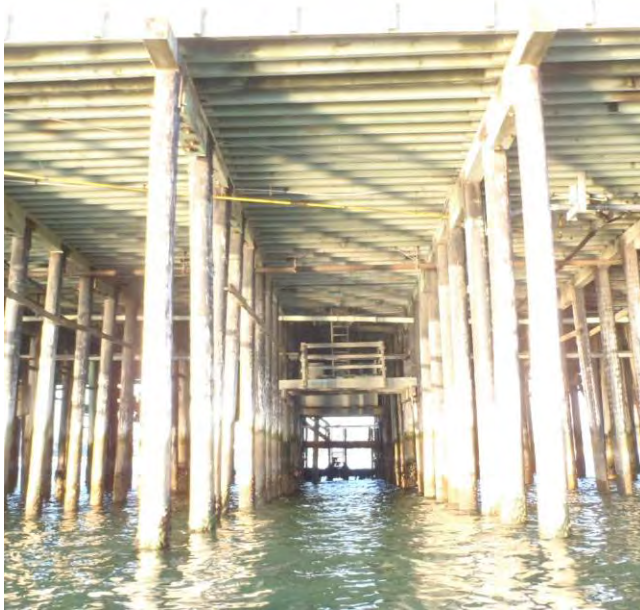
There are 10 access portals (hatches) on the Wharf deck located in the sidewalk, near the center of the Wharf, that provide access to a landing directly below (see Photo 6-3 and Photo 6-4). This allows firefighters access to fight fire in the substructure from the platform below or to lower a fire nozzle below to fight fire. Access portals are numbered, but fire department markers were not evident.

Photo 6-3: Fire Access Portal Platform at Bent 80

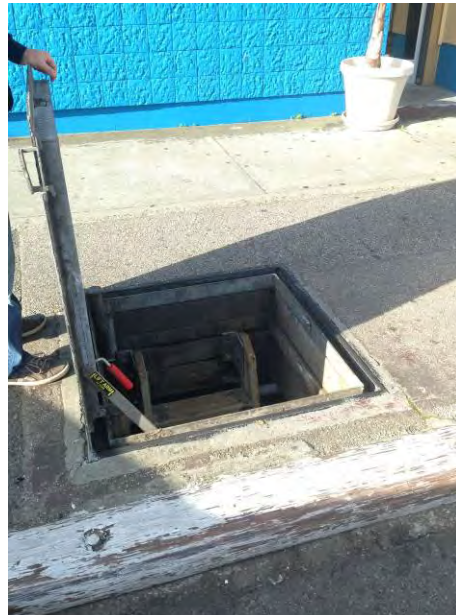
Photo 6-4: Fire Access Portal Bent 120

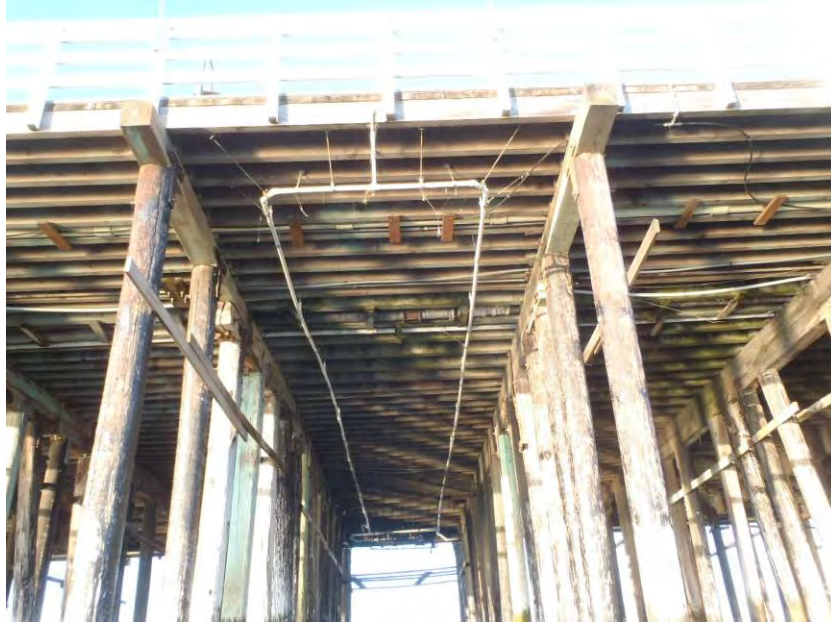
Photo 6-5: Bent 62 Sprinklers

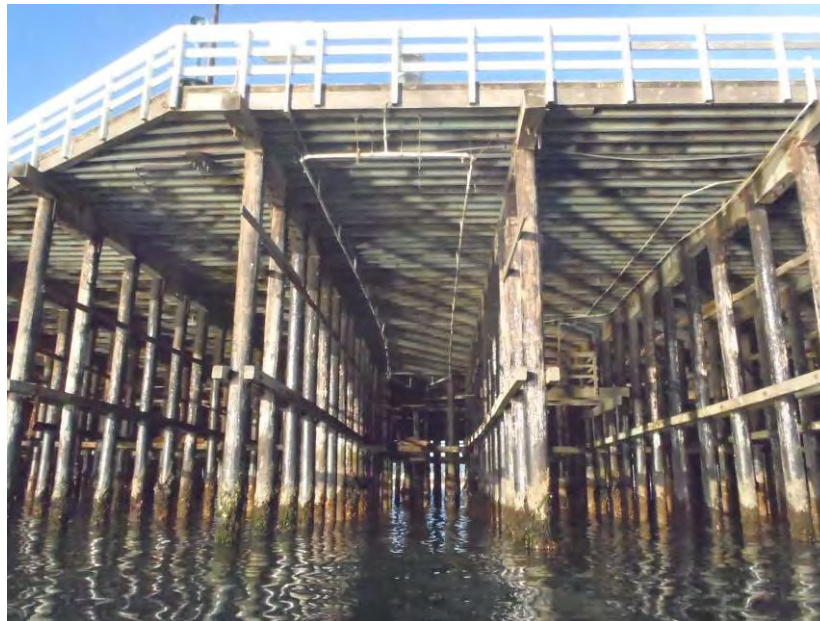
Photo 6-6: Bent 138 Sprinklers

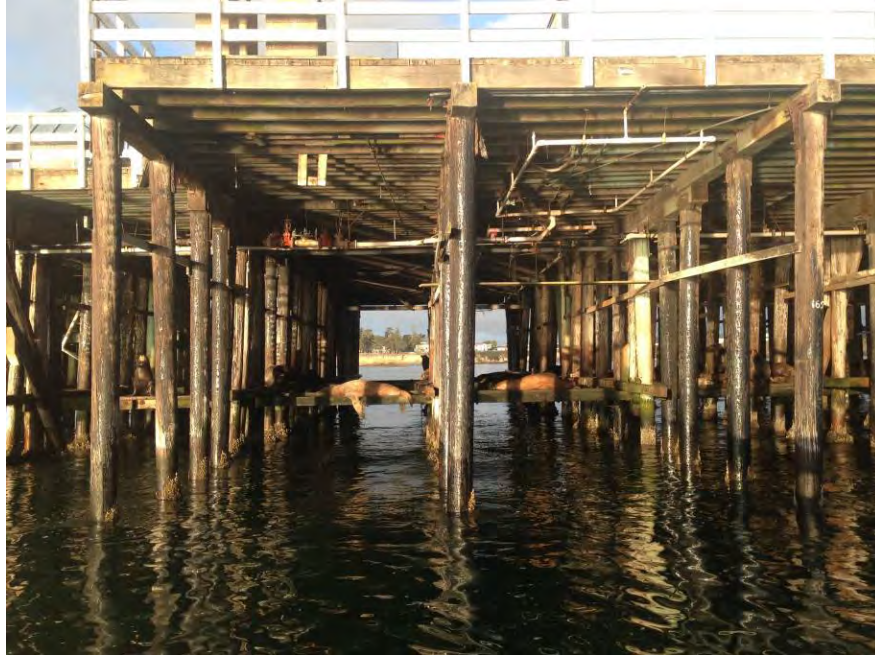
Photo 6-7: Sprinkler and BFP Bent 165

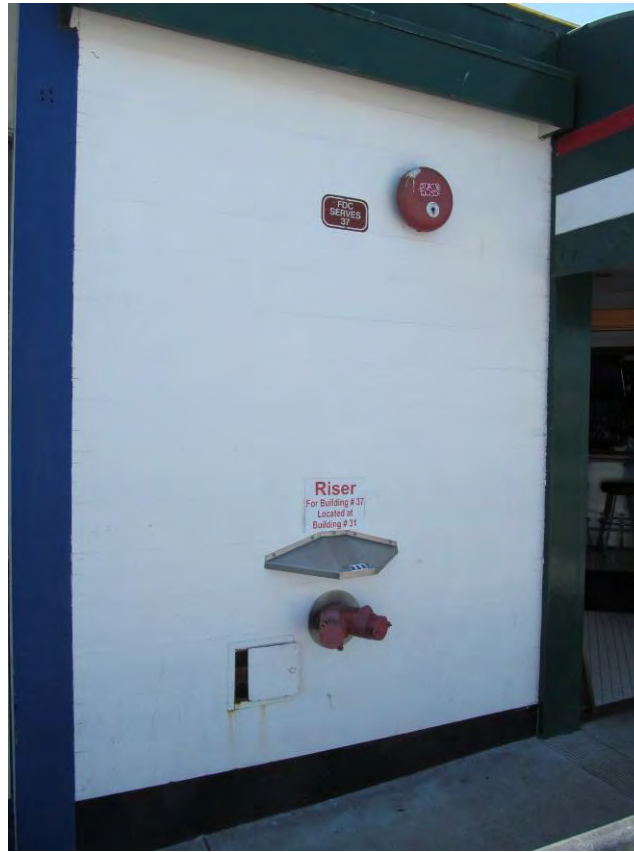
The superstructure or buildings above the Wharf are protected by overhead sprinkler systems. The separate tenant spaces have dedicated wet sprinkler risers complete with double check backflow preventer, flow switch, alarm bell, and fire department connection. The wet sprinkler risers and fire department connections are conspicuously located with alarm bell and signs (see Photo 6-8). Building fire sprinkler shop drawings were not reviewed.

Photo 6-8: Typical Riser, Fire Department Connection, Bell, and Signage.

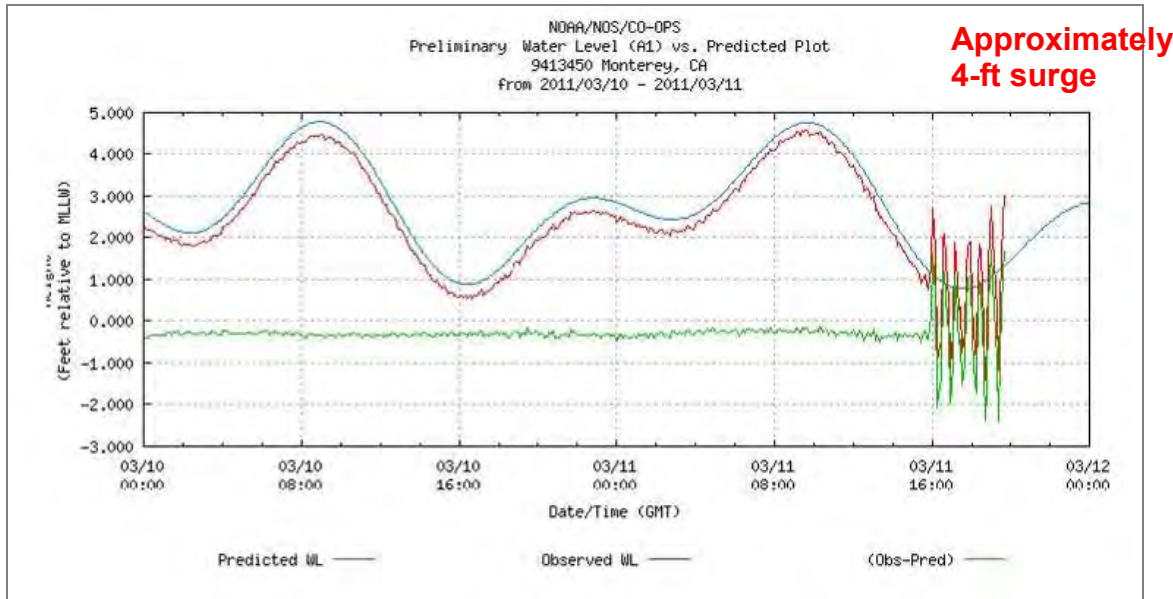
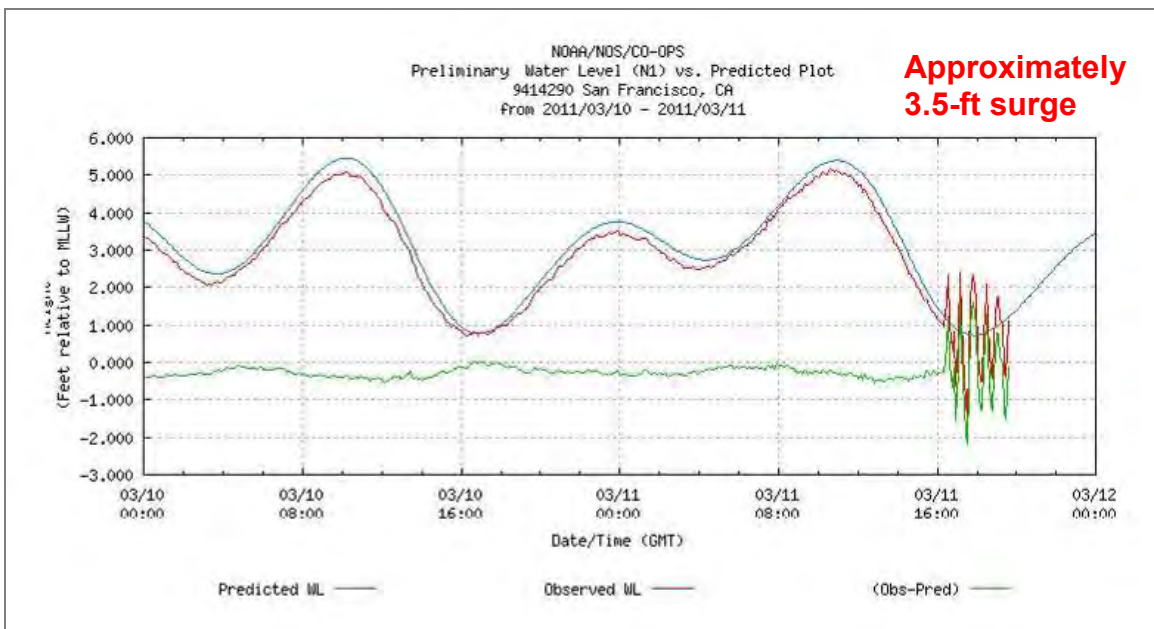
The tsunami hazard is not new to the California Coast because the entire Pacific Rim is highly seismically active. During the most recent 9.0 magnitude earthquake in Japan in March 2011, a tsunami reached Santa Cruz and caused substantial damage to the Santa Cruz Small Craft Harbor. Figure 10-3 shows the observed tsunami-induced surge at NOAA's Monterey and San Francisco tide gauges, just hours after the earthquake hit Japan and sent the tsunami waves to the U.S. West Coast. Although the Santa Cruz Yacht Harbor sustained considerable damage, the Wharf was undamaged. This is largely due to the location on the open coast without a narrowing of the waterway, as was the case at the Yacht Harbor and also the damaged harbor in

Crescent city. Approximately 4- and 3.5-ft surge were recorded at Monterey and San Francisco, respectively.

Figure 10-3: Tsunami-Induced Surge Observed at NOAA CO-OPS Gauges Hours after Japan 9.0 Magnitude Earthquake

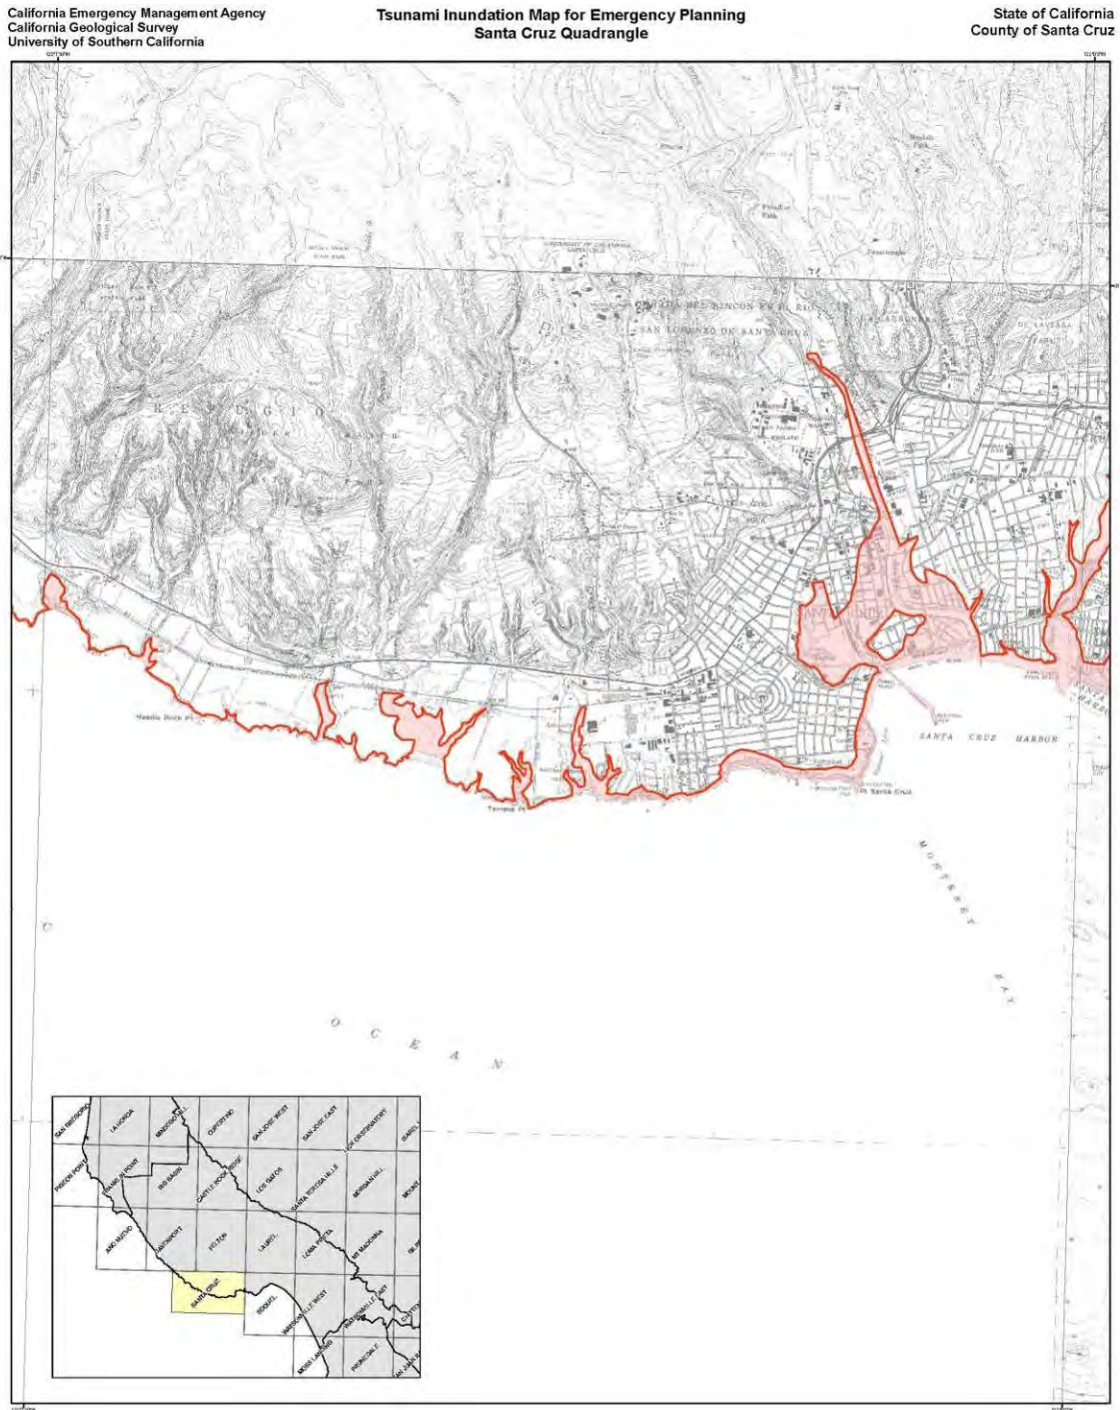
A joint effort by the California Emergency Management Agency, the California Geological Survey, and the University of Southern California modeled a suite of tsunami source events, representing realistic local and distant earthquakes and hypothetical extreme undersea, near-shore landslides (CGS, 2009). The produced maps are designed for emergency planning along the California coast. However, each map does not represent inundation from a single event, but an ensemble of potential source events affecting each specific region. Figure 10-4 illustrates the tsunami inundation zone within the City of Santa Cruz. The Wharf, the entire beach, and the majority of the Downtown area are within the potential tsunami inundation zone.

Figure 10-4: Tsunami Inundation Zones within the City of Santa Cruz (Extracted from the California Geological Survey Website)
