Santa Cruz Wharf Engineering Report

October 8, 2014

Engineering Evaluation Summary

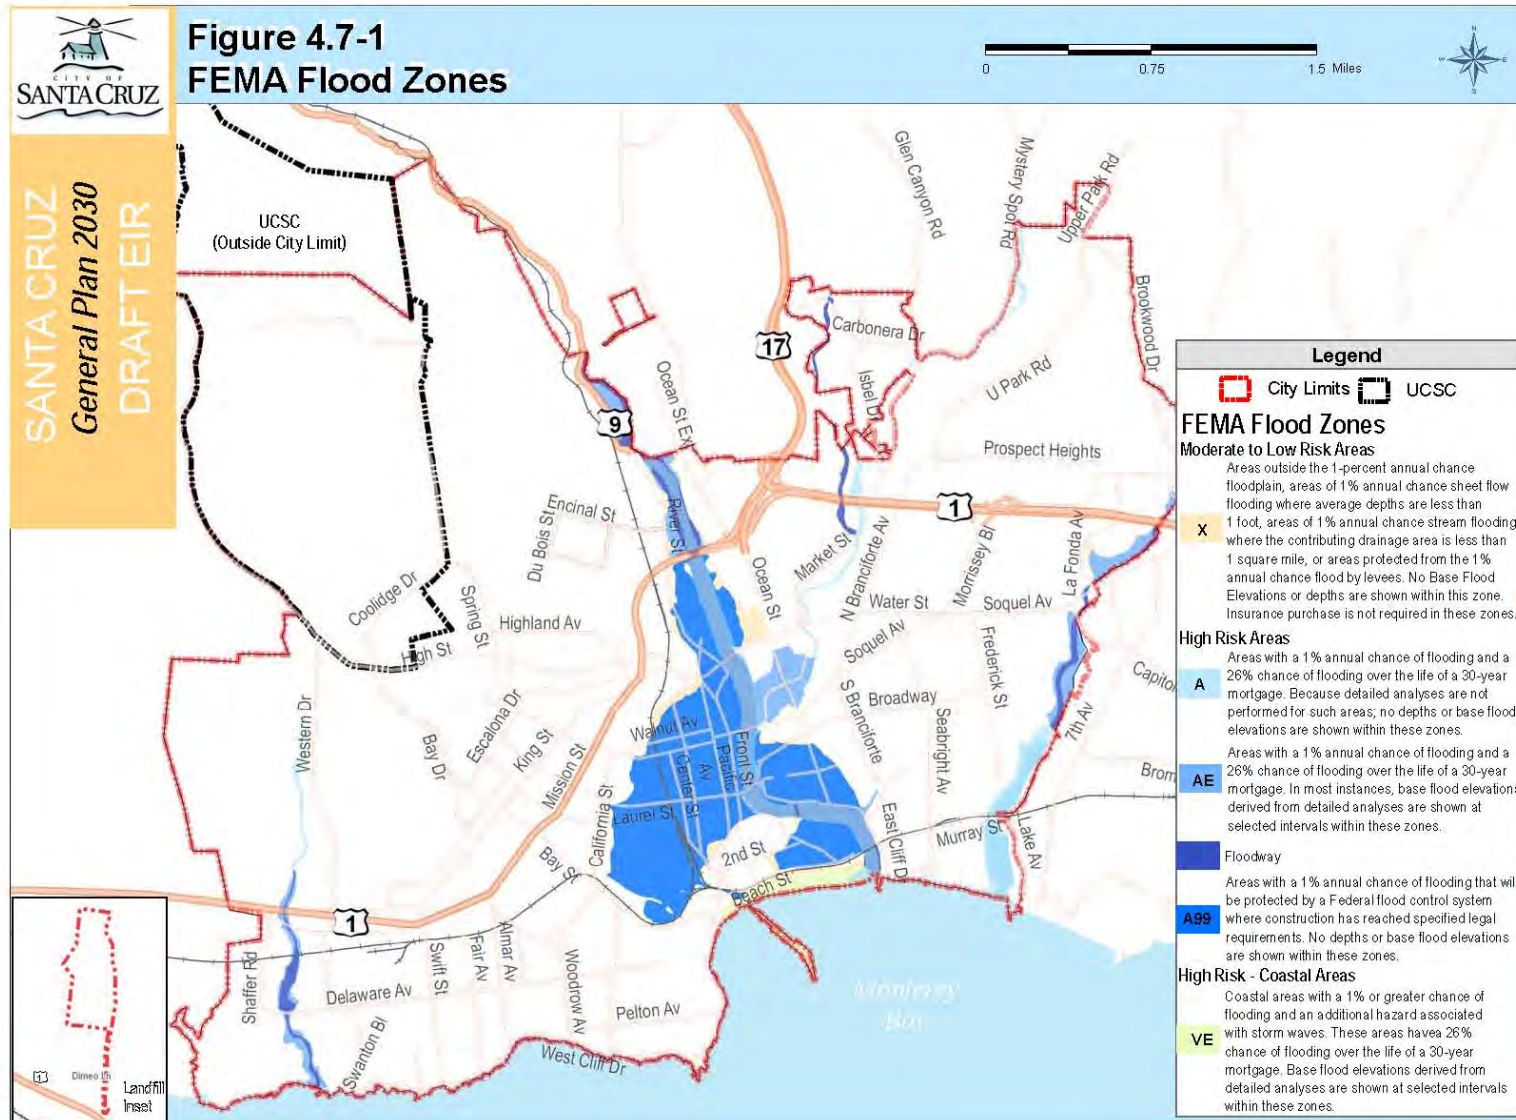
The City of Santa Cruz leads an effort to update the City's General Plan extending to year 2030 (City of Santa Cruz, 2012). The General Plan notes that although the City has been working to improve the flood capacity of the San Lorenzo River levees over the past two decades and reaches significant improvements, the risk of flooding may still occur. However, the flood improvements were recognized by the Federal Emergency Management Agency (FEMA) and they re-issued the Digital Flood Insurance Rate Map (DFIRM) to re-designate much of the Downtown area to the A-99 Flood Zone, an area protected from a 1% chance of flooding by a Federal flood control system under construction. Figure 10-5 illustrates the re-issued FEMA DFIRM, as extracted from the City's General Plan 2030.

Figure 10-5: FEMA Flood Zones within the City of Santa Cruz (Extracted from the City of Santa Cruz Areas General Plan 2030)

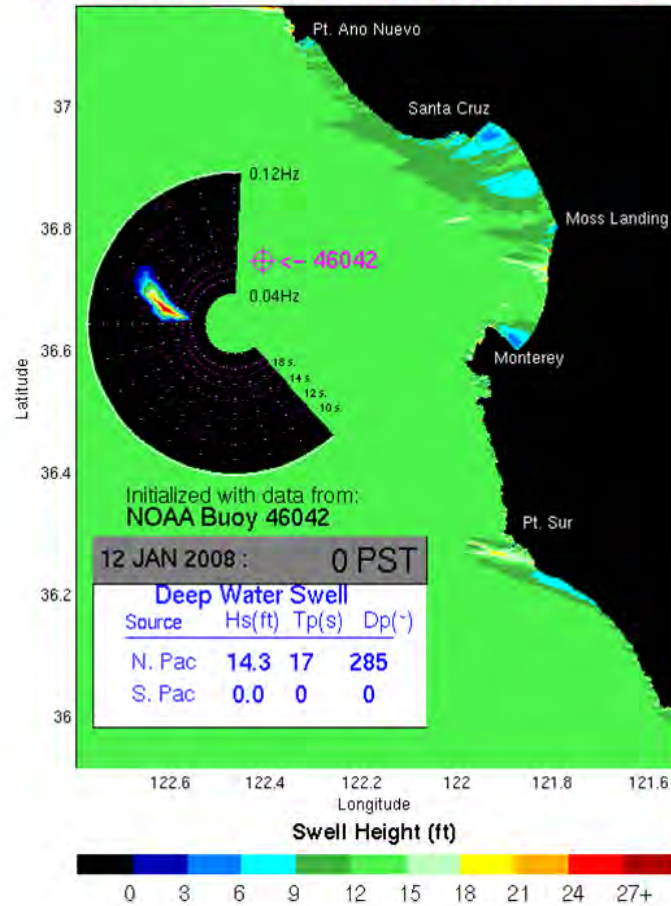
The Coastal Data Information Program (CDIP) of the Scripps Institution of Oceanography developed a regional swell model off the coast of the Monterey Bay. Two snapshots were downloaded from the CDIP website: one is during west-northwest swells and the other is during south swells (Figure 10-7 and Figure 10-8). Historically, during predominant west through northwest swells, a significant wave reduction was observed at the Wharf due to refraction around Point Santa Cruz. The USGS model shows an approximately 35% of wave energy remaining near the Wharf during west-northwest swells (Storlazzi et. al., 2011). The CDIP snapshot also shows a significant amount of wave dissipation near the Wharf. However, during south swells, the CDIP snapshot shows the wave energy can propagate into the area with minor or no reduction, due to its direct exposed to the south. The annual wave rose shows potential waves up to 30 ft. from the west – northwest quadrant and 20 ft. from the south. With the assumption of 35%-40% of energy remaining, the west - northwest swells yield an approximate maximum wave of 12 ft. near the Wharf. With the assumption of no wave reduction for south swells, the potential south swells result in an approximate maximum wave of 20 ft. near the Wharf. Given the seabed is at 26-ft below MLLW, the waves are possibly not breaking near the end of the Wharf.

Figure 10-7: CDIP Monterey Bay Swell Model – a Snapshot during WNW Swells

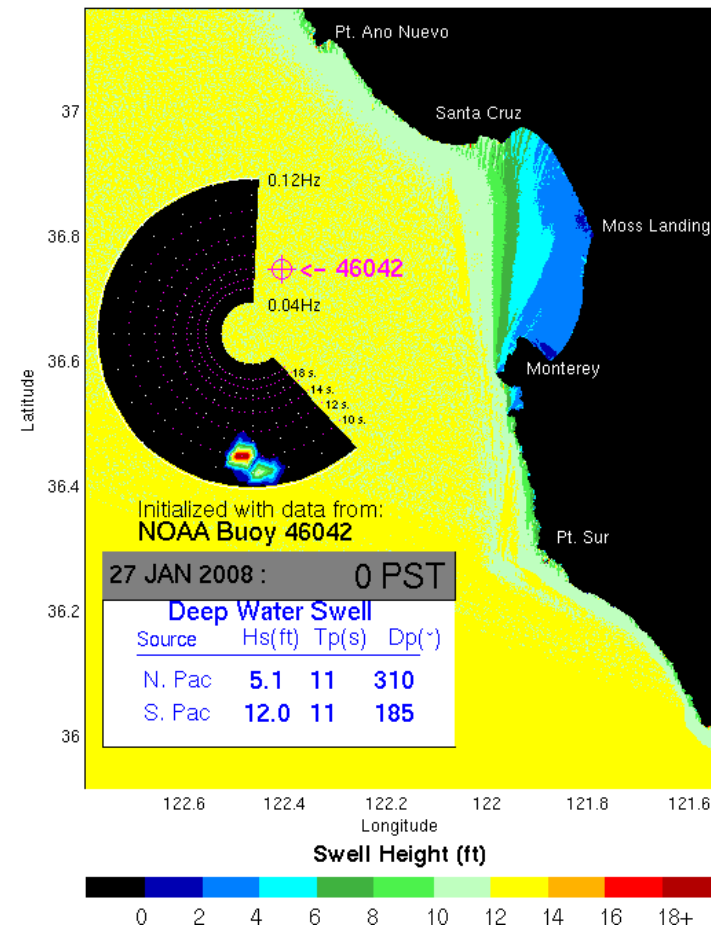
Figure 10-8: CDIP Monterey Bay Swell Model – a Snapshot during South Swells

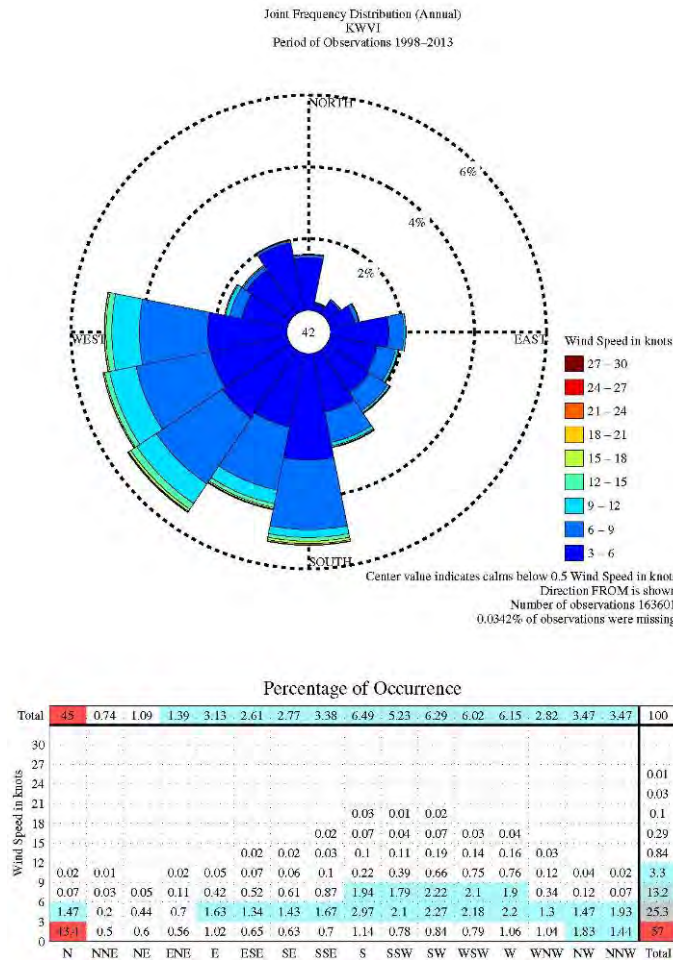
The Watsonville Airport, approximately 13 miles to the east, is one of the Meteorological Terminal Aviation Routine weather report (METAR) network stations (Station ID: KWVI). The 2-minute duration winds were analyzed from 1998 to the present. Figure 10-9 (below) and Figure 10-29 through Figure 10-32 (Attachment) show the annual and seasonal wind roses for the Airport. Wind speeds less than 0.5 knots are considered calm conditions.

Figure 10-9: Annual Wind Rose at the Watsonville Airport

Results show the predominant winds are from the south through west quadrant, especially during the spring, summer, and fall seasons. During late fall to early spring, the north and northwest winds start increasing their occurrences, with the greatest during the winter season. Additionally, the winter has the most frequent storms, with 0.4% of the time winds exceeding 18 knots, followed by the spring and fall season with 0.08% and 0.11%, respectively. None of the winds exceeding 18 knots in summer during 16-year data analyzed for the Watsonville Airport. Given the Wharf is directly exposed to the south, the potentially largest winds from the south through southwest might need to be taken into account.

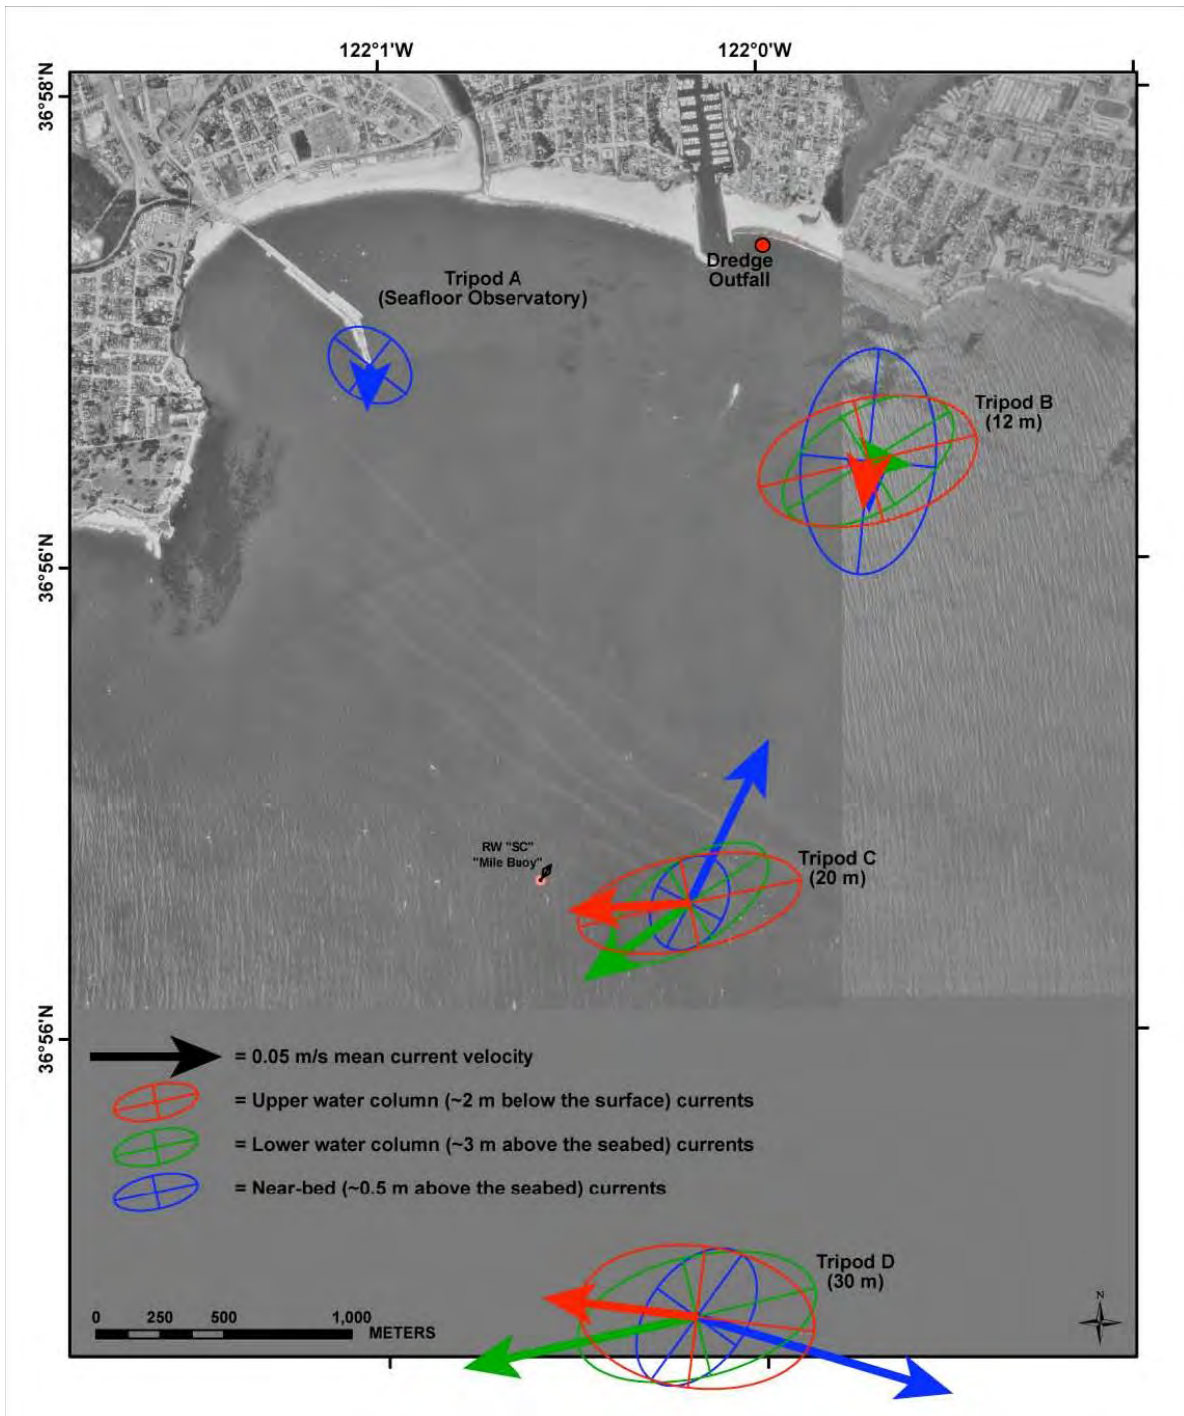
Additionally, the USGS Sea Floor Observatory (Tripod A) and three additional seabed tripods, mounted with four upward-looking acoustic Doppler current meters (ADCM) and three downward-looking ADCMs, were deployed between 9 m and 30 m isobaths near the Wharf (Storlazzi et. al., 2011). Figure 10-10 presents the measured current results at various depths during the study period between October 2009 and December 2009. The mean currents offshore were much stronger and more uniform (Tripods C & D) than those closer to shore (Tripods A & B), where the mean currents were weaker and more variable. Closer to the seabed, the currents primarily were oriented cross-shore (in north-south direction) closer to shore, but alongshore (in east-west direction) at Tripod D. Currents near the surface primarily were oriented alongshore (Storlazzi et. al., 2011). Except the mean currents near seabed at Tripod C, the mean currents are primarily oriented out of the Bay, which is consistent with the observation in the Desalination Project. The largest measured current speed during this period is approximately 0.5 knots (0.28 m/s) at the seabed near the Wharf.

Figure 10-10: Illustration of Principal Axis Ellipses and Mean Current Speeds and Directions by Depths (Extracted from Storlazzi et. al., 2011)

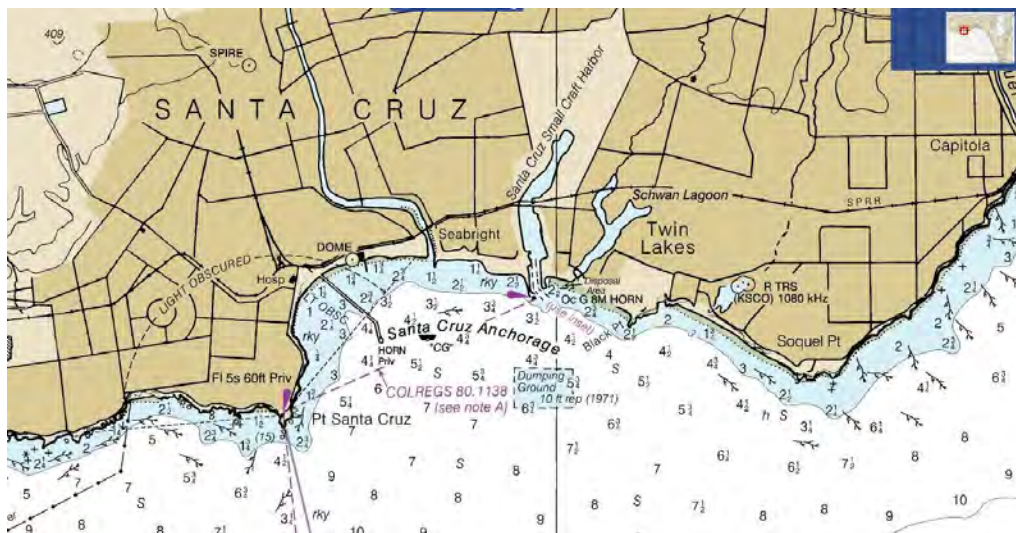
Santa Cruz Wharf is clearly identified on the nautical chart, as shown on Figure 10-11. The Wharf is well lit, and has 2 “obstruction” lights on each corner of the end (however these 2 lights are not indicated on the nautical chart-see recommendations). With these fixed aids to navigation (on chart, light and horn) the risk from collision due navigation error is low and adding additional fixed aids would do little to reduce this risk.

Figure 10-11 Nautical Chart of Santa Cruz Harbor and COLREGS Excerpt

1. Widen the Wharf with vertical timber piles to increase its resistance to lateral wave and tsunami forces.
2. Evacuate the Wharf during periods of predicted extreme waves, as occurred in 1985 and 1998
3. Apply for a correction to the US Coast Guard to correct Chart 18685 (Monterey Bay) to indicate obstruction lights at the end of the Wharf
4. Limit anchorage on the west side of the Wharf to outside 200 feet (see recommendation 4, Section 6). Notify the US Coast Guard of such to update the Nautical Chart and US Coast Pilot (companion text book to the Chart)
5. Implement the West Walkway as called for in the Master Plan to protect the west side of the Wharf and buildings
