Boardwalk

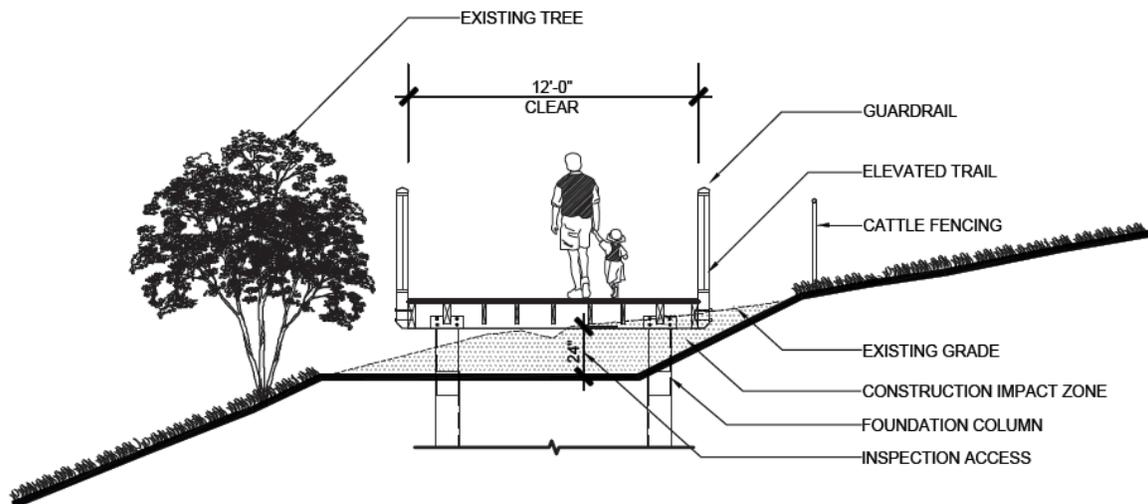
ALTERNATE SECTION D2

Standards for a multi-use trail require an 8 foot wide minimum accessible surface and 2 feet clear width on each side. Therefore the deck will need to have a 12 foot clear interior width and also require 4-1/2 foot high safety railings. A boardwalk structure is limited to a 3-5% grade, with a strong preference for a flat surface due to limited slip resistance and in consideration of wheelchair/wheeled users limitations, rather than up to 10% slopes allowed for the other surface materials.

A boardwalk section is shown below at Section D2 of the CNPS alignment.

A boardwalk for the CNPS alignment will become longer and will require grading (notching into the hillside) due to the existing topography. Grading will also be required to bring in equipment to drill piers and to haul in materials. These conditions will modify existing drainage patterns creating the need for swales, laying back the slope and greater

erosion control measures. The surface of the boardwalk must be raised above the soil by a minimum 2 feet for foundation inspection and the ability to maintain the structure. The space created below the structure will have to be closed off to minimize illegal camping and will become an ongoing maintenance problem, as experienced by the City on other structures.
