# OPERATION, MAINTENANCE, REPAIR, REPLACEMENT AND REHABILITATION (OMRR&R) MANUAL

## San Lorenzo River, California

3 July 2020

# Volume I: Main Report

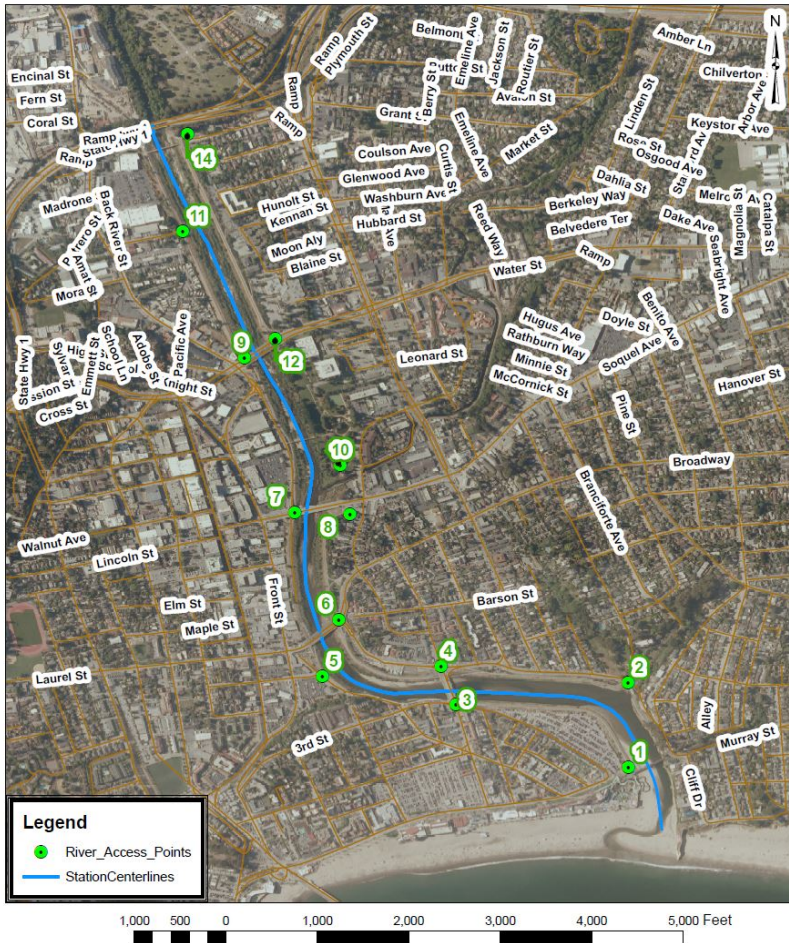
Figure 3. San Lorenzo River access points

Primary vehicle observation and access points for viewing and flood fighting on the San Lorenzo River are located at the project access point locations listed below (Figure 3). Even numbering represents access points on the left bank. Odd numbering represents access points on the right bank.

- ◆ 3rd & Beach Streets (1)
- ◆ Riverside Avenue Bridge (3)
- ◆ Laurel Street Bridge (5)
- ◆ Soquel Avenue Bridge (7)
- ◆ Water Street Bridge (9)
- ◆ Josephine Street (11)
- ◆ East Cliff Street (2)
- ◆ Riverside Avenue Bridge (4)
- ◆ Laurel Street Bridge (6)
- ◆ Soquel and Dakota Avenues (8)
- ◆ Dakota Avenue at Branciforte Creek (10)
- ◆ Water Street Bridge (12)
- ◆ From Ocean Street on Felker Street (14)

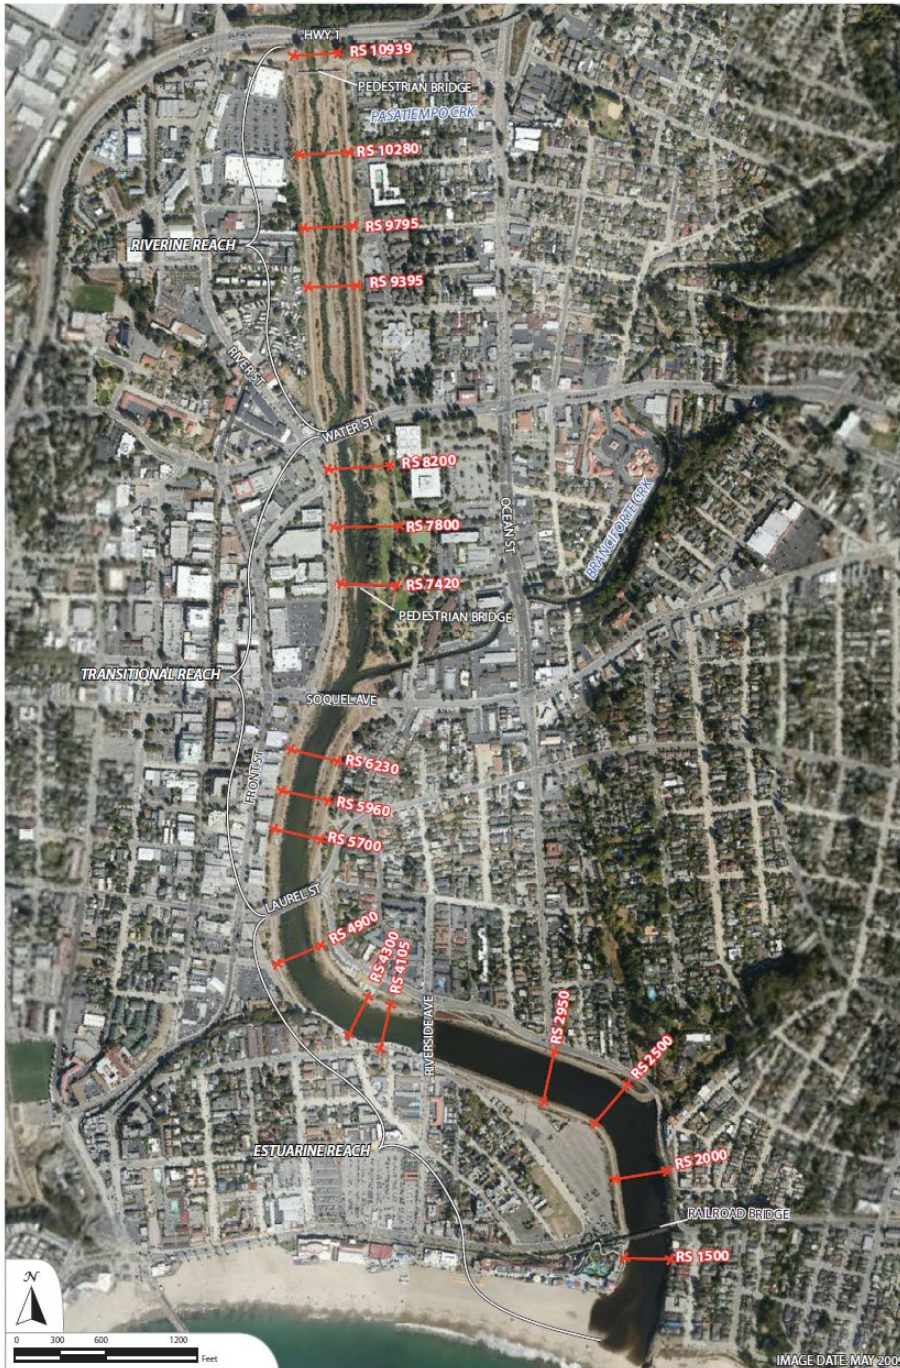
Figure 6. Locations of cross-sections used for the city's monitoring program (Waterways Consulting 2017)

The City of Santa Cruz has been collecting cross-section data at the listed sediment survey stations periodically since 2001 (Figure 6; Table 10). Use of these fixed stations will aid in understanding long-term shoaling issues and can be supplemented with additional survey stations as needed to provide more detail of an observed excessive sediment area. It is recommended that an additional survey station be added upstream of Highway 1 as needed for observed excessive shoaling. Additionally, a hydraulic model has been provided to the City of Santa Cruz that can be used to check channel capacity for the design event against each new survey. It is highly recommend that this hydraulic model be used after each periodic survey to confirm channel capacity or delineate areas requiring removal of excess shoaling. At a minimum, data at six cross-sections (shown in **bold** in Table 10) should be taken for every survey conducted.

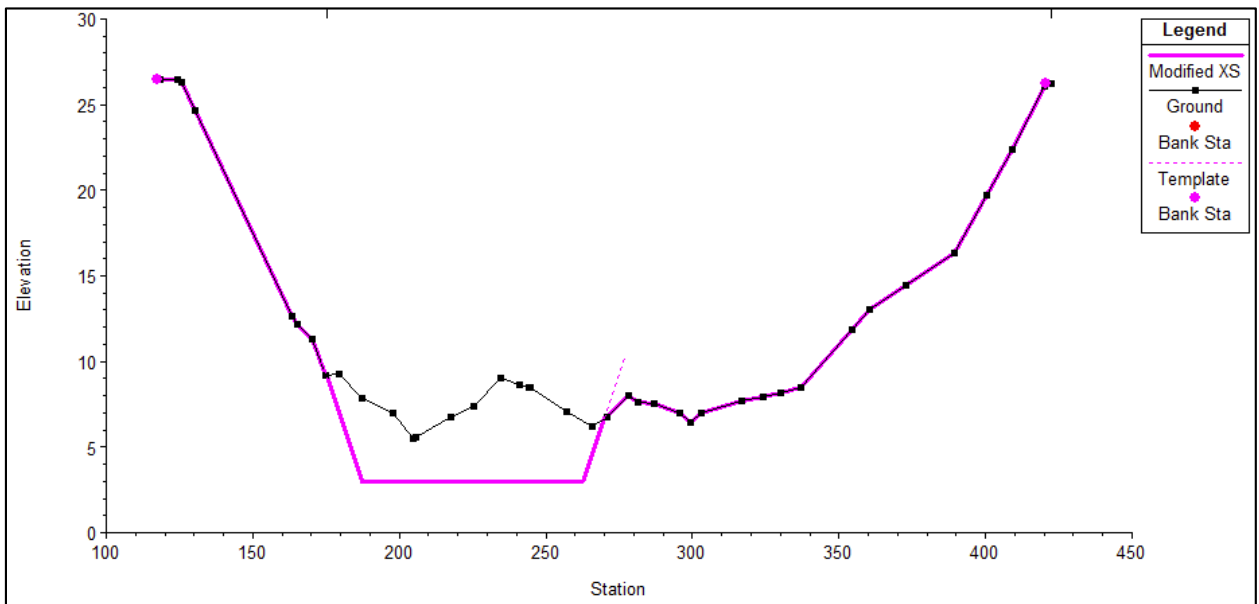
Figure 7 Geomorphic Bankfull Channel Excavation Concept (not for design or construction purposes)

- ◆ **Option 1: Conventional Channel Excavation Design.** The excess sediment is excavated across the width of the channel to the 2011 bed-profile elevation.
- ◆ **Option 2: Geomorphic Bankfull Channel Excavation Design.** A narrower, deeper, geomorphic bankfull channel is excavated within a portion of the channel that restores the required channel conveyance capacity and potentially reduces the amount of future excavation required for the Project (Figure 7).

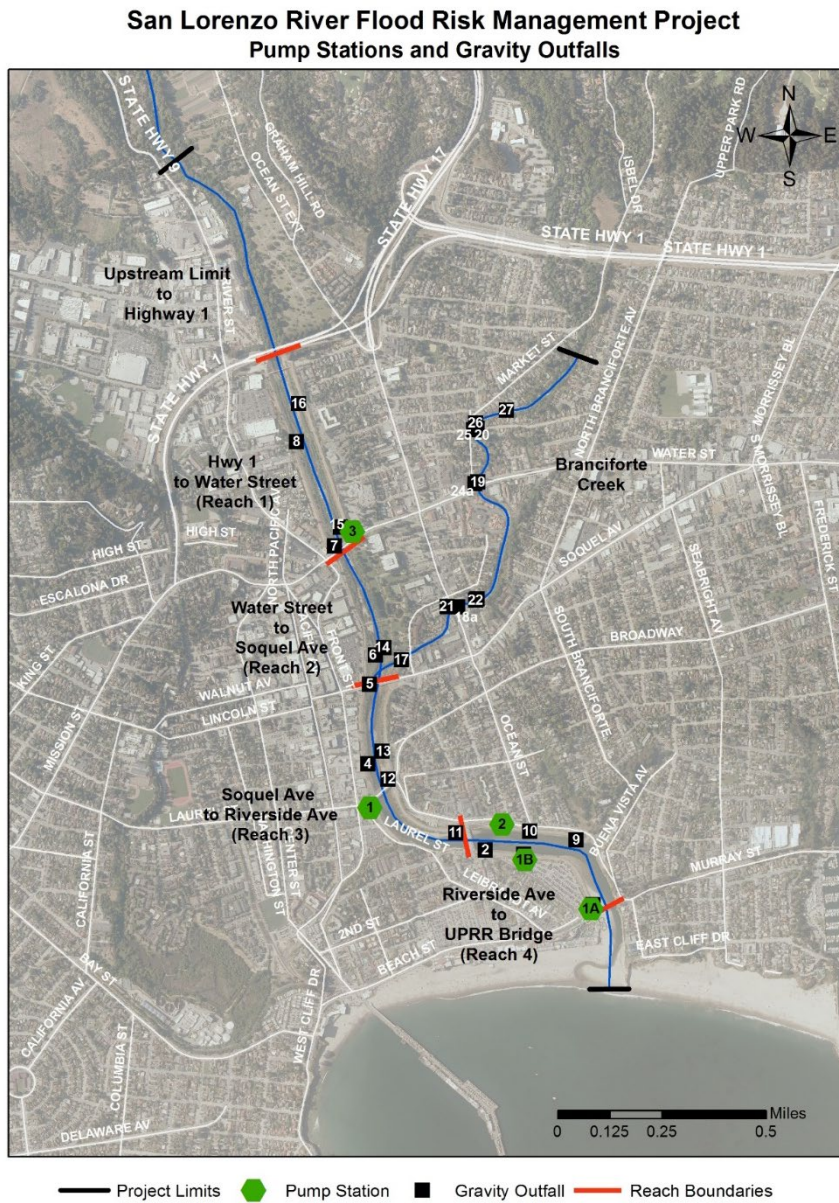
Figure 8. Approximate locations of pump stations and gravity outfalls

The interior drainage system is intended to function for the most part under gravity flow through the gravity outlets, and pumping stations are not to become operative until it is no longer possible to drain the system by means of gravity flow. This condition exists when the water surface elevation in the San Lorenzo River and Branciforte Creek becomes high enough to close all flap gates. A location map and summary of pump stations are provided in Figure 8 and Table 12.

Figure 8 shows the approximate locations of Original Project drainage structures. The flap gates have been replaced with duckbill valves in many cases.
